48 Barrow Street

Proposed Construction

Existing Conditions

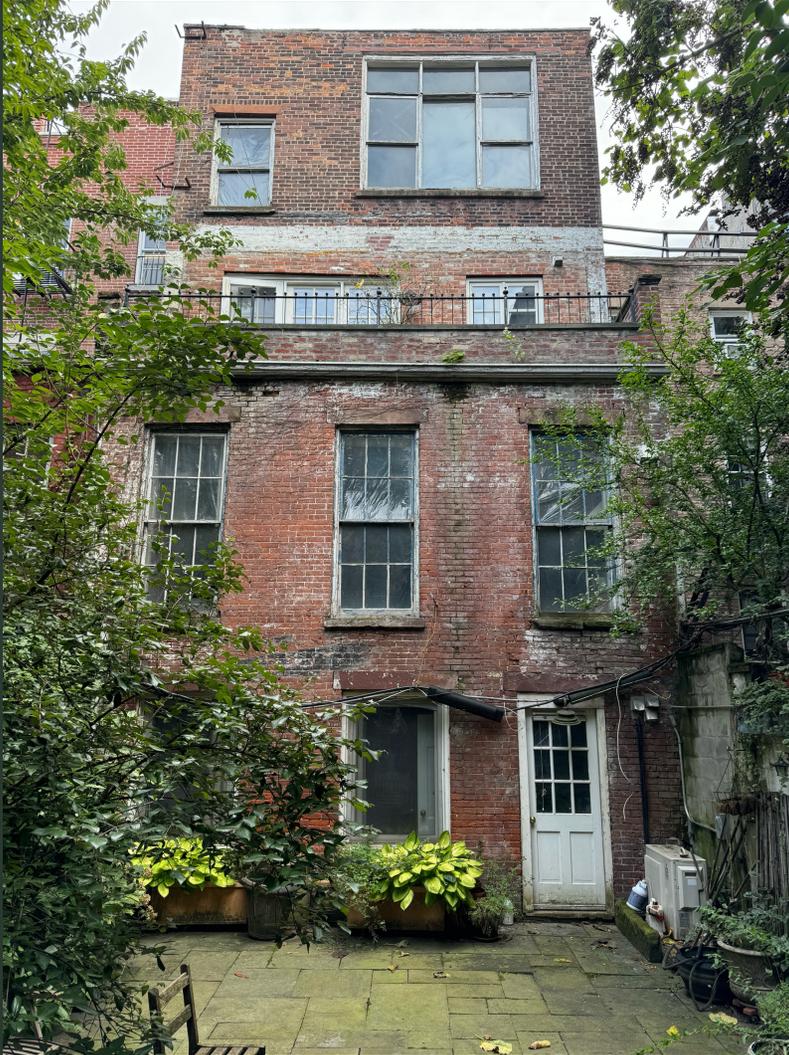
Rear of House from Yard

- Structural repair to back and west wall needed
 - West wall of 48 Barrow does not have a party wall along its full length
 - Addition on second and third floor made only using one wythe of brick on side walls
 - There is no foundation below the original extension - the foundation is below the load bearing brick wall at the end of the double parlor - the wall for 2nd and 3rd floors which originally matched the other houses in the row

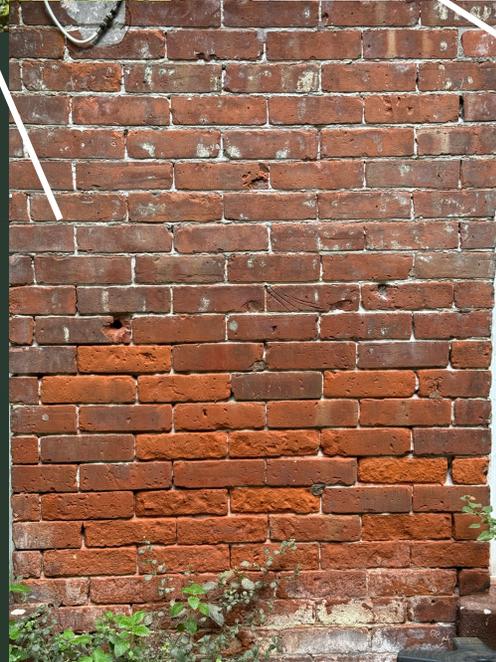
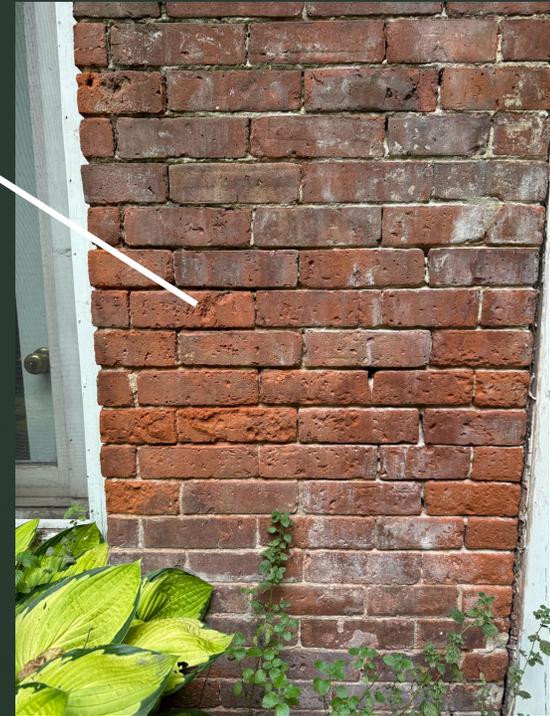
Brick Condition

Ground floor -
original brick in
poor condition

- New foundation added below exterior wall of extension
- Existing rear wall at extension and second and third floors removed
- Steel joists added at Parlor floor ceiling level to support structure above
- Steel beams added in rear wall of extension to support new rear wall
- East and west wall stabilized and tied-in
- New windows across back of house to allow more light
- Large ribbon window on third floor - connecting history of artist residence

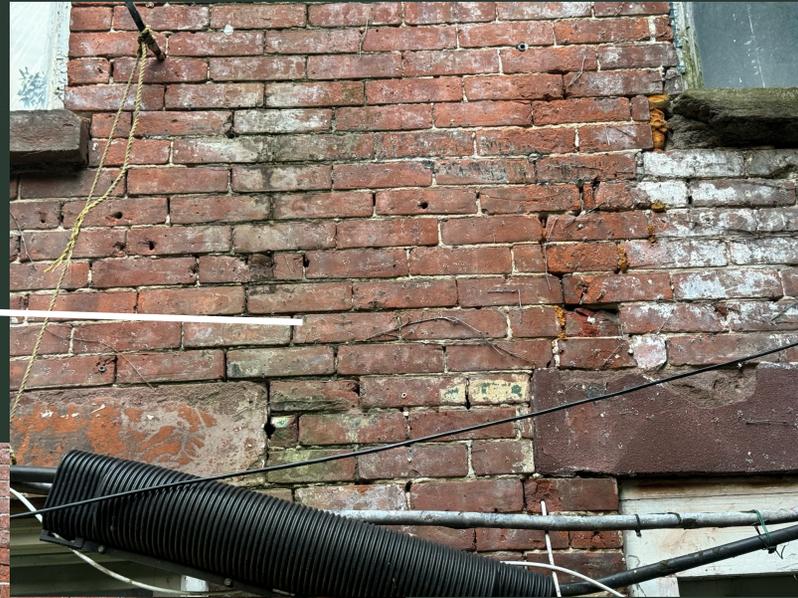
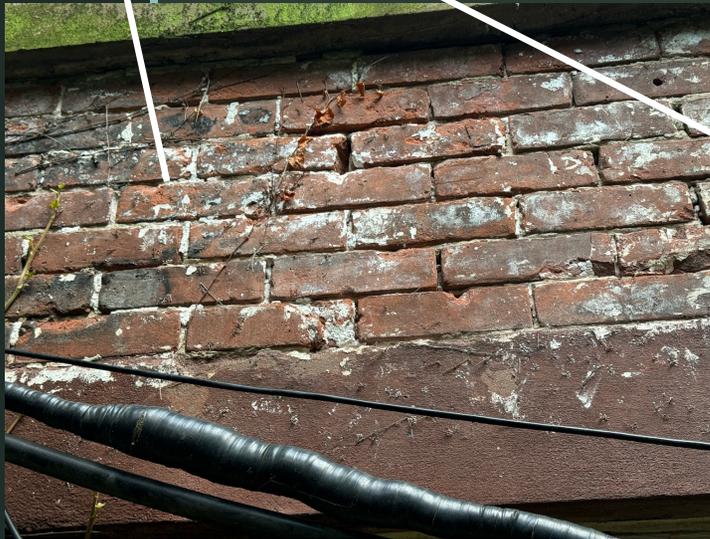
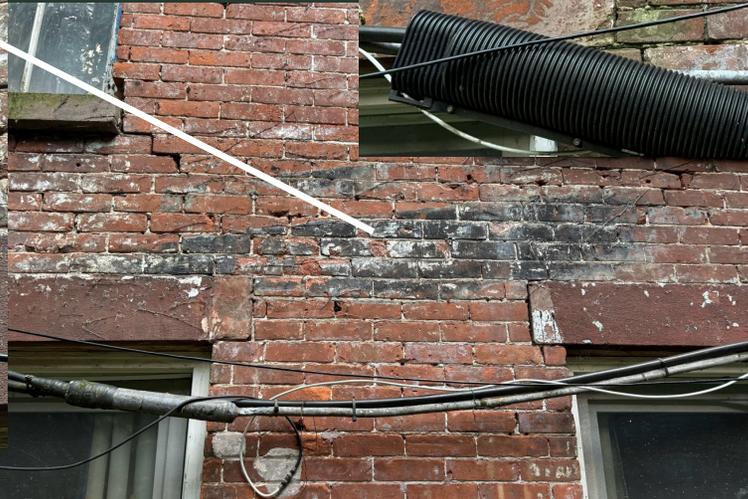
Brick Conditions

Original brick on Parlor Floor in poor condition due to fire in 2001 when a restaurant was on the ground floor

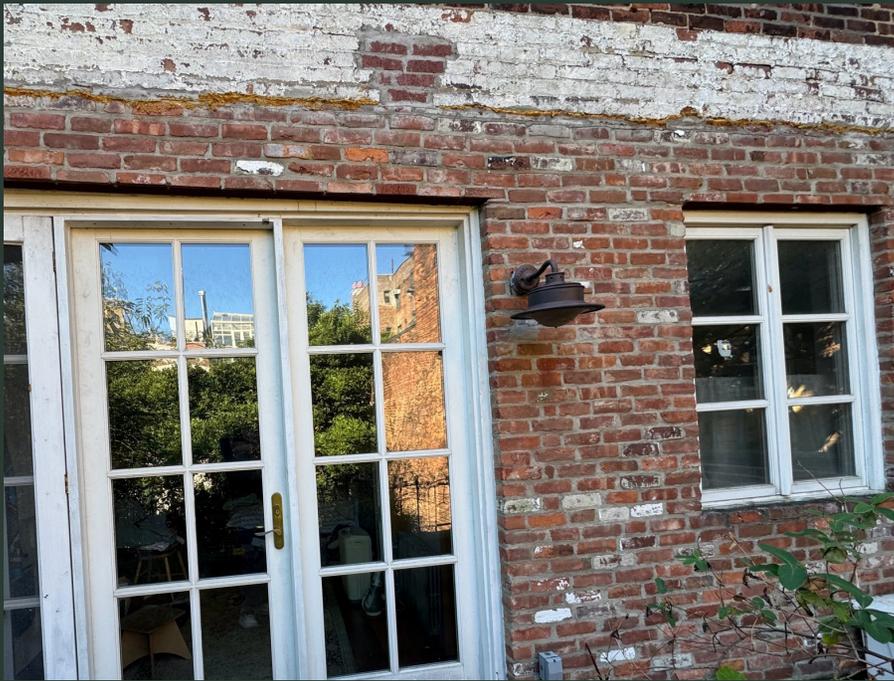
Brick Condition

2nd Floor has brick only brick facia

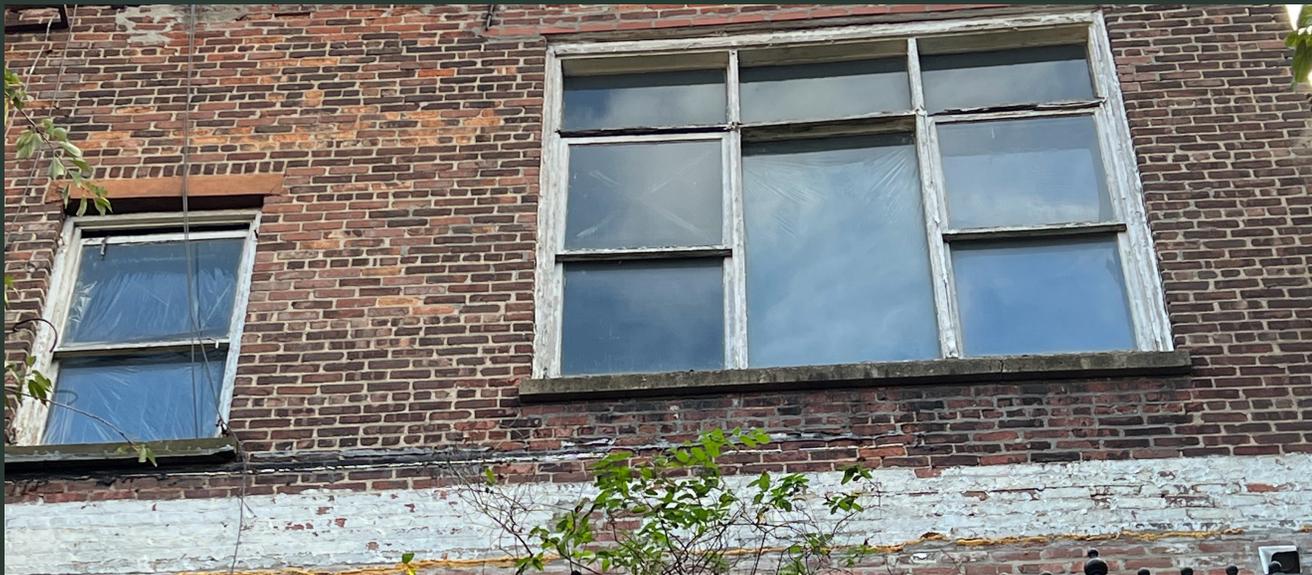
Brick Conditions

Third floor addition - different than original brick
