34 WEST 12TH STREET

LANDMARKS PRESENTATION:

Re: 34 W 12th Street, NY, NY – Existing brick façade at back.

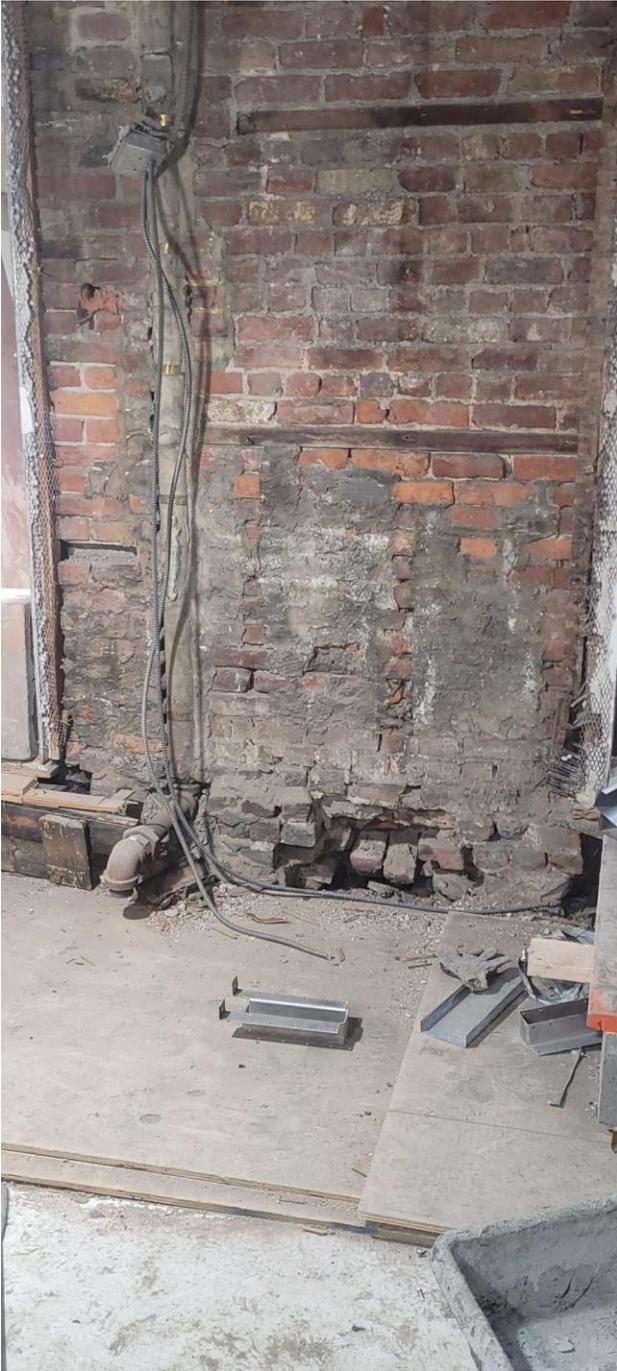
Bricks were loose, mortars at joints were weak. Bricks at base were falling apart.

Based on our findings above, it is our professional opinion that the existing back façade shall be re-built with new. In order to preserve the appearance of the back façade as much as possible, we will propose re-using old bricks as veneer with metal studs backing.

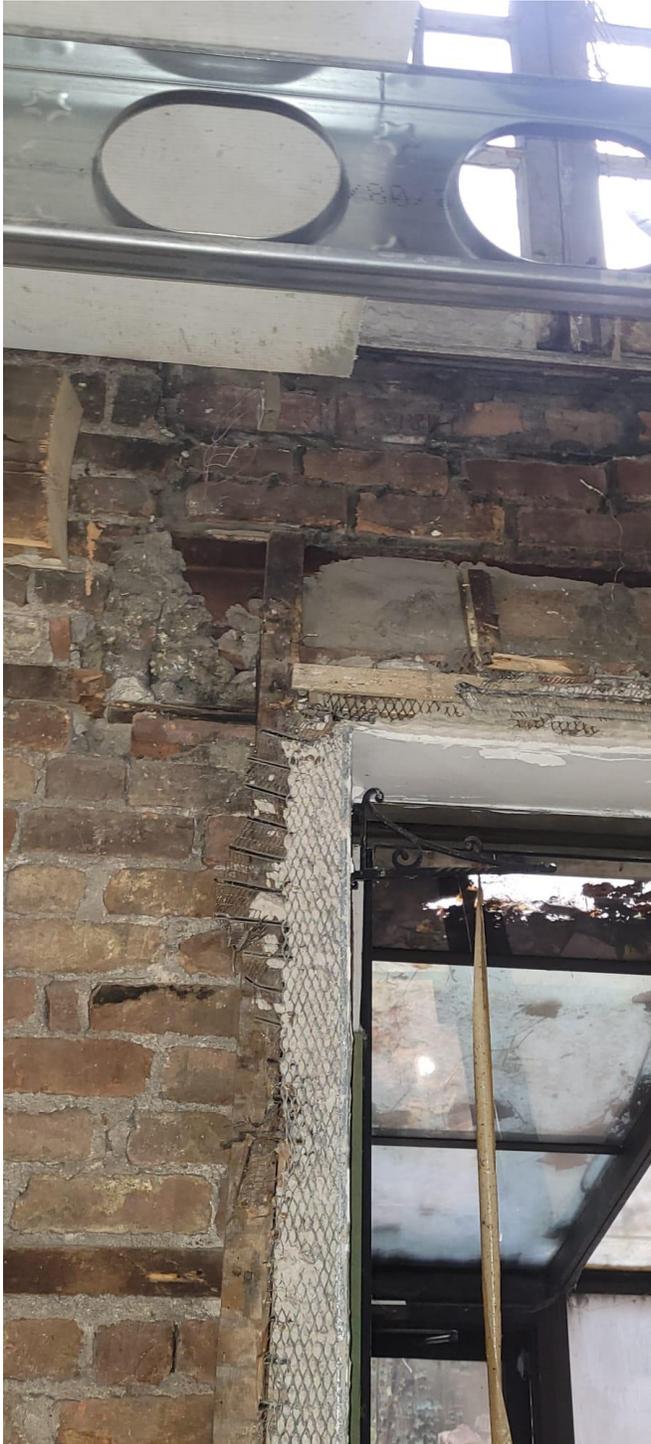
Bricks were found settling. Loose mortar joints were found.

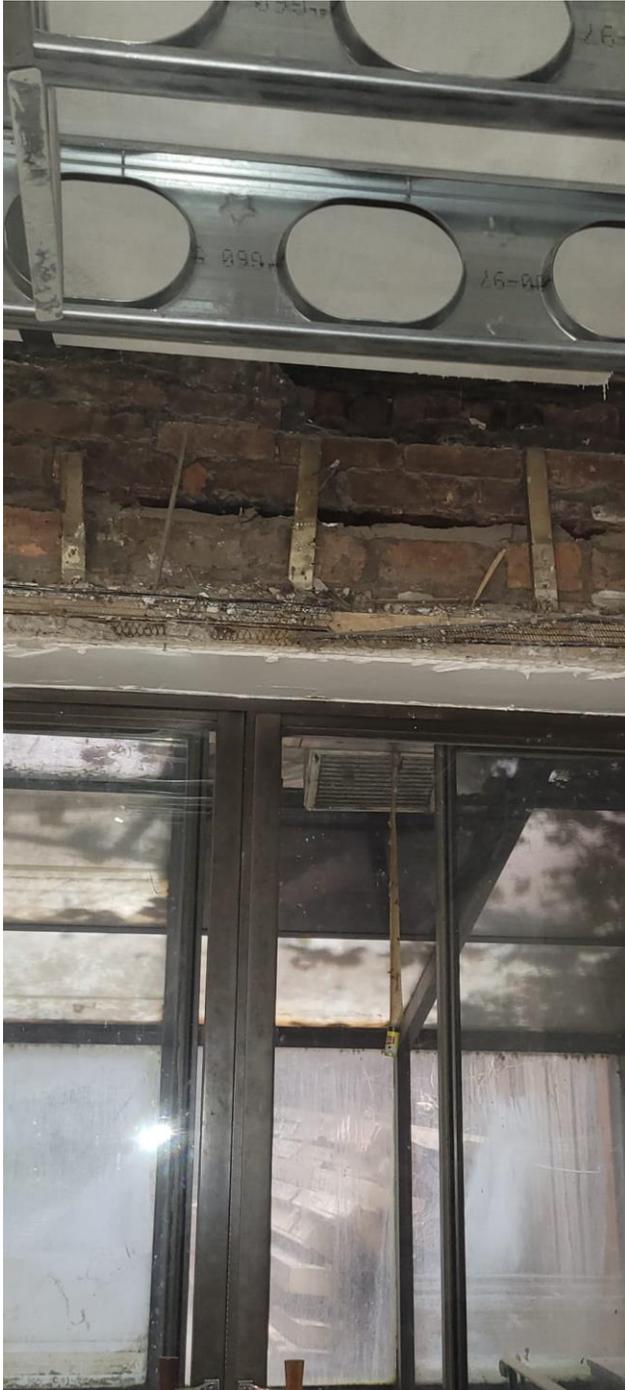
Bricks were found settling. Wide crack was observed. Loose mortar joints were found.

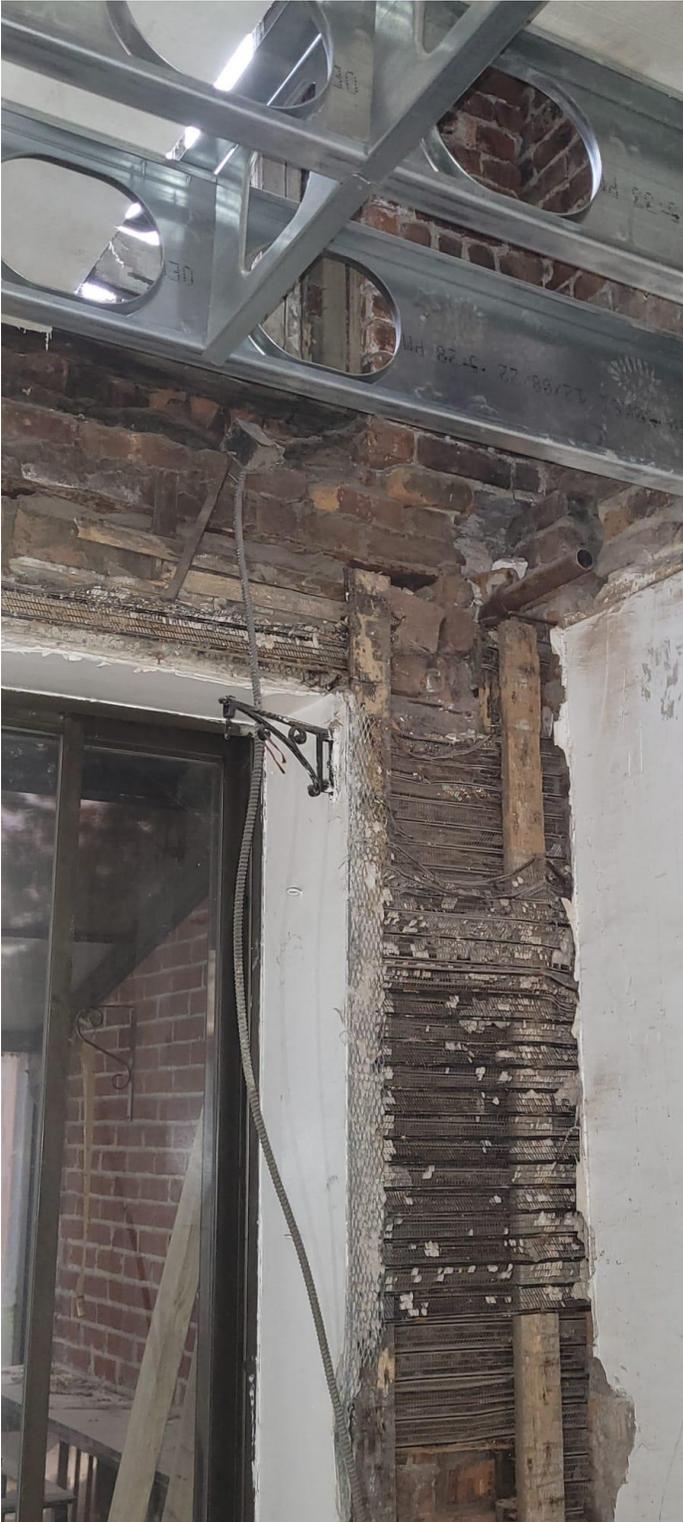
Loose mortar joints.

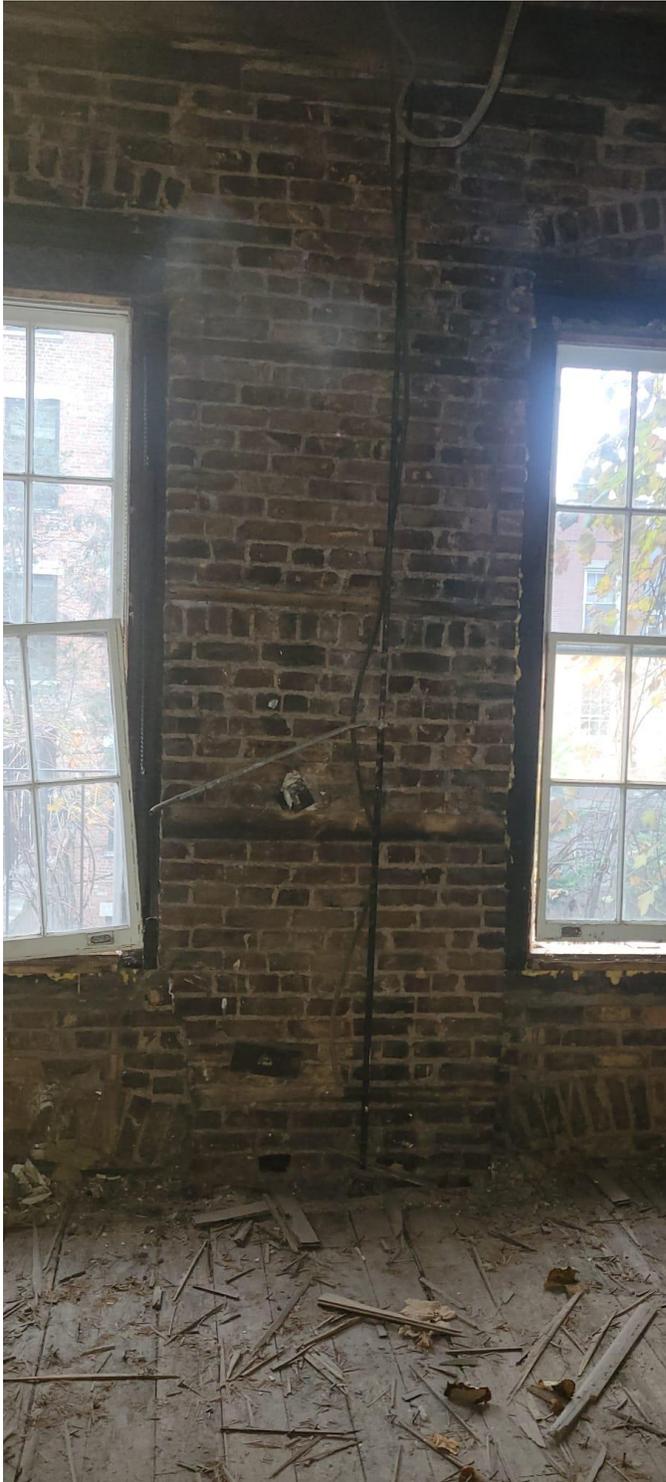
Bricks were misaligned. Mortar joints were loose and weak.

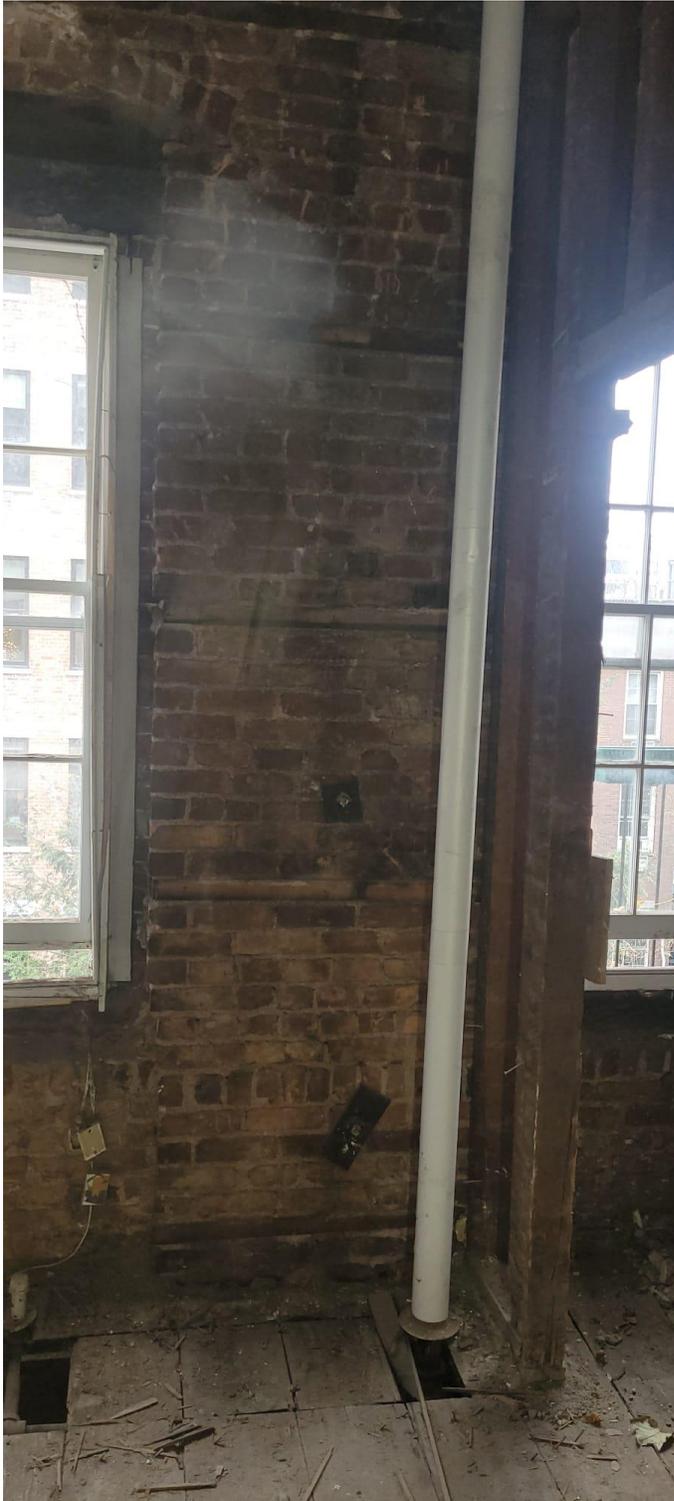
Loose mortar joints.

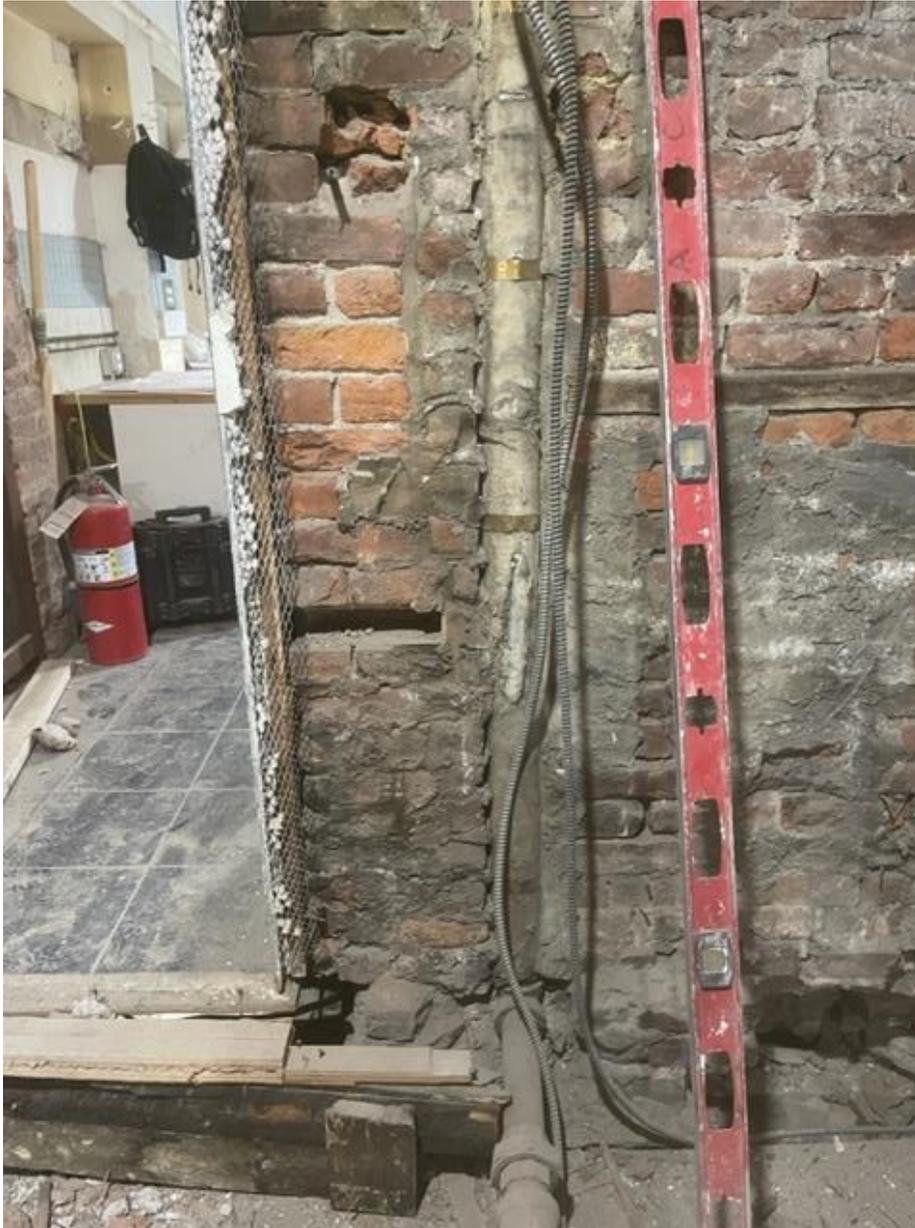
Missing bricks, loose / missing mortar joint

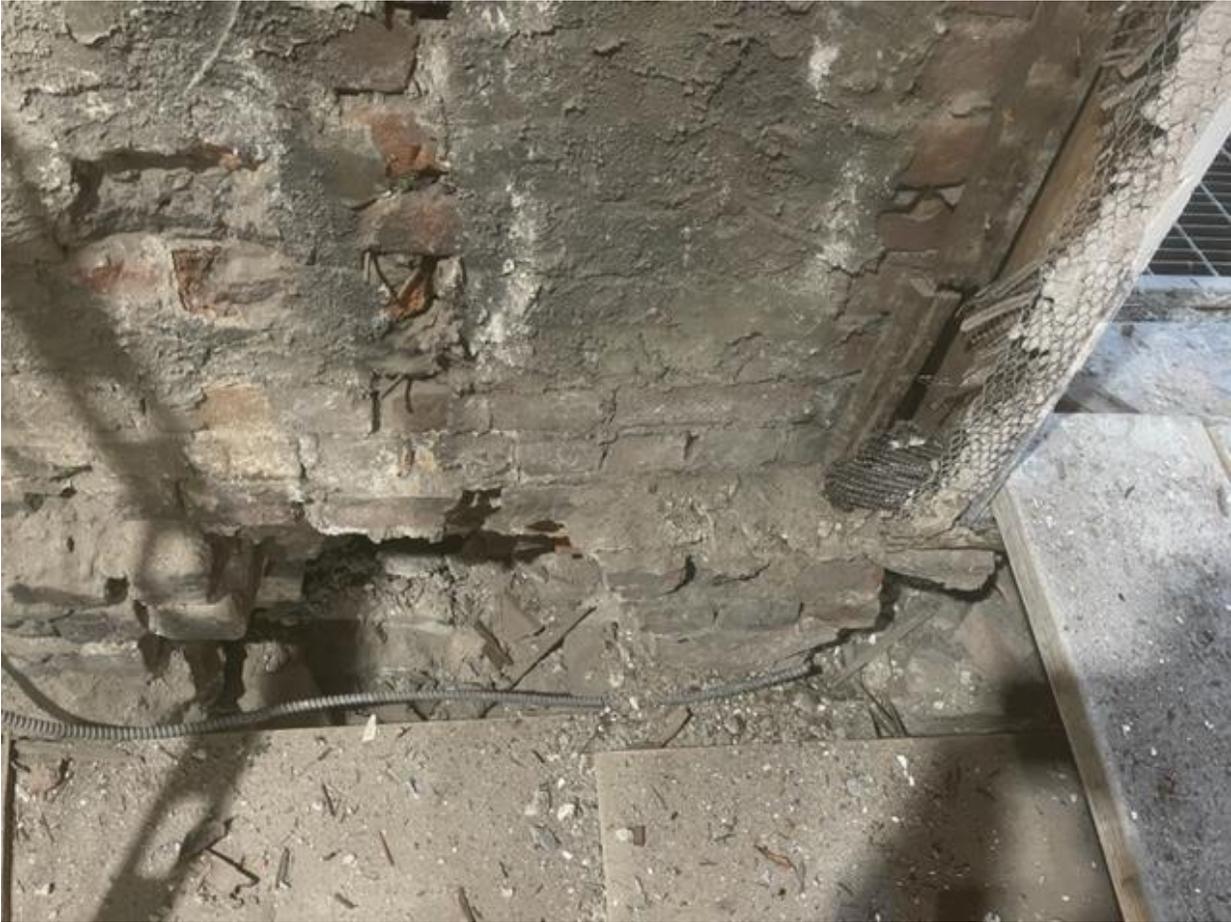
Missing bricks, loose / missing mortar joint

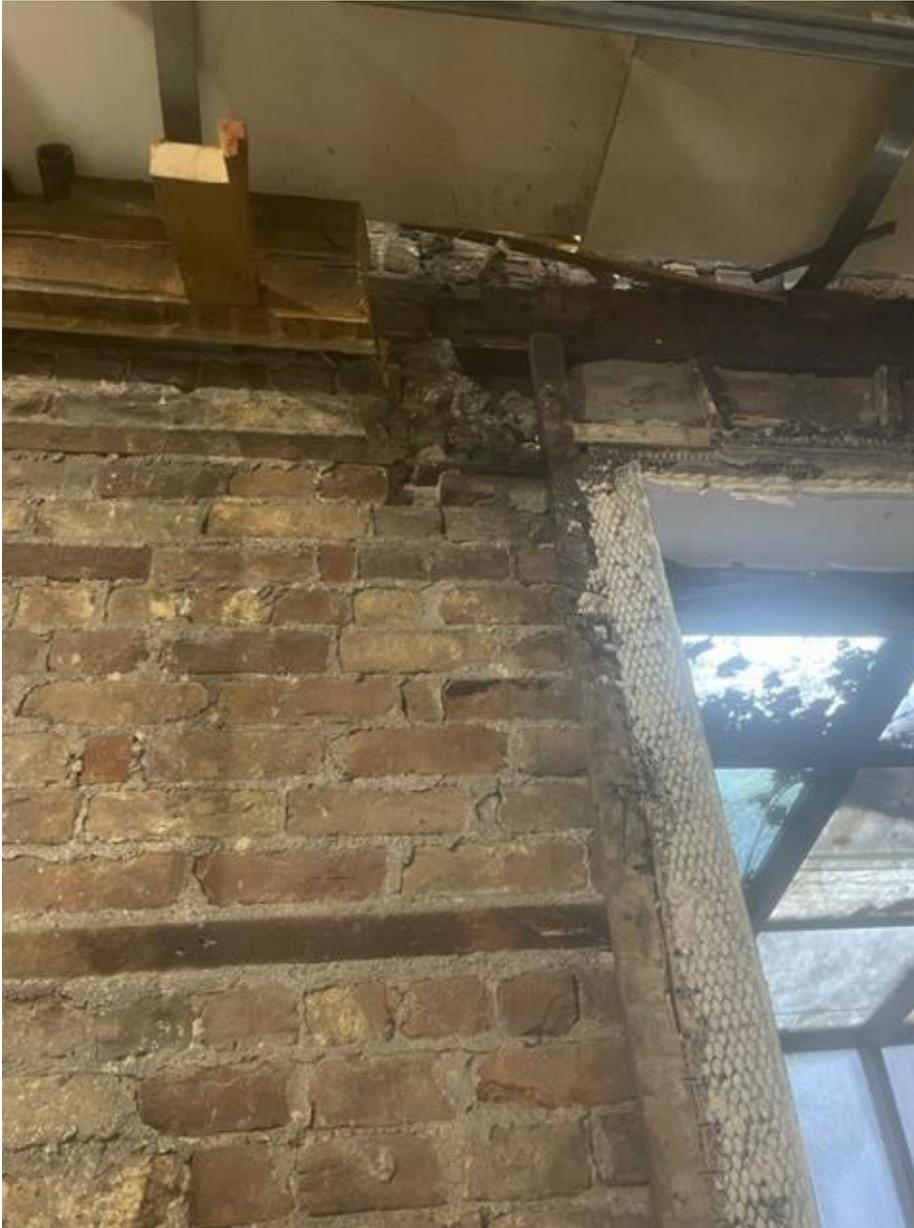
Missing bricks, loose / missing mortar joint

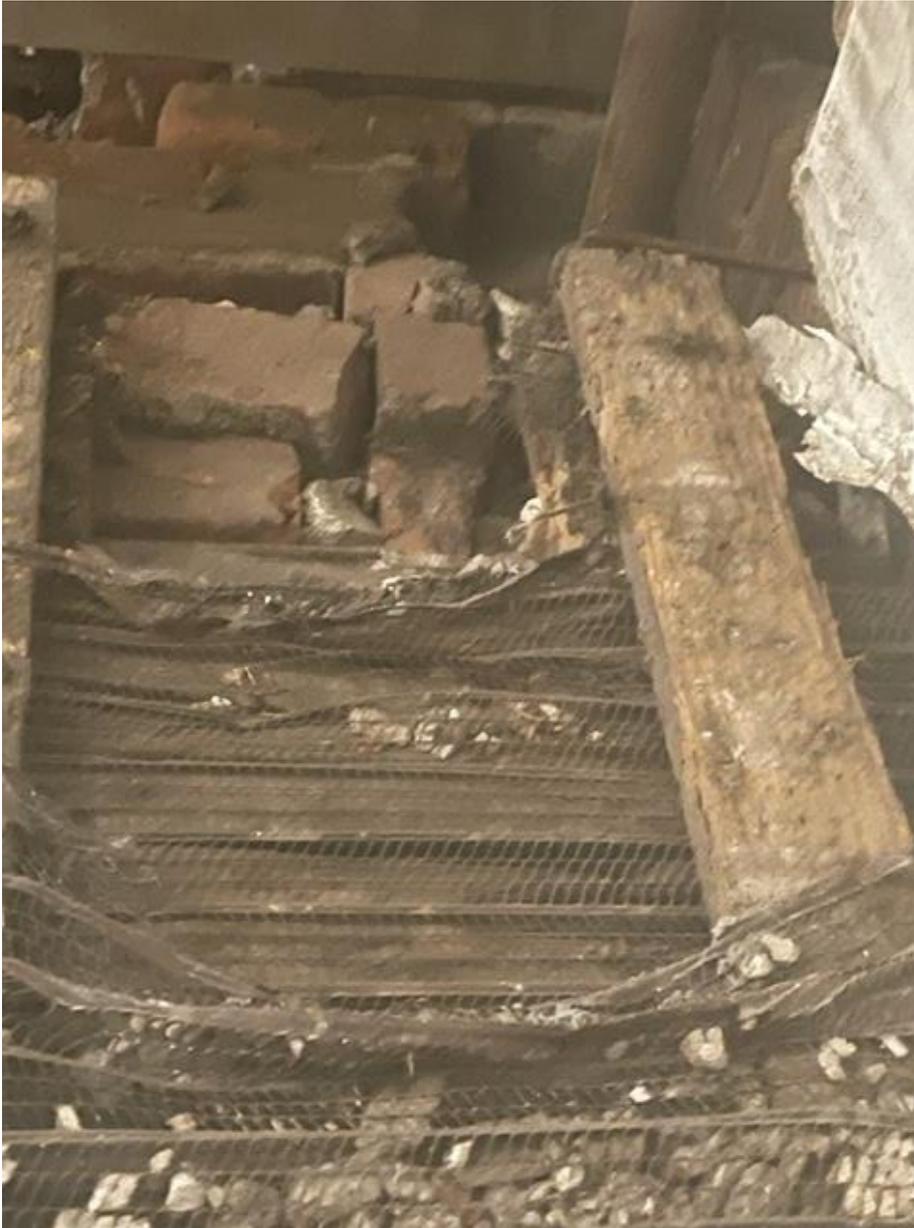
Missing bricks, loose / missing mortar joint

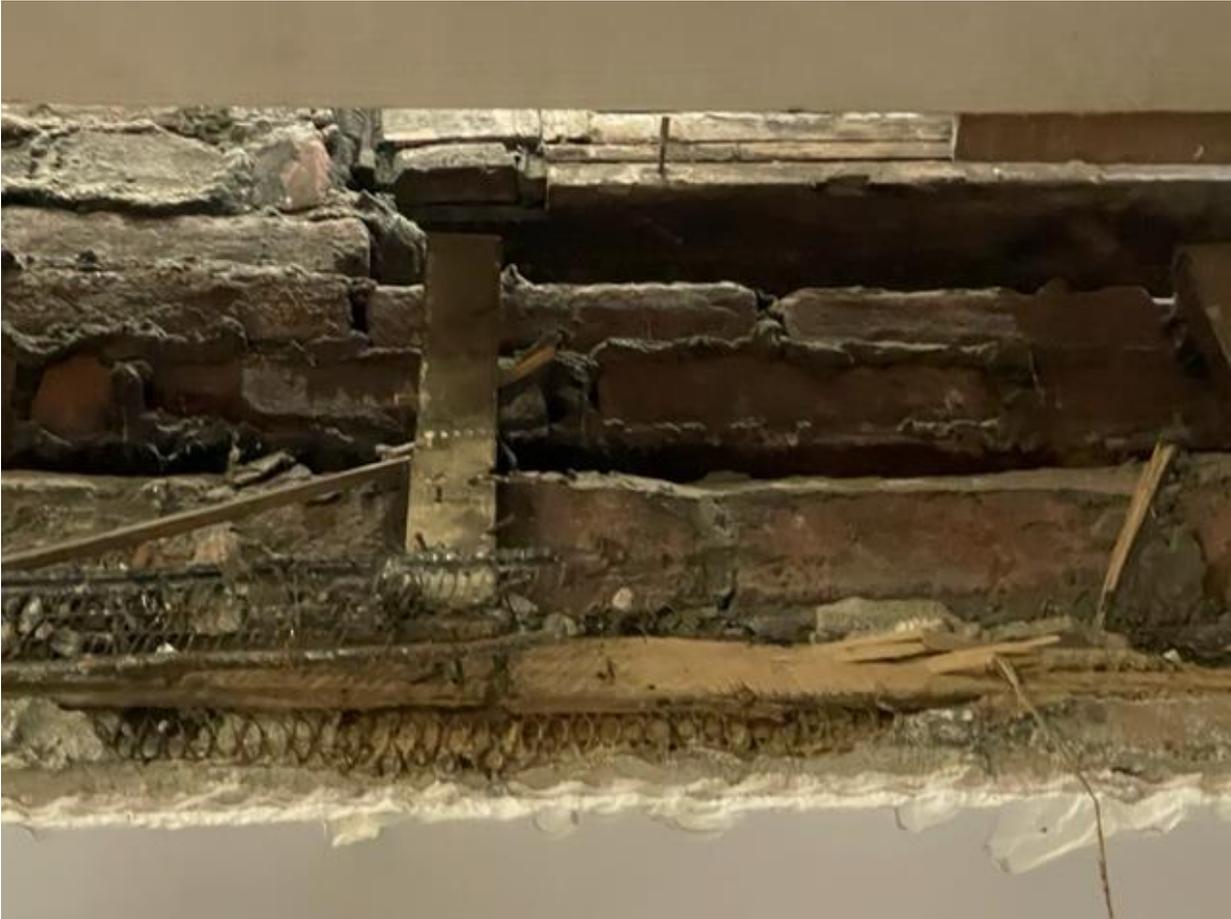
Missing bricks, loose / missing mortar joint

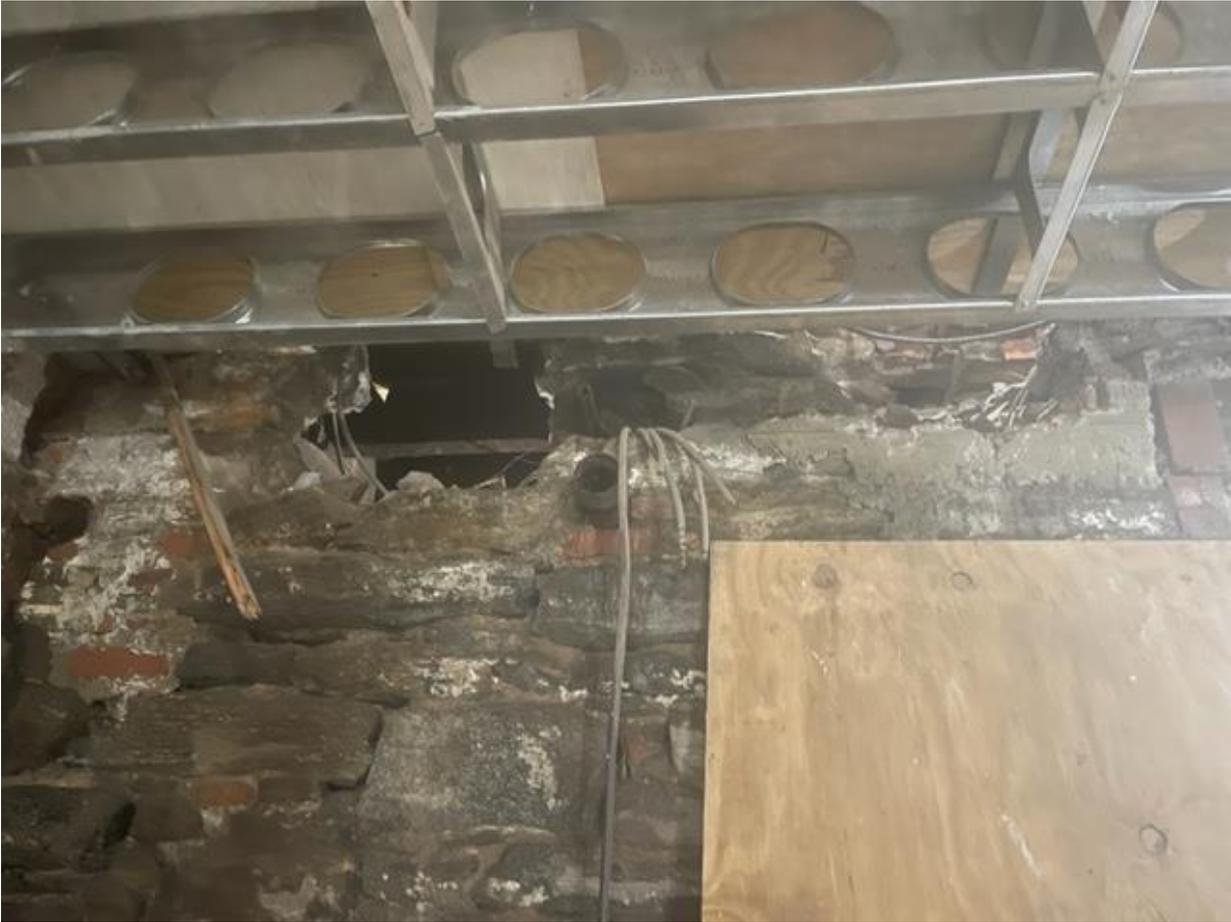
Missing bricks, loose / missing mortar joint

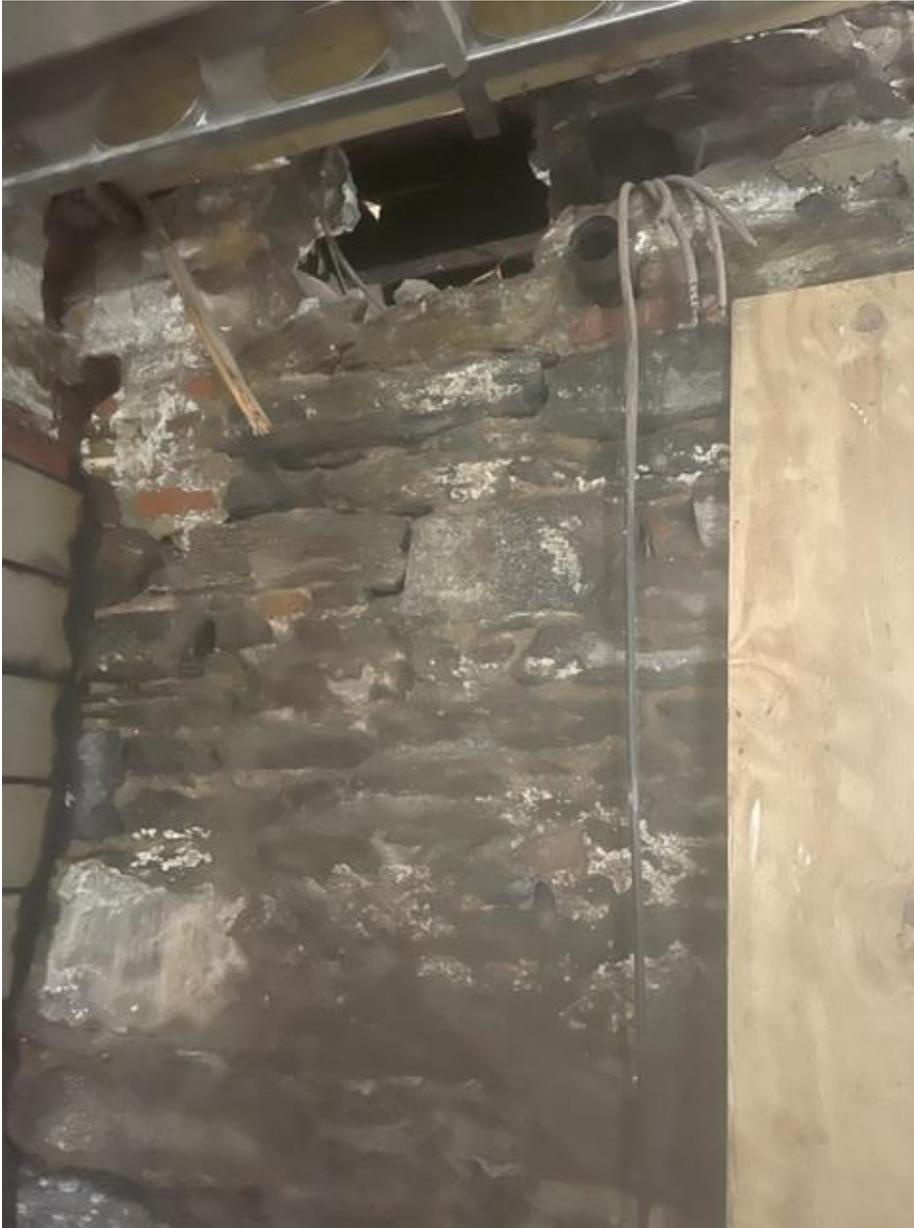
Missing bricks, loose / missing mortar joint

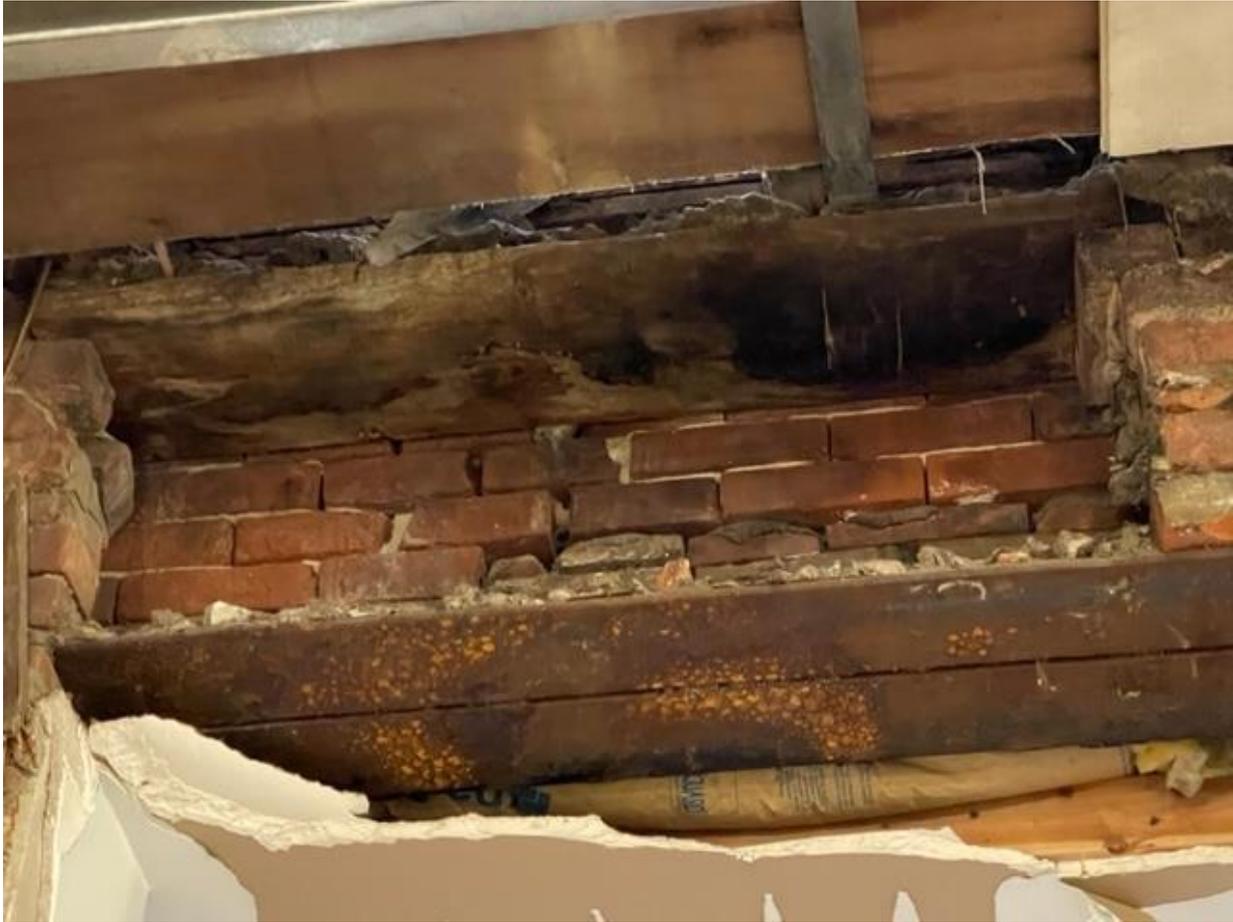
Missing bricks, loose / missing mortar joint

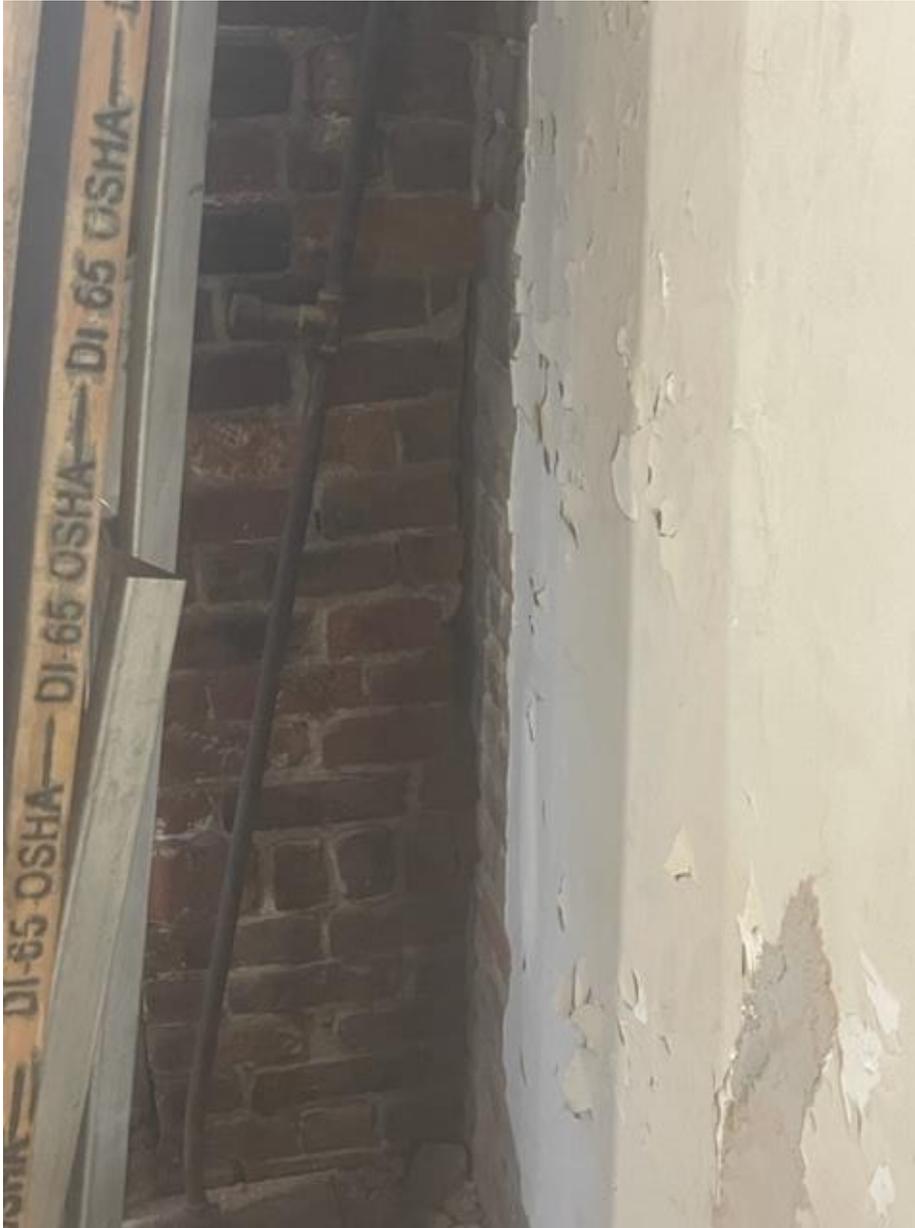
Back façade separated from side wall

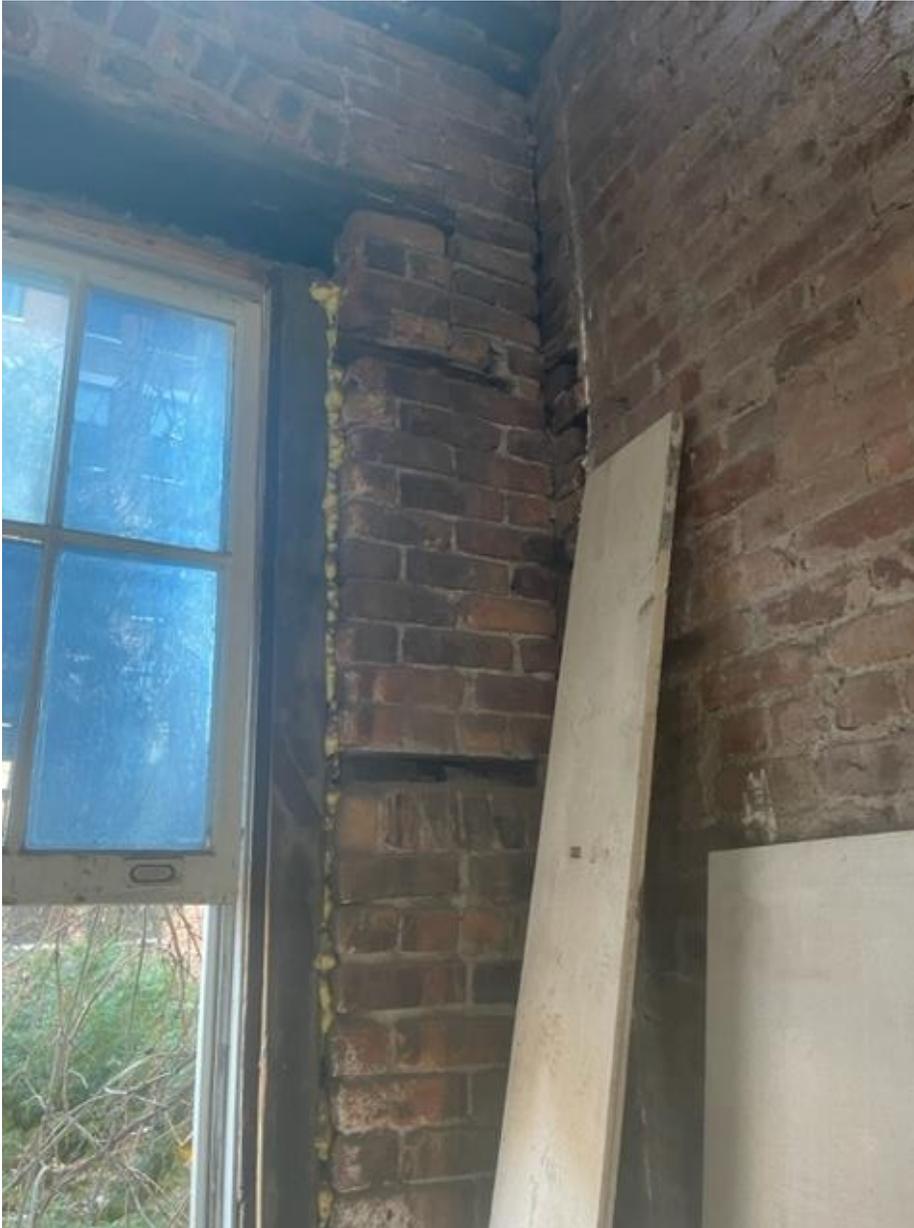
Back façade separated from side wall

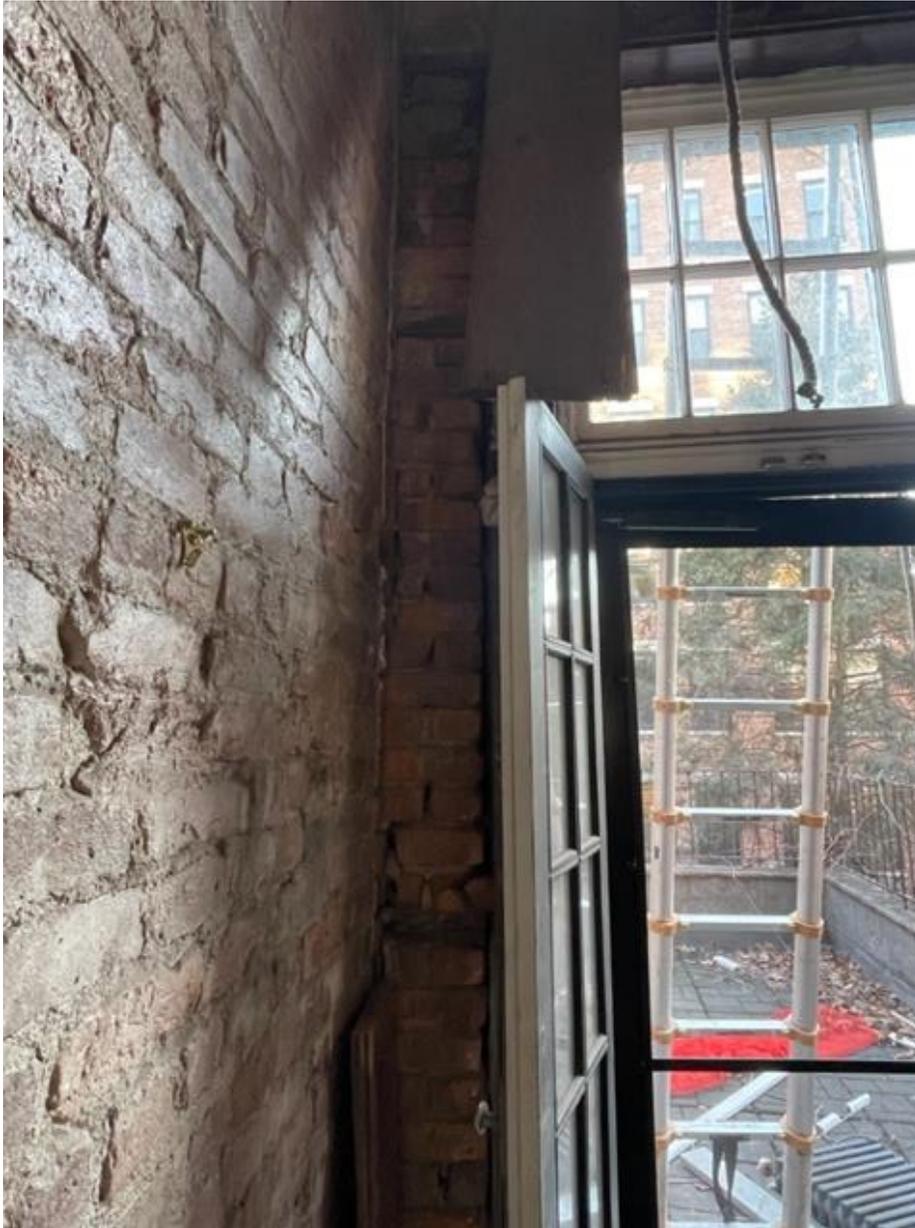
Back façade separated from side wall
