PROJECT LOCATION
829 Greenwich St
Manhattan

LPC DISTRICT
Greenwich Village
Historic District

EXISTING CONDITIONS

APPENDIX

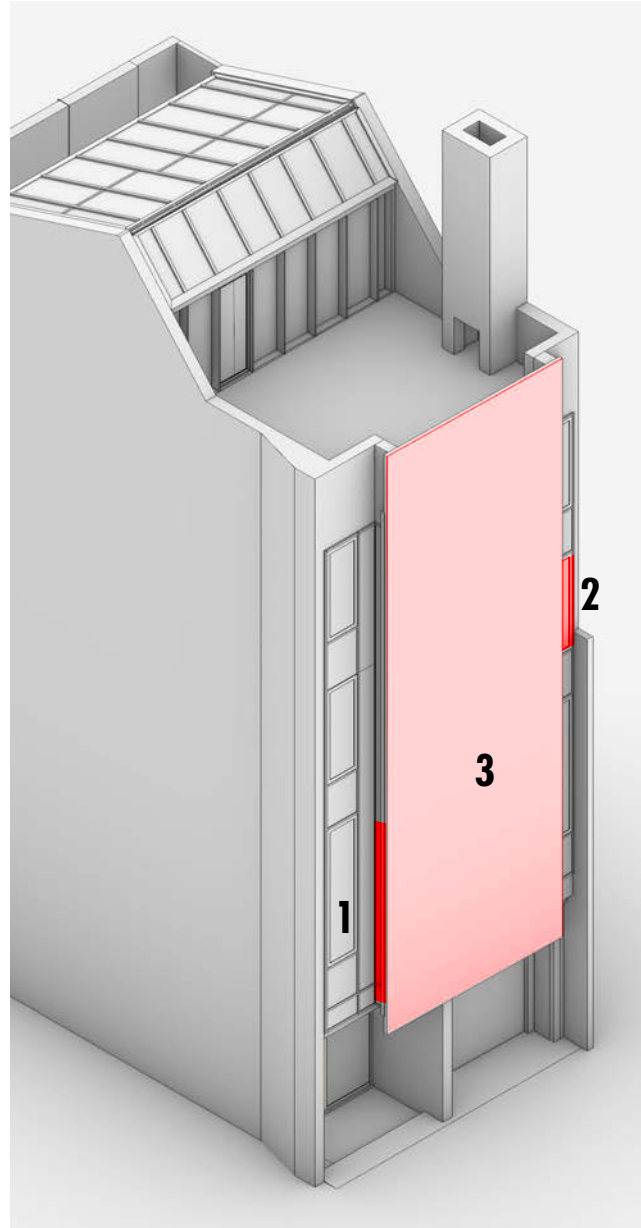
1

Displaced gasket

Staining at IGU edge and on trim

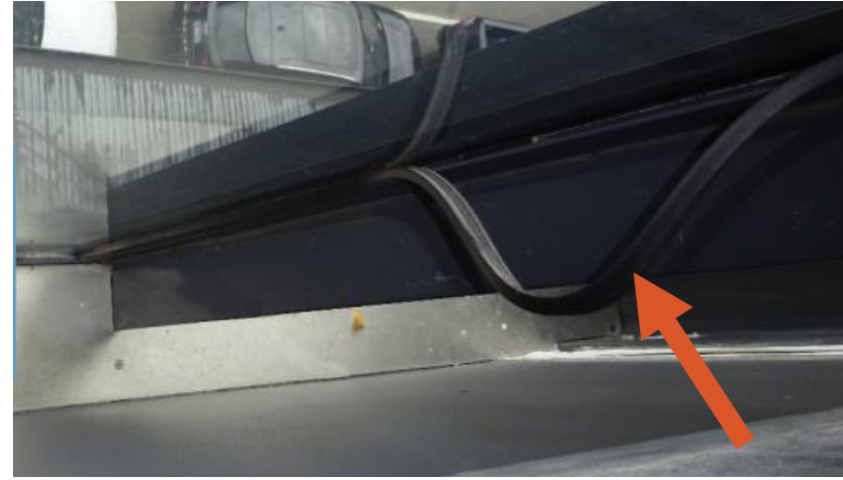
2

Displaced IGU spacers

Deteriorated gaskets at operable vents

Water leaks throughout entire building envelope caused mold growth on majority of building interior, which needed to be professionally abated

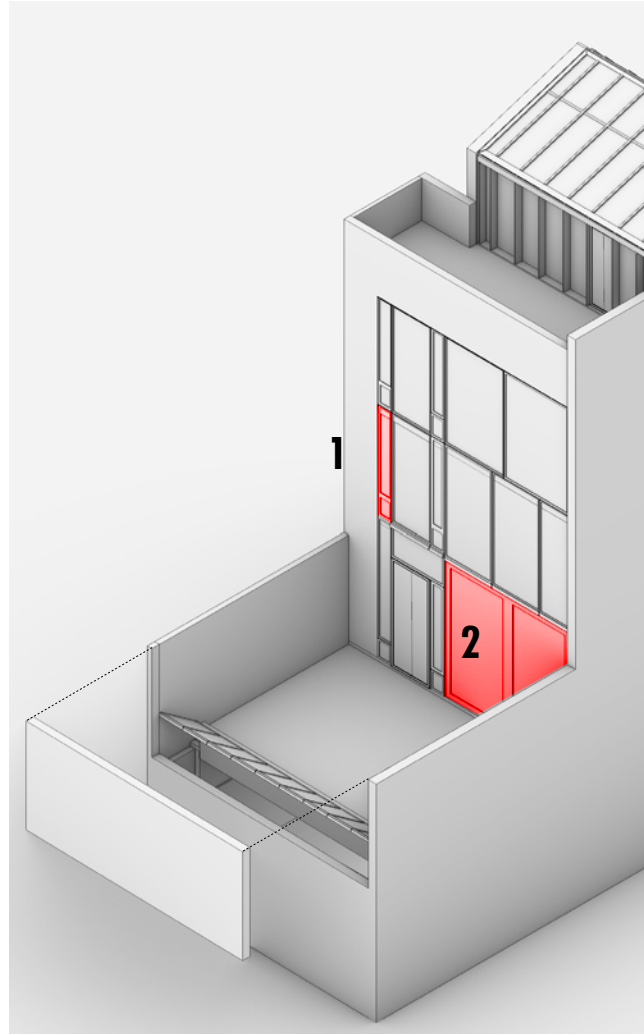
1

Deteriorated gaskets at operable vents

Discontinuous gasket

Water stain

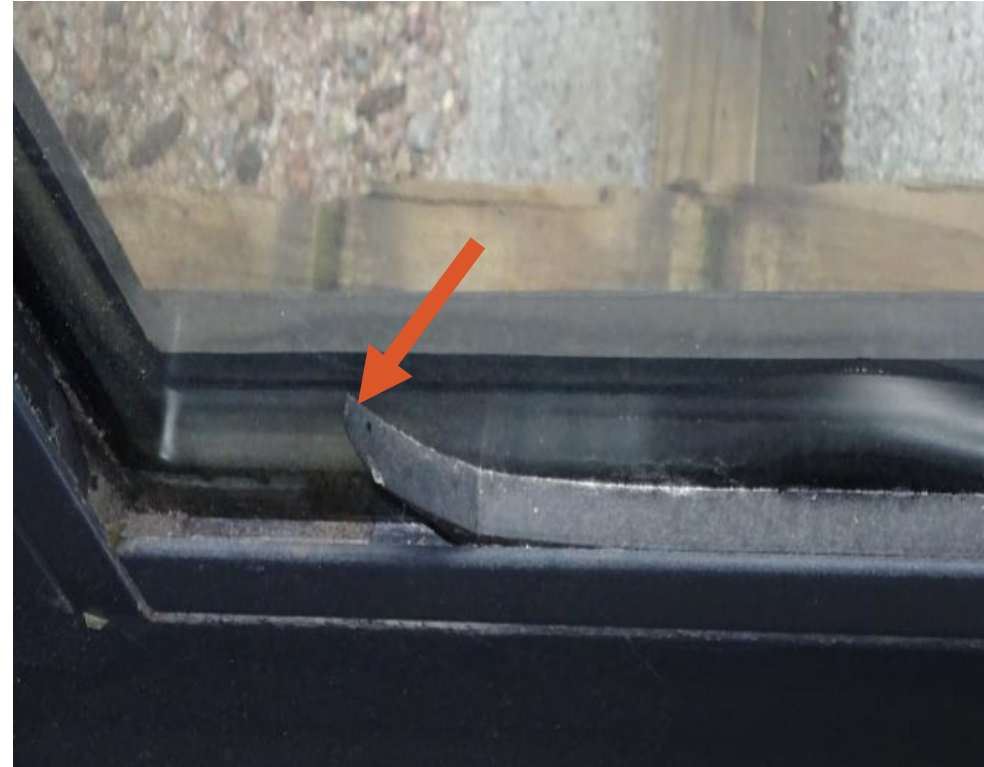
2

Misalignment / lack of gasket compression at bi-fold door

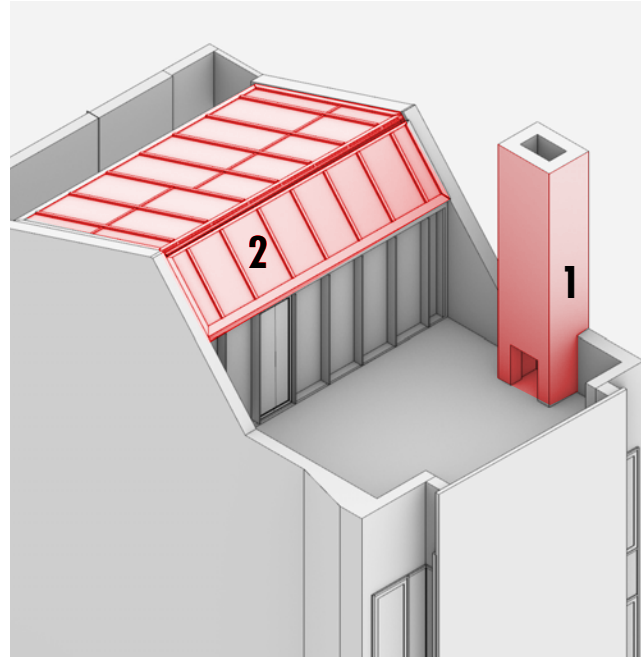
1
Deteriorated mortar at brick masonry chimney

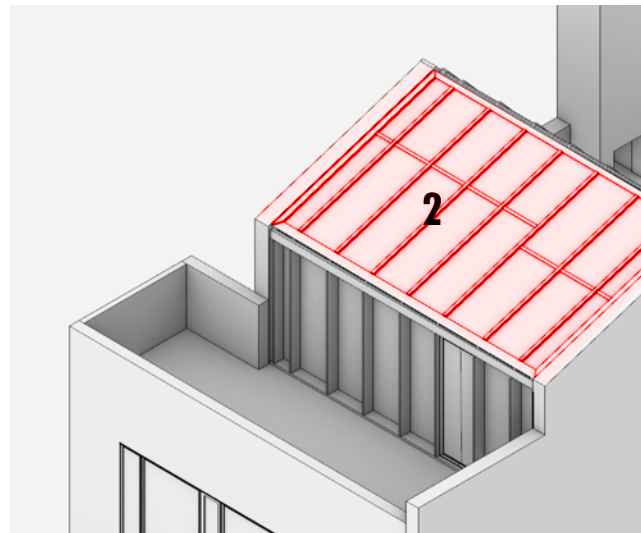
2
Excessive solar heat gain from roof skylight (shade installed to reduce heat gain)

Large skylight and bulkhead has air leaks, condensation at frames, and contributes to excessive solar heat gain

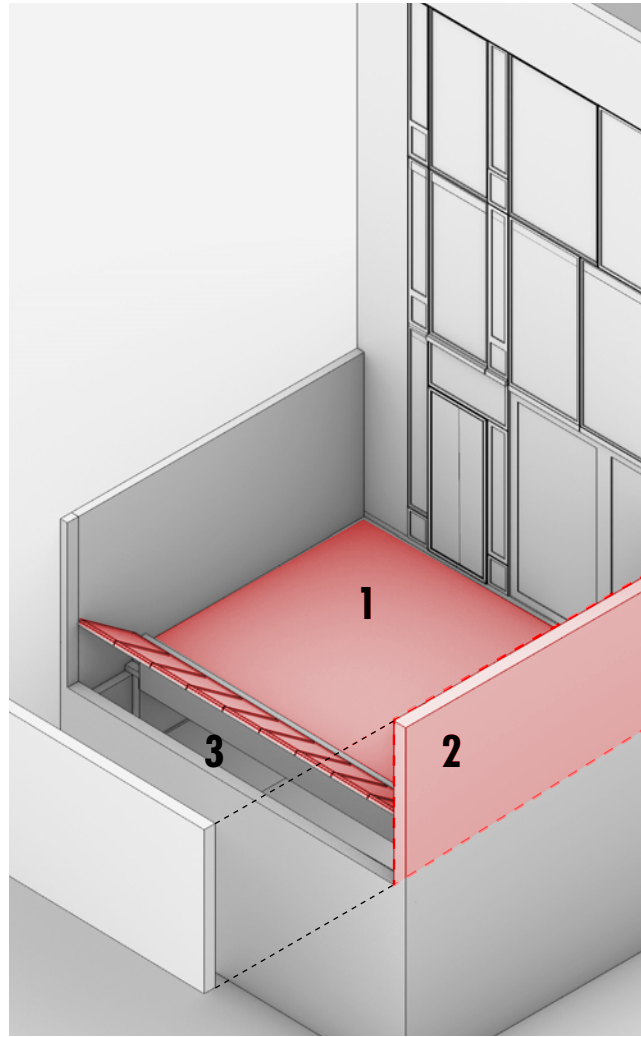
1

Existing roofing

Water below and within roofing assembly

Ceiling repairs at area of reported water leakage

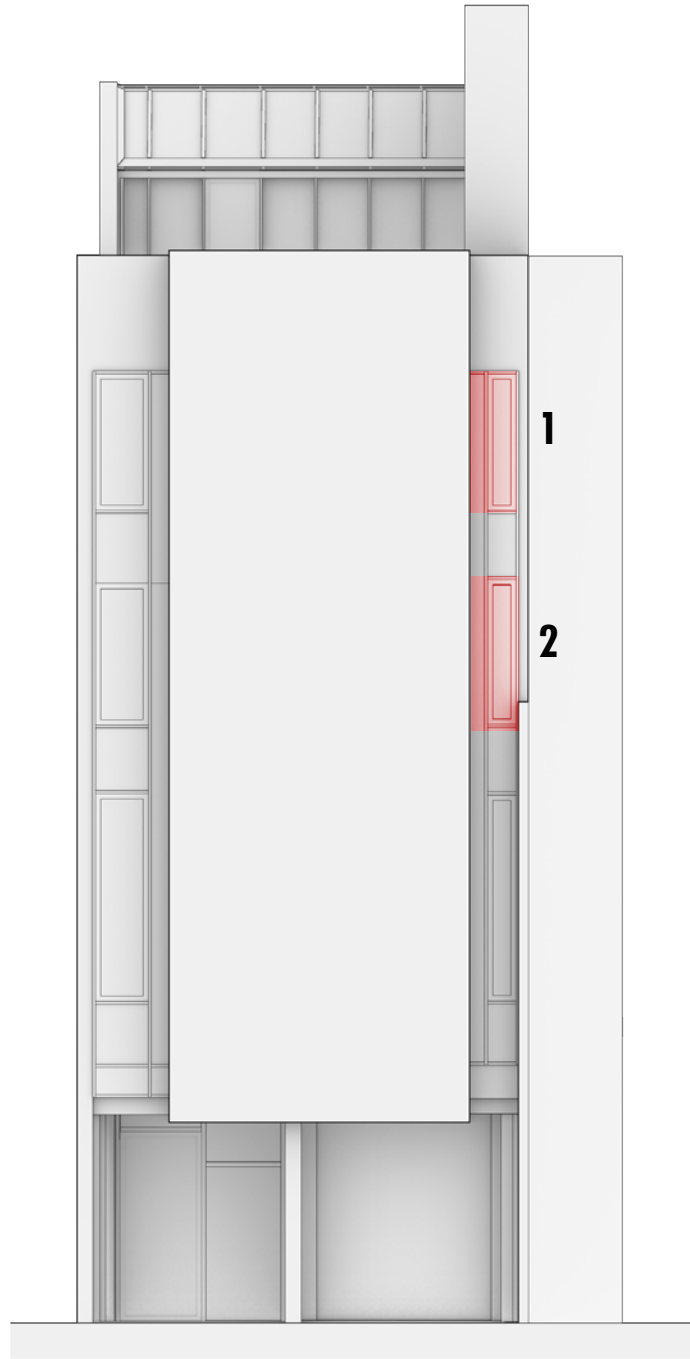
1

Existing front facade windows do not provide adequate light to interior habitable spaces at 2nd & 3rd floors, as per building code requirements

Original third floor front bedroom glazing area does not comply with code requirements

Floor area = 123 SF
 Required light (10%) = 12.3 SF
 Provided light = 8.2 SF

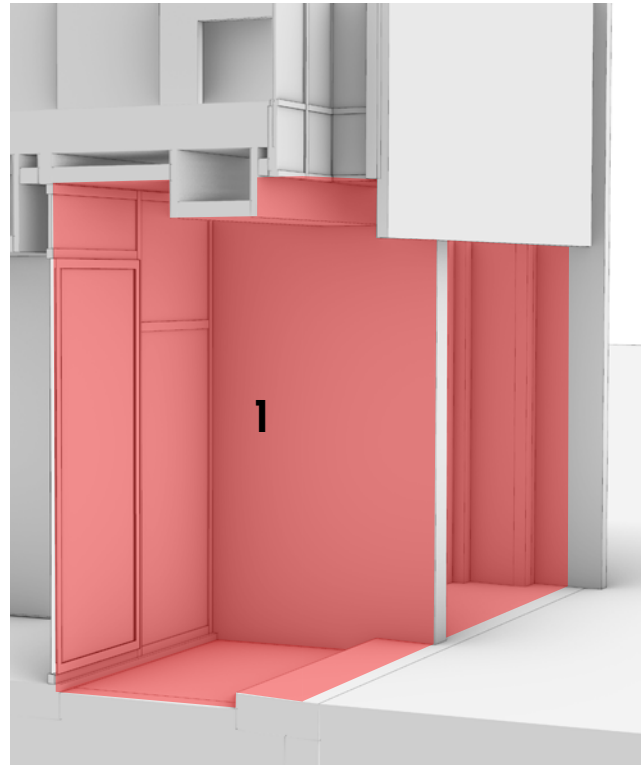
1

Recessed spaces at the entry door and garage door on the ground level of the front facade are deep enough to be used as shelters for transient individuals, creating a safety hazard
