#### SHEET LIST

##### Project Background

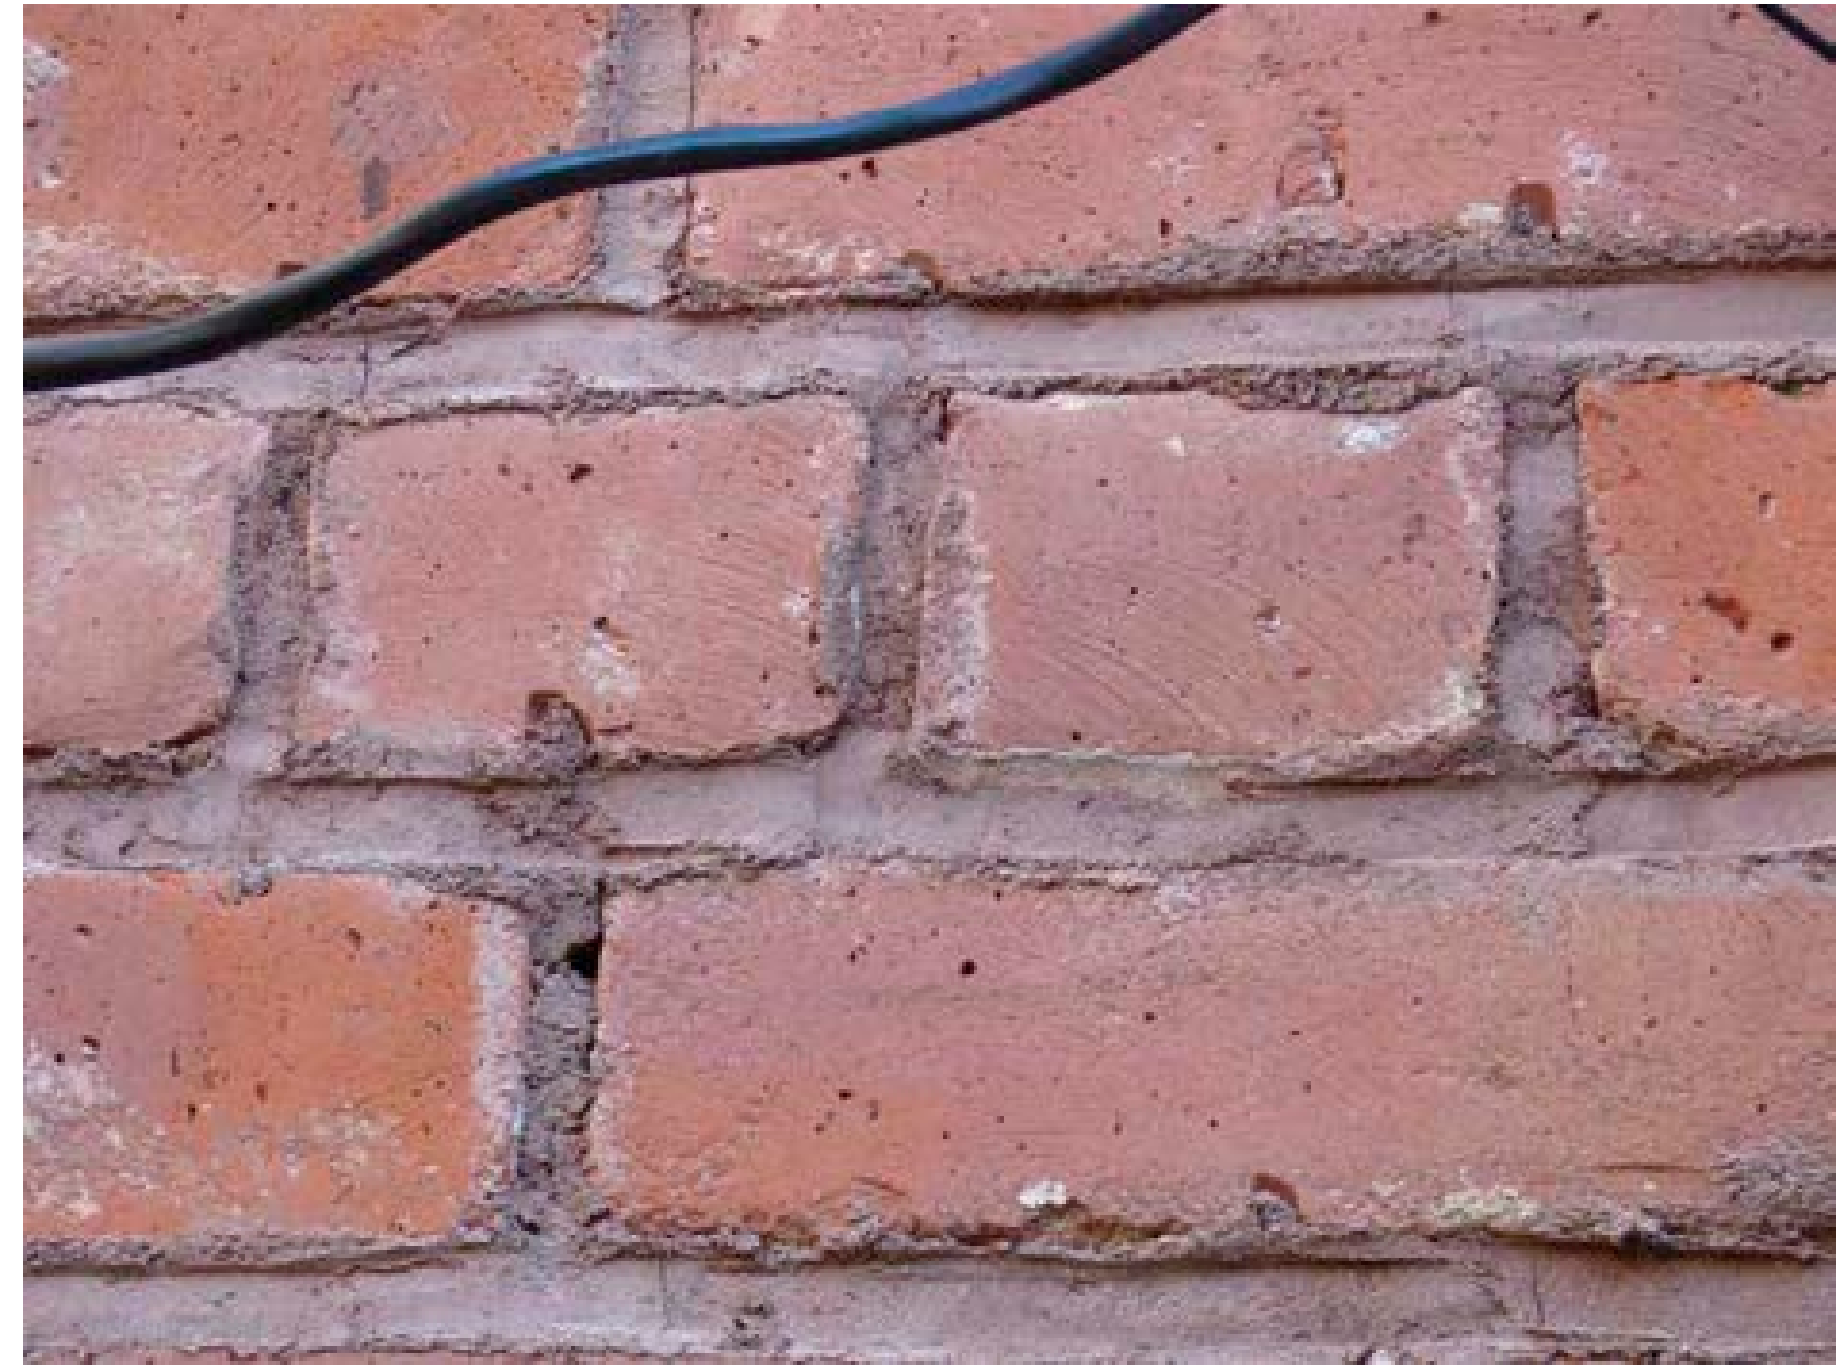
Typical conditions, including visible abrasions and loss of the fire skin

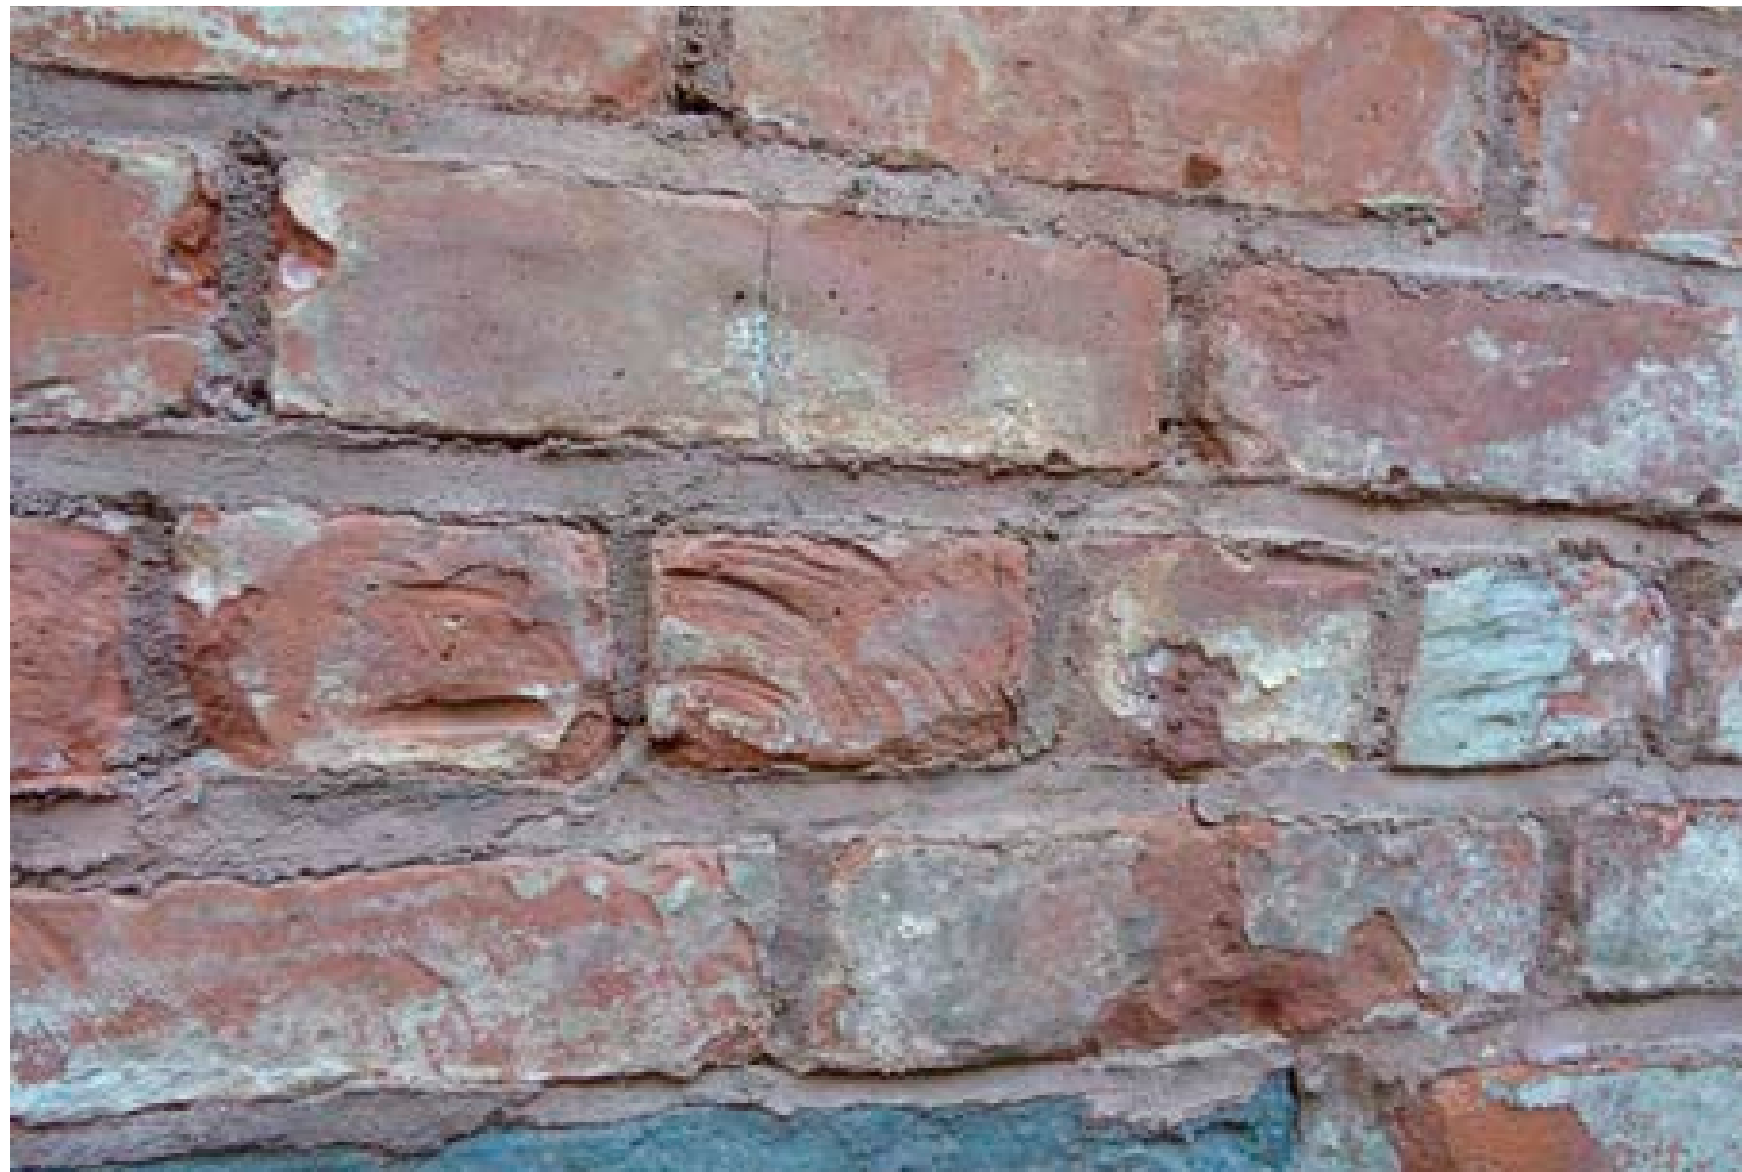
Detail of brick at the rear facade showing typical conditions, including abrasions from a mechanical grinder, spalling and material loss, efflorescence, and improper mortar type.

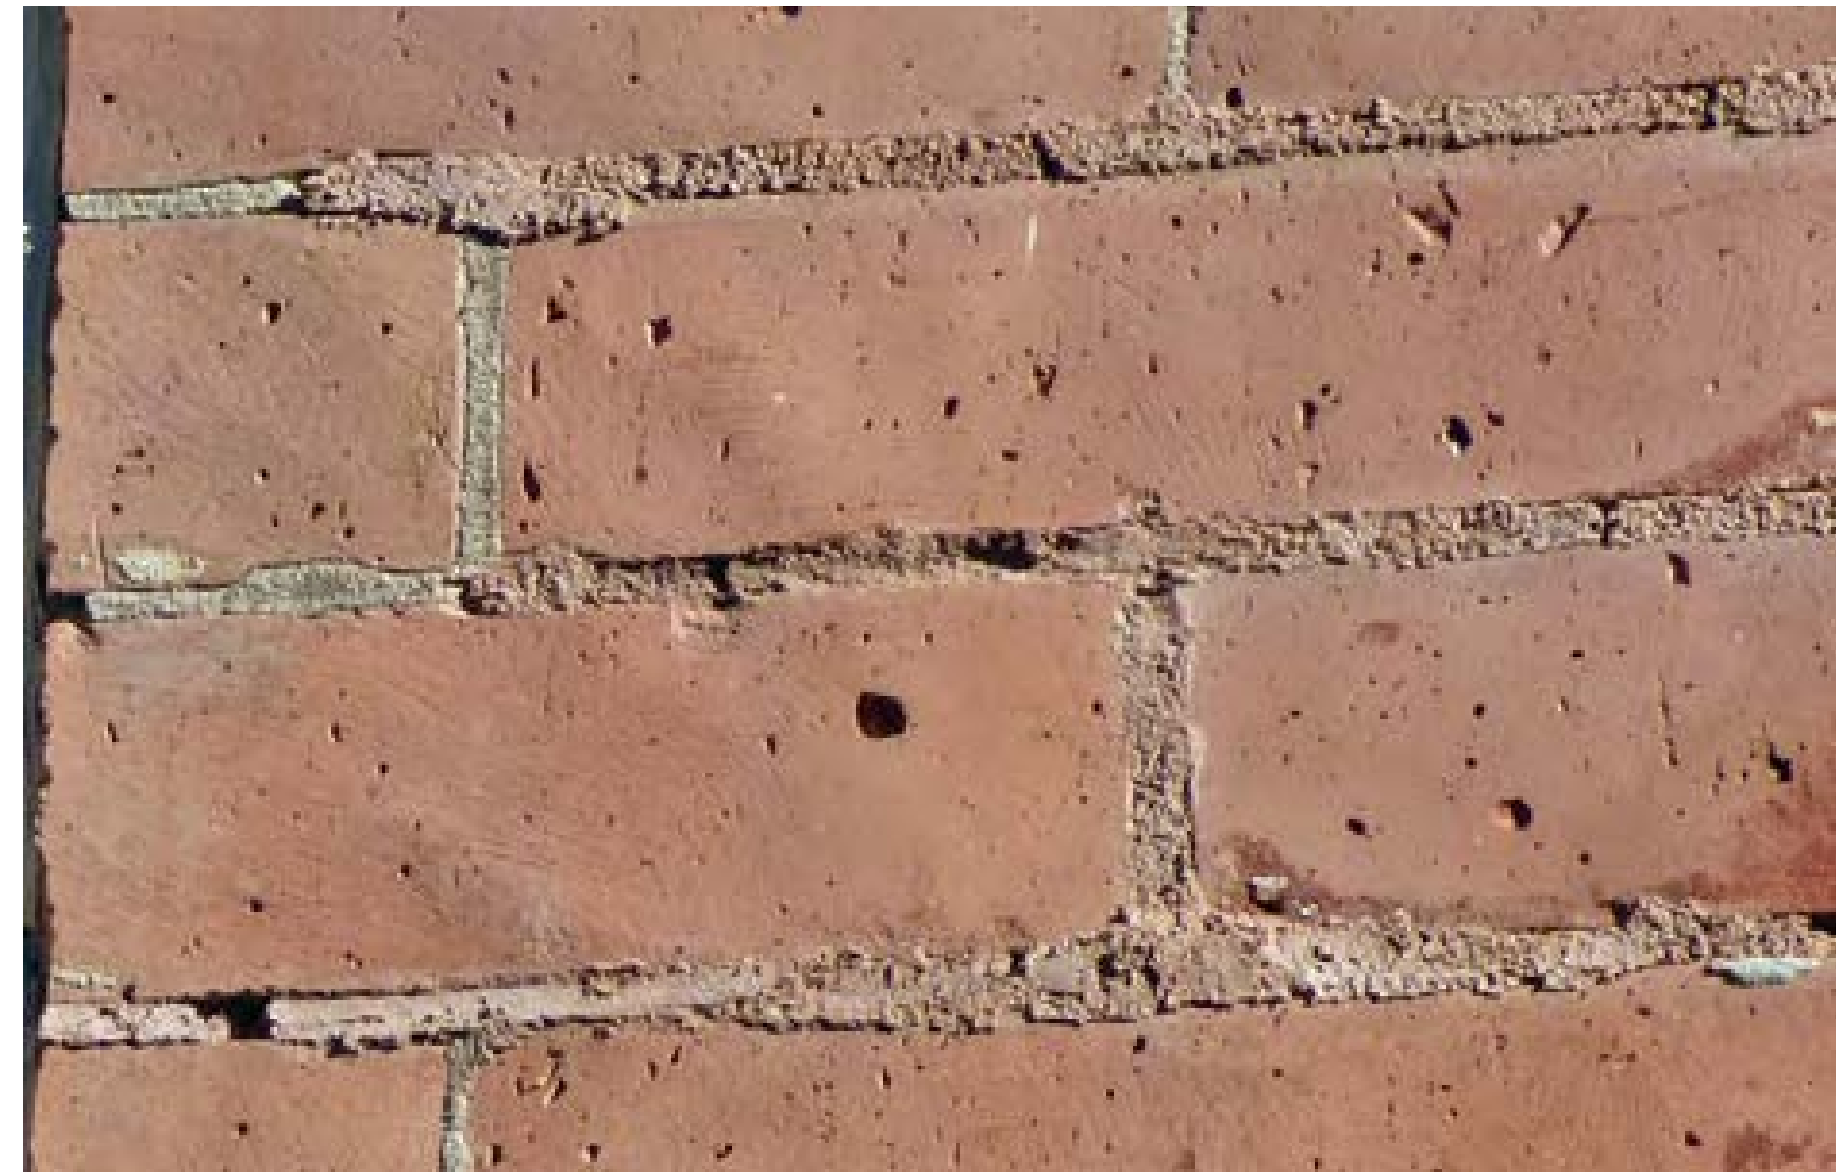
Typical conditions, including visible abrasions and loss of the fire skin

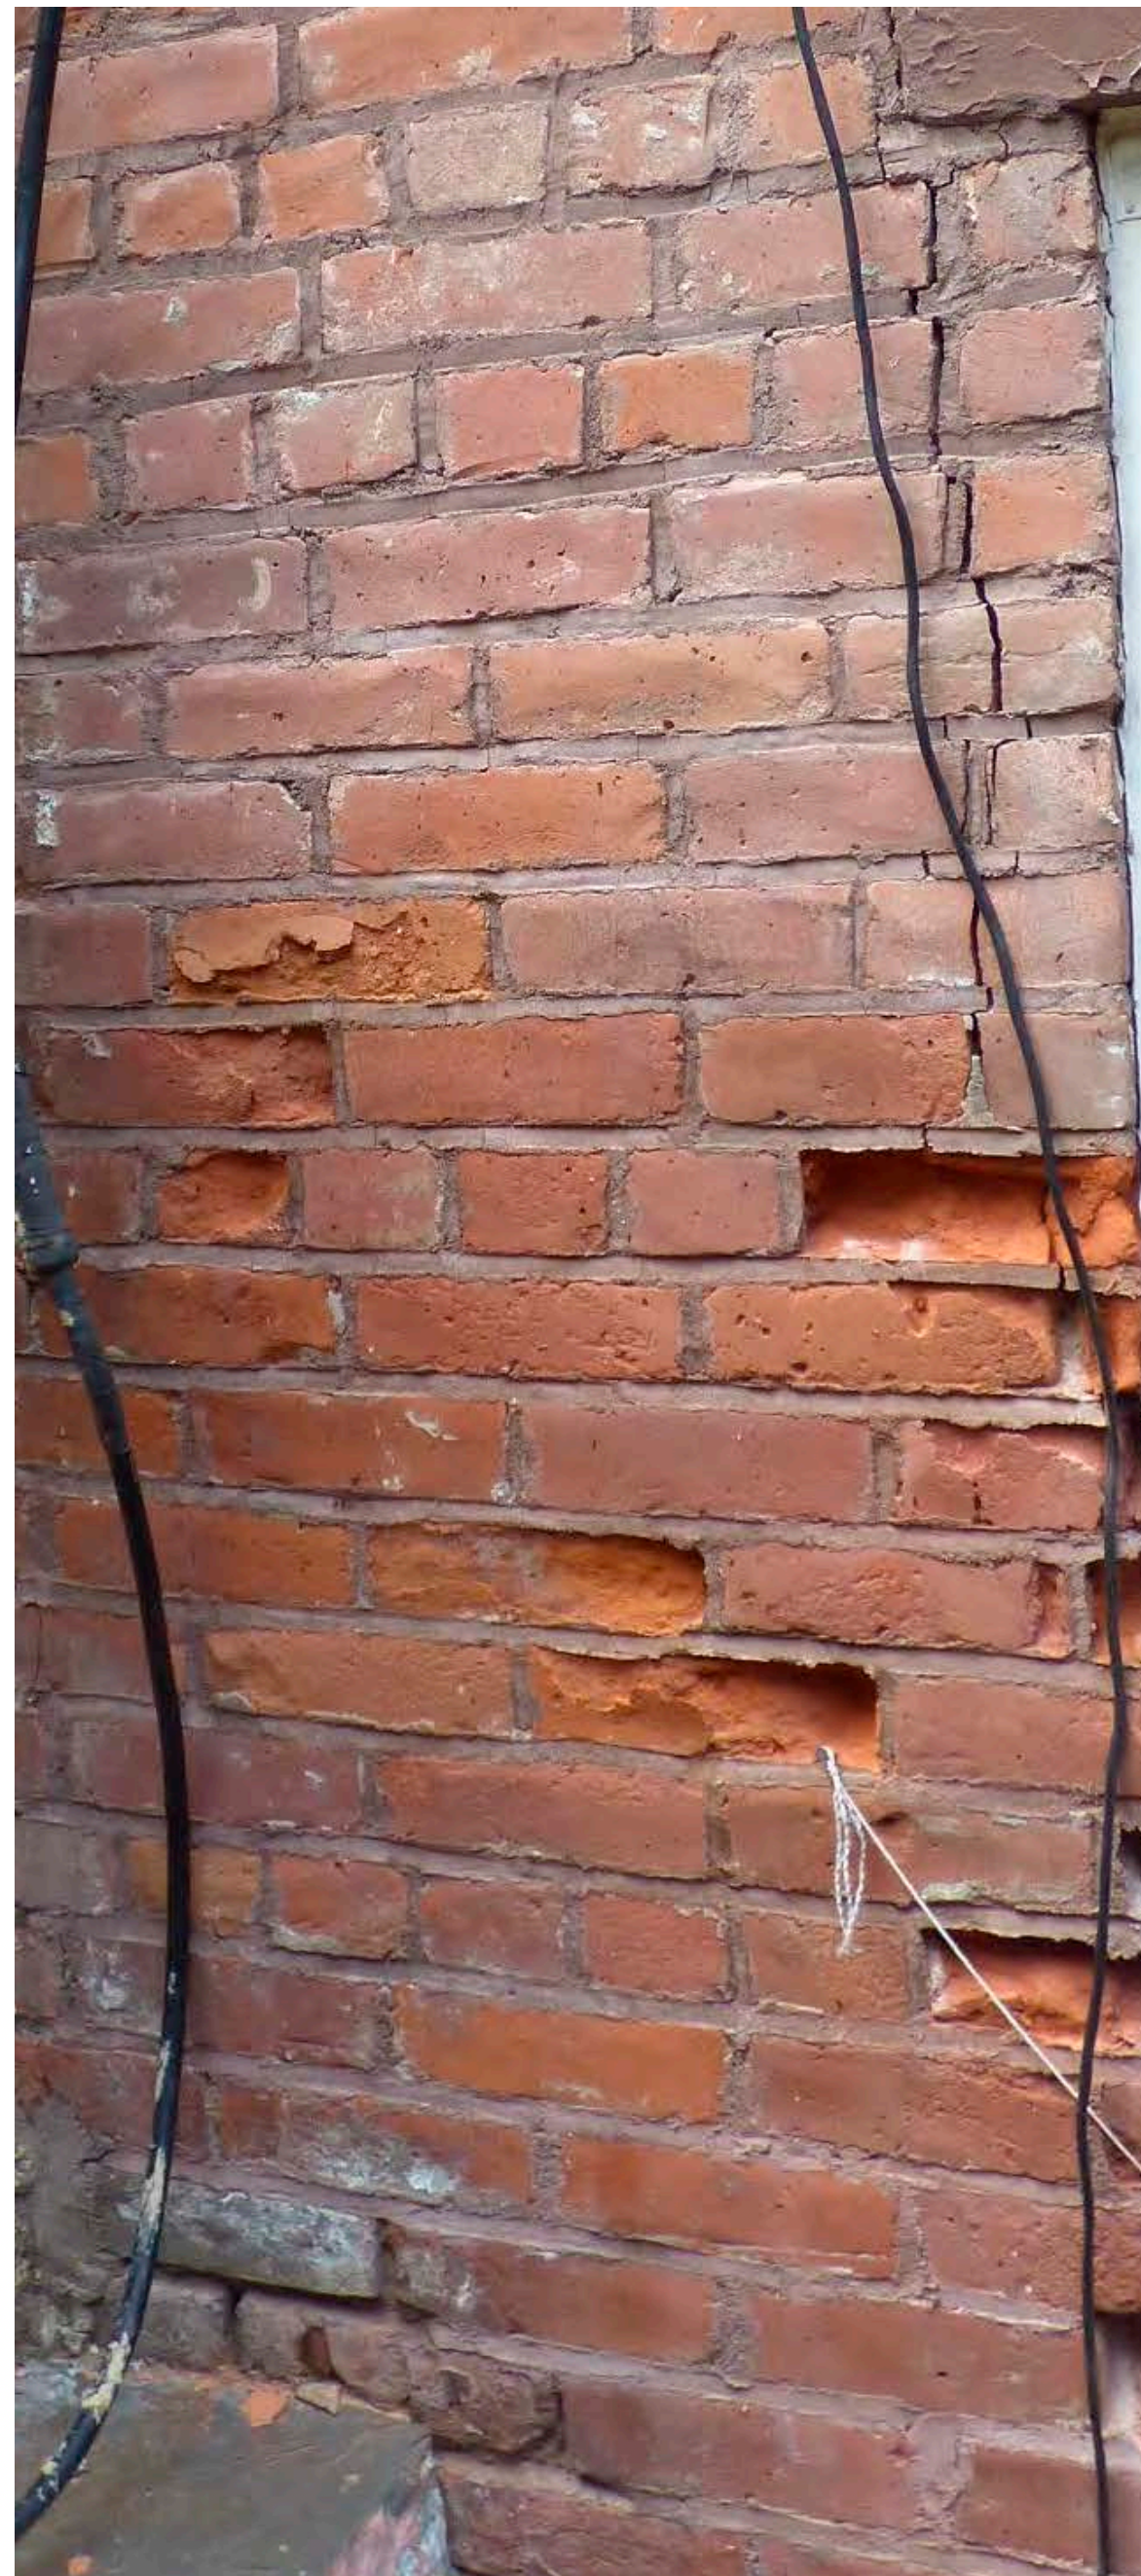
Detail of brick at the Garden level showing significant spalling and material loss, and efflorescence

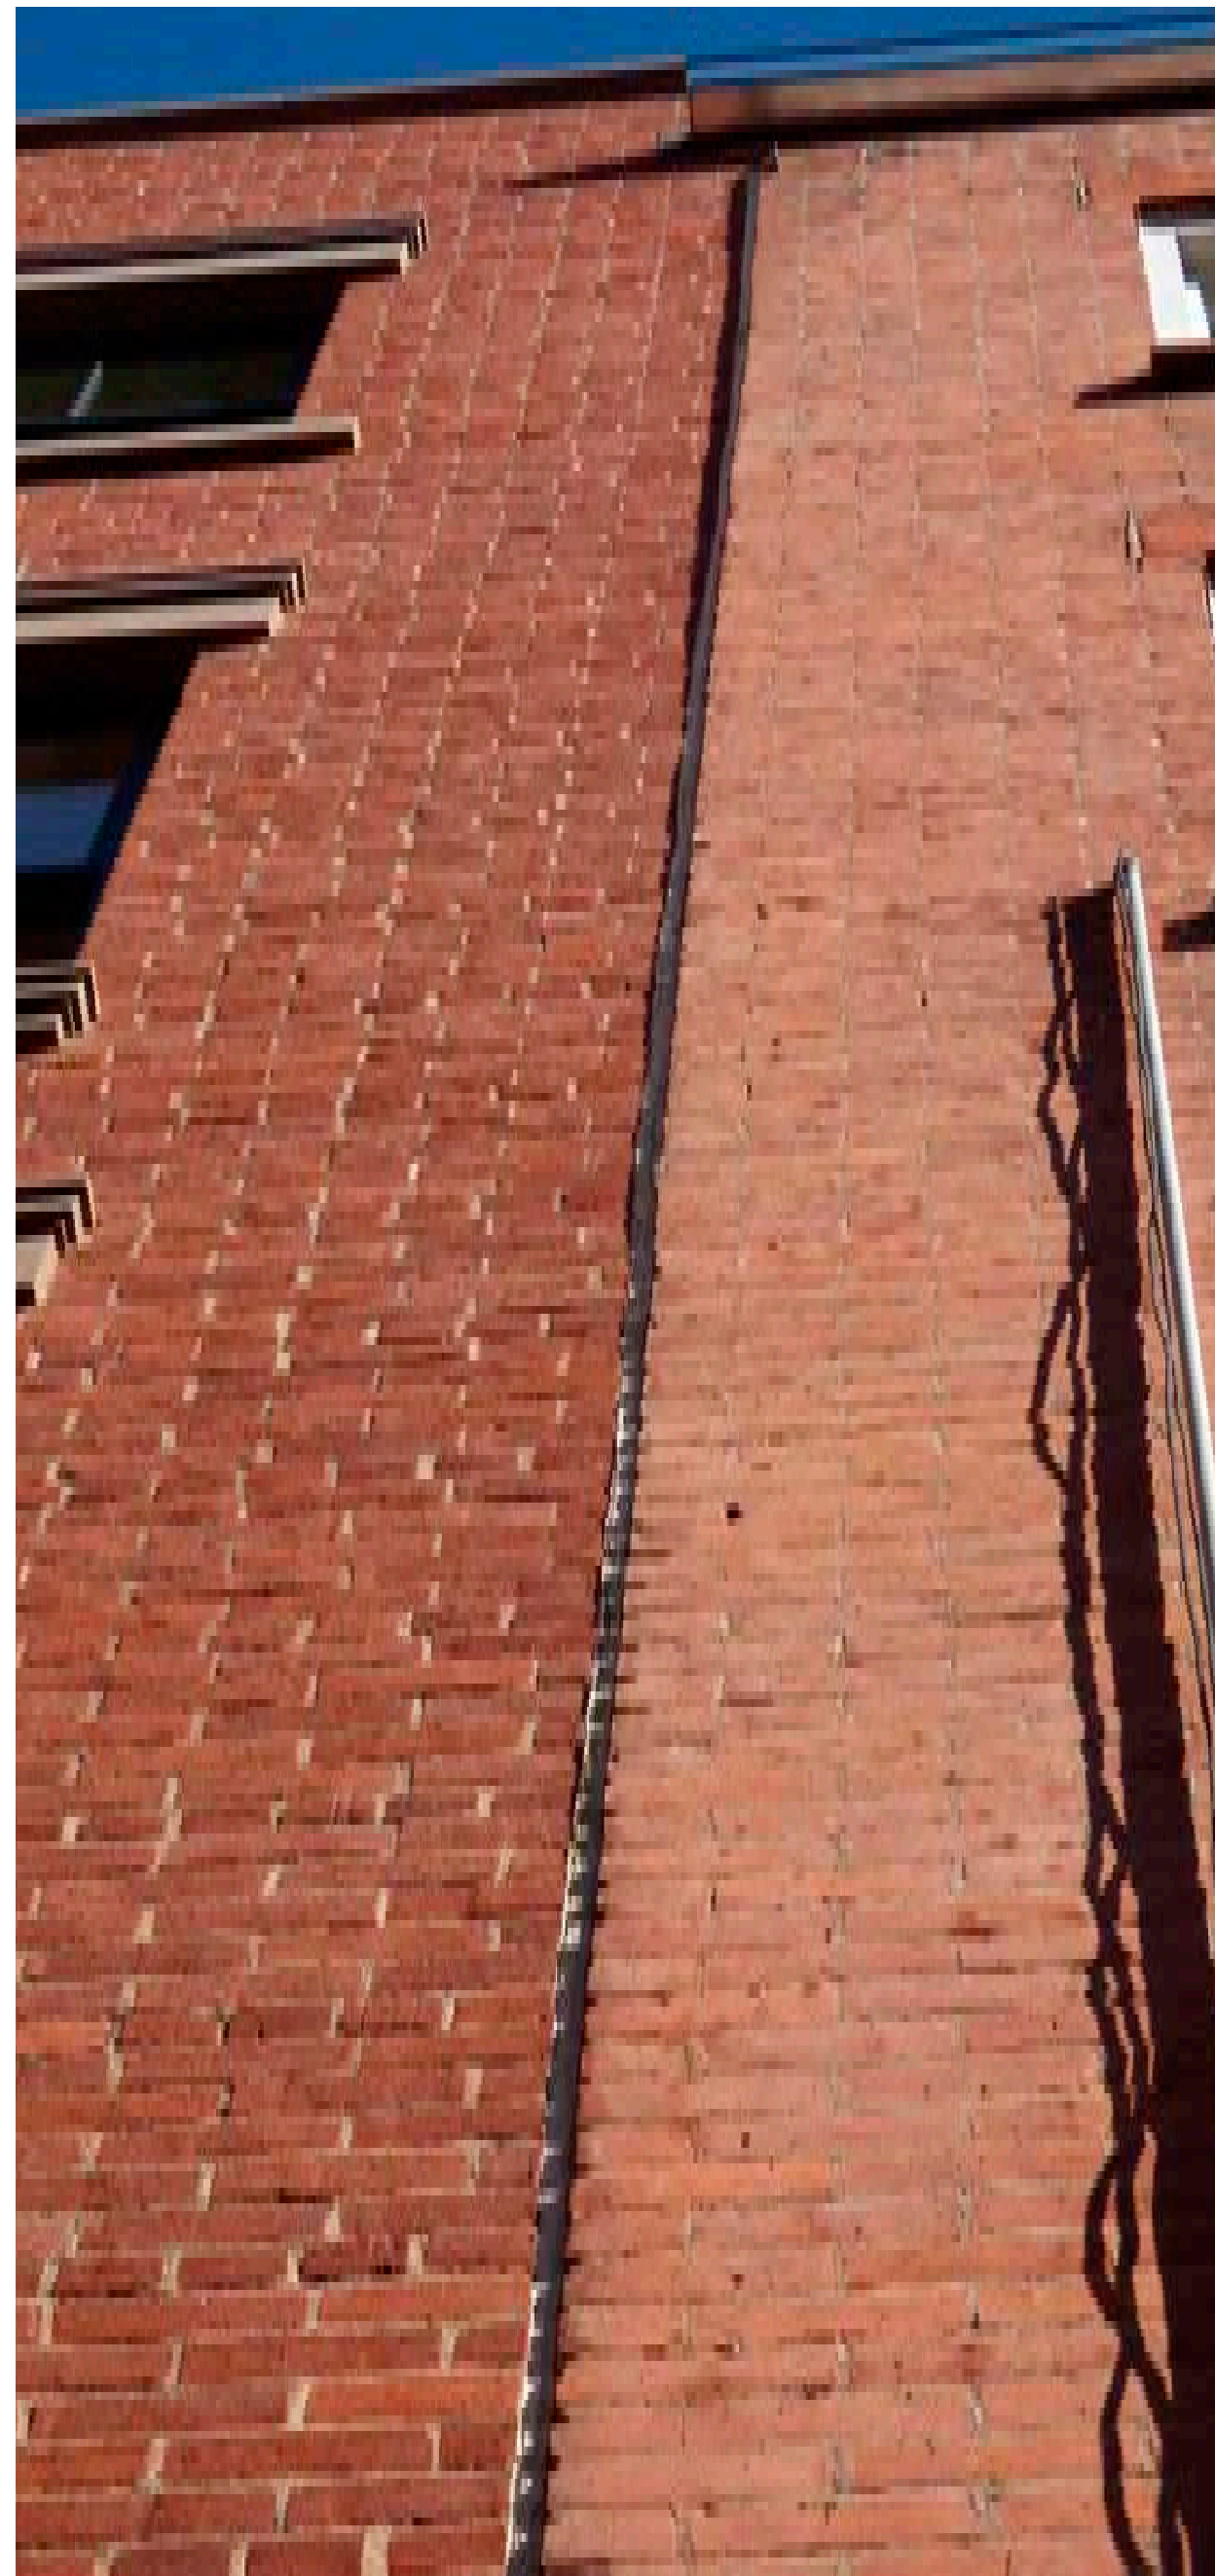
Expansion joint between 338 and 340 W 12th; the historic facade of 338 is visibly out of plumb

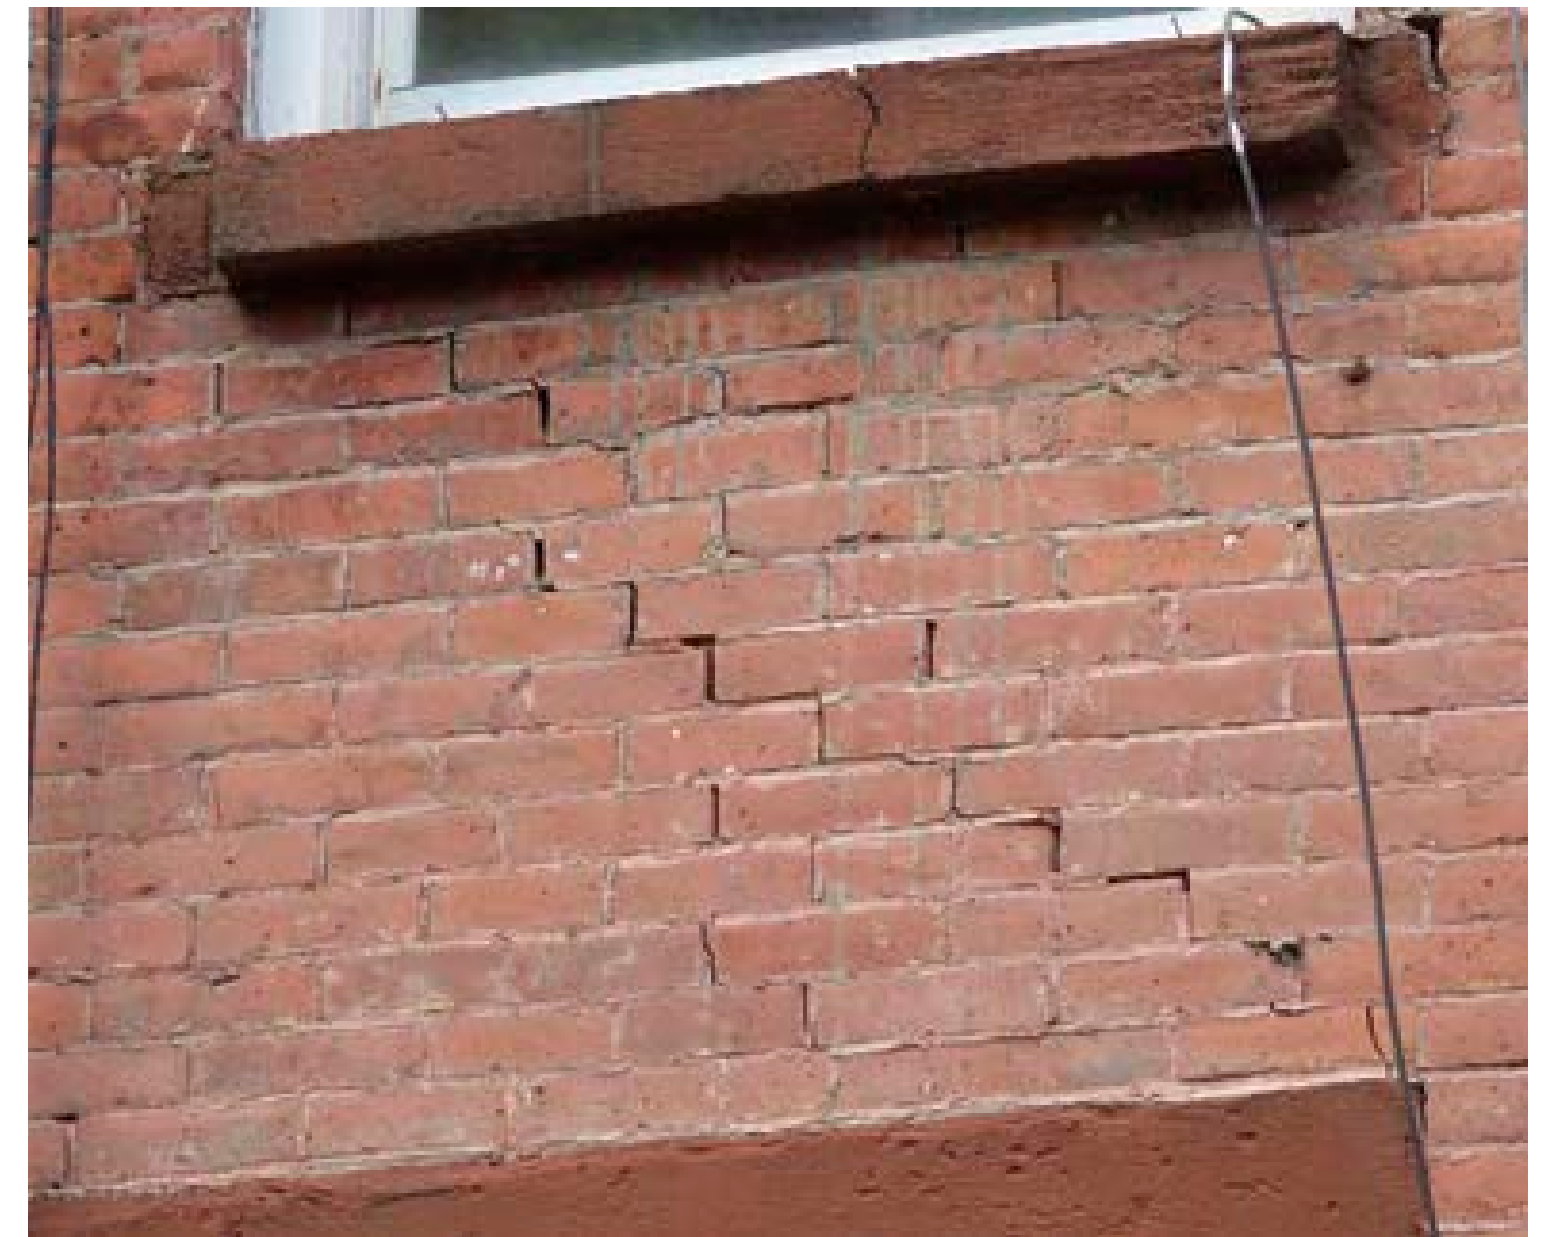
Detail of the brick between the parlor and second floors, showing step cracking and a crack through the stone sill

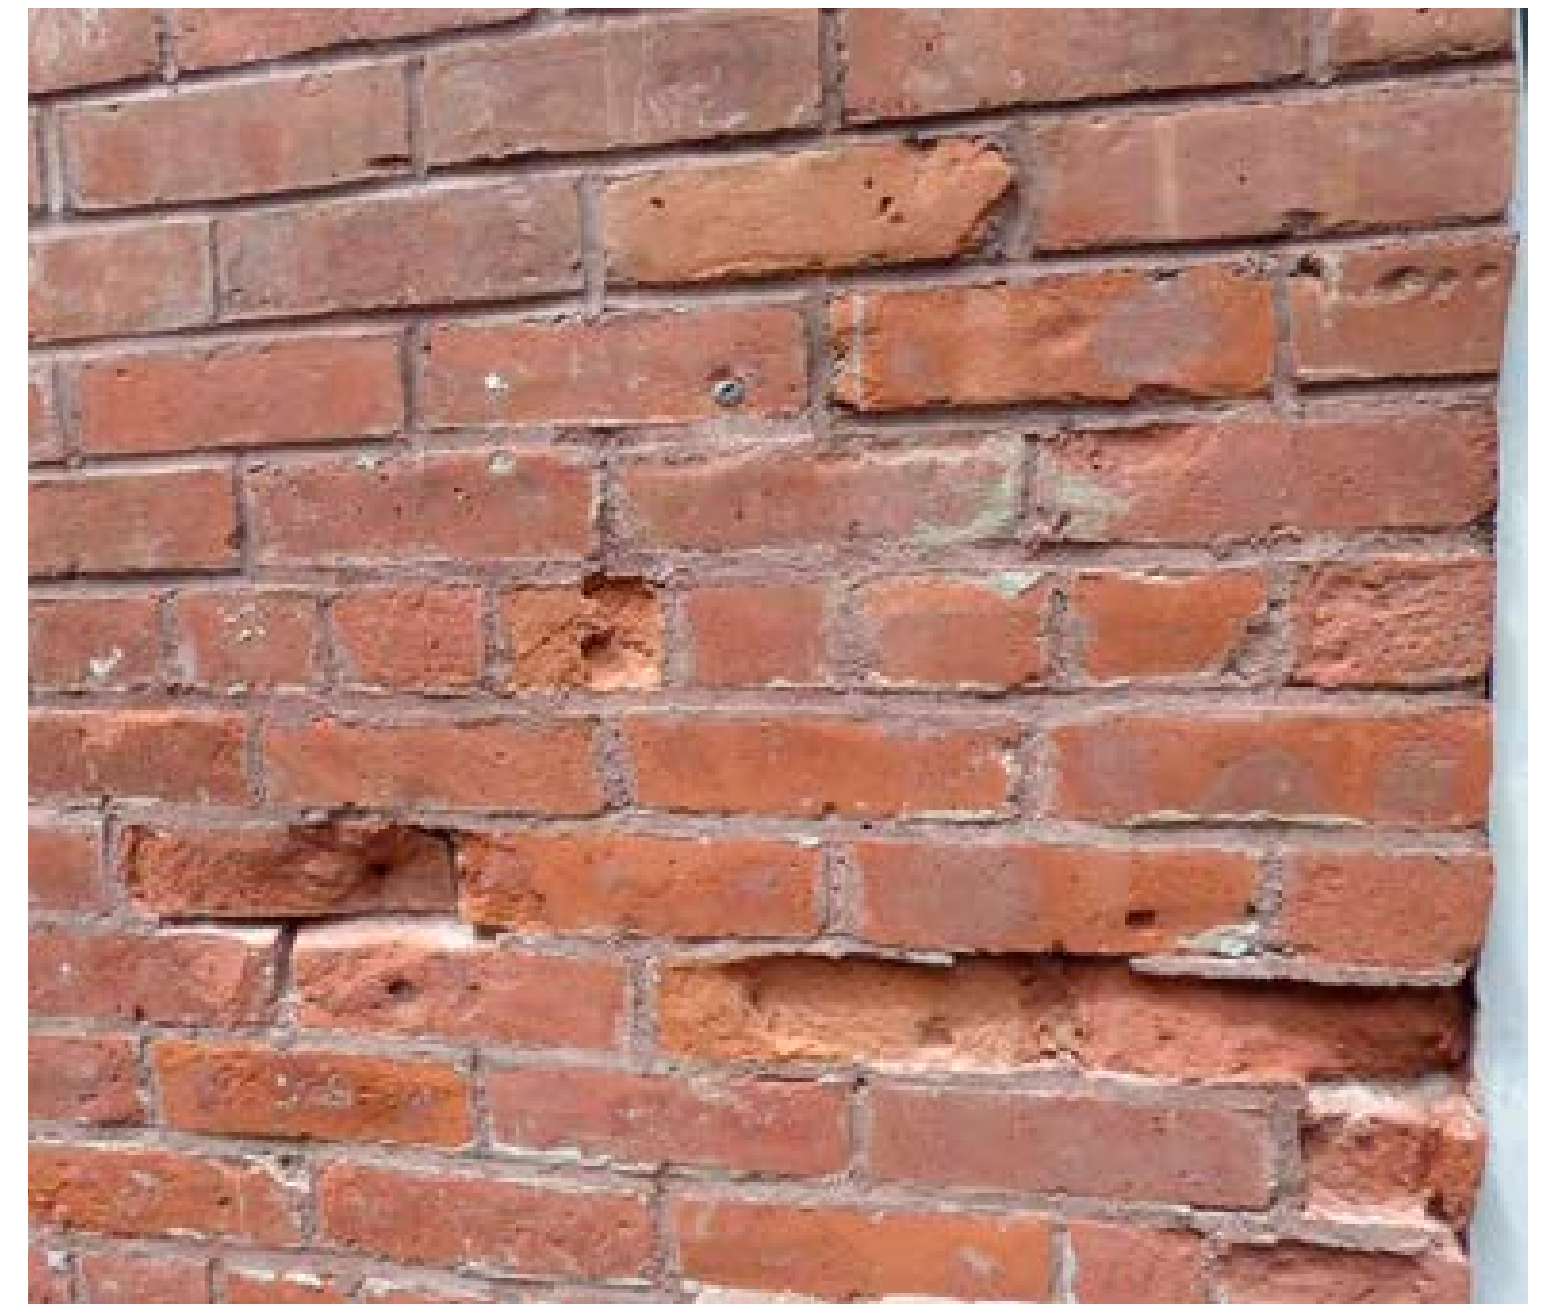
Detail of the brick at the ground floor, showing lack of a fire skin and significant spalling

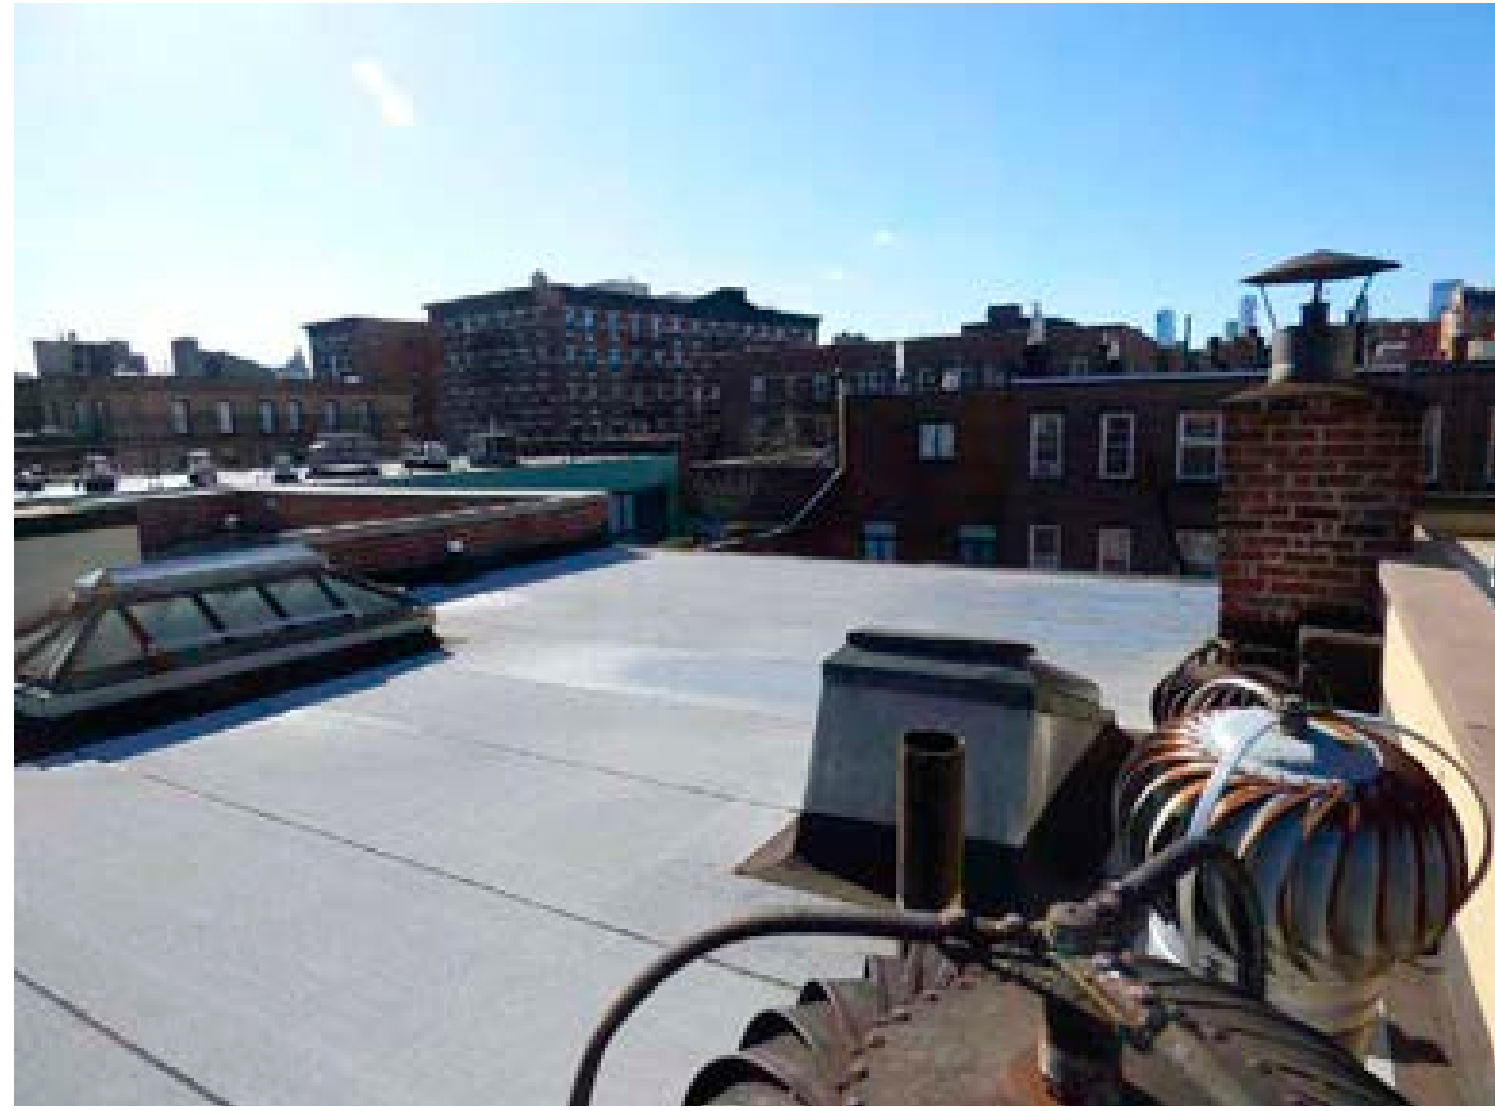
Roof (HQP, 2023), Looking Southeast
