#### SHEET LIST

##### Project Background

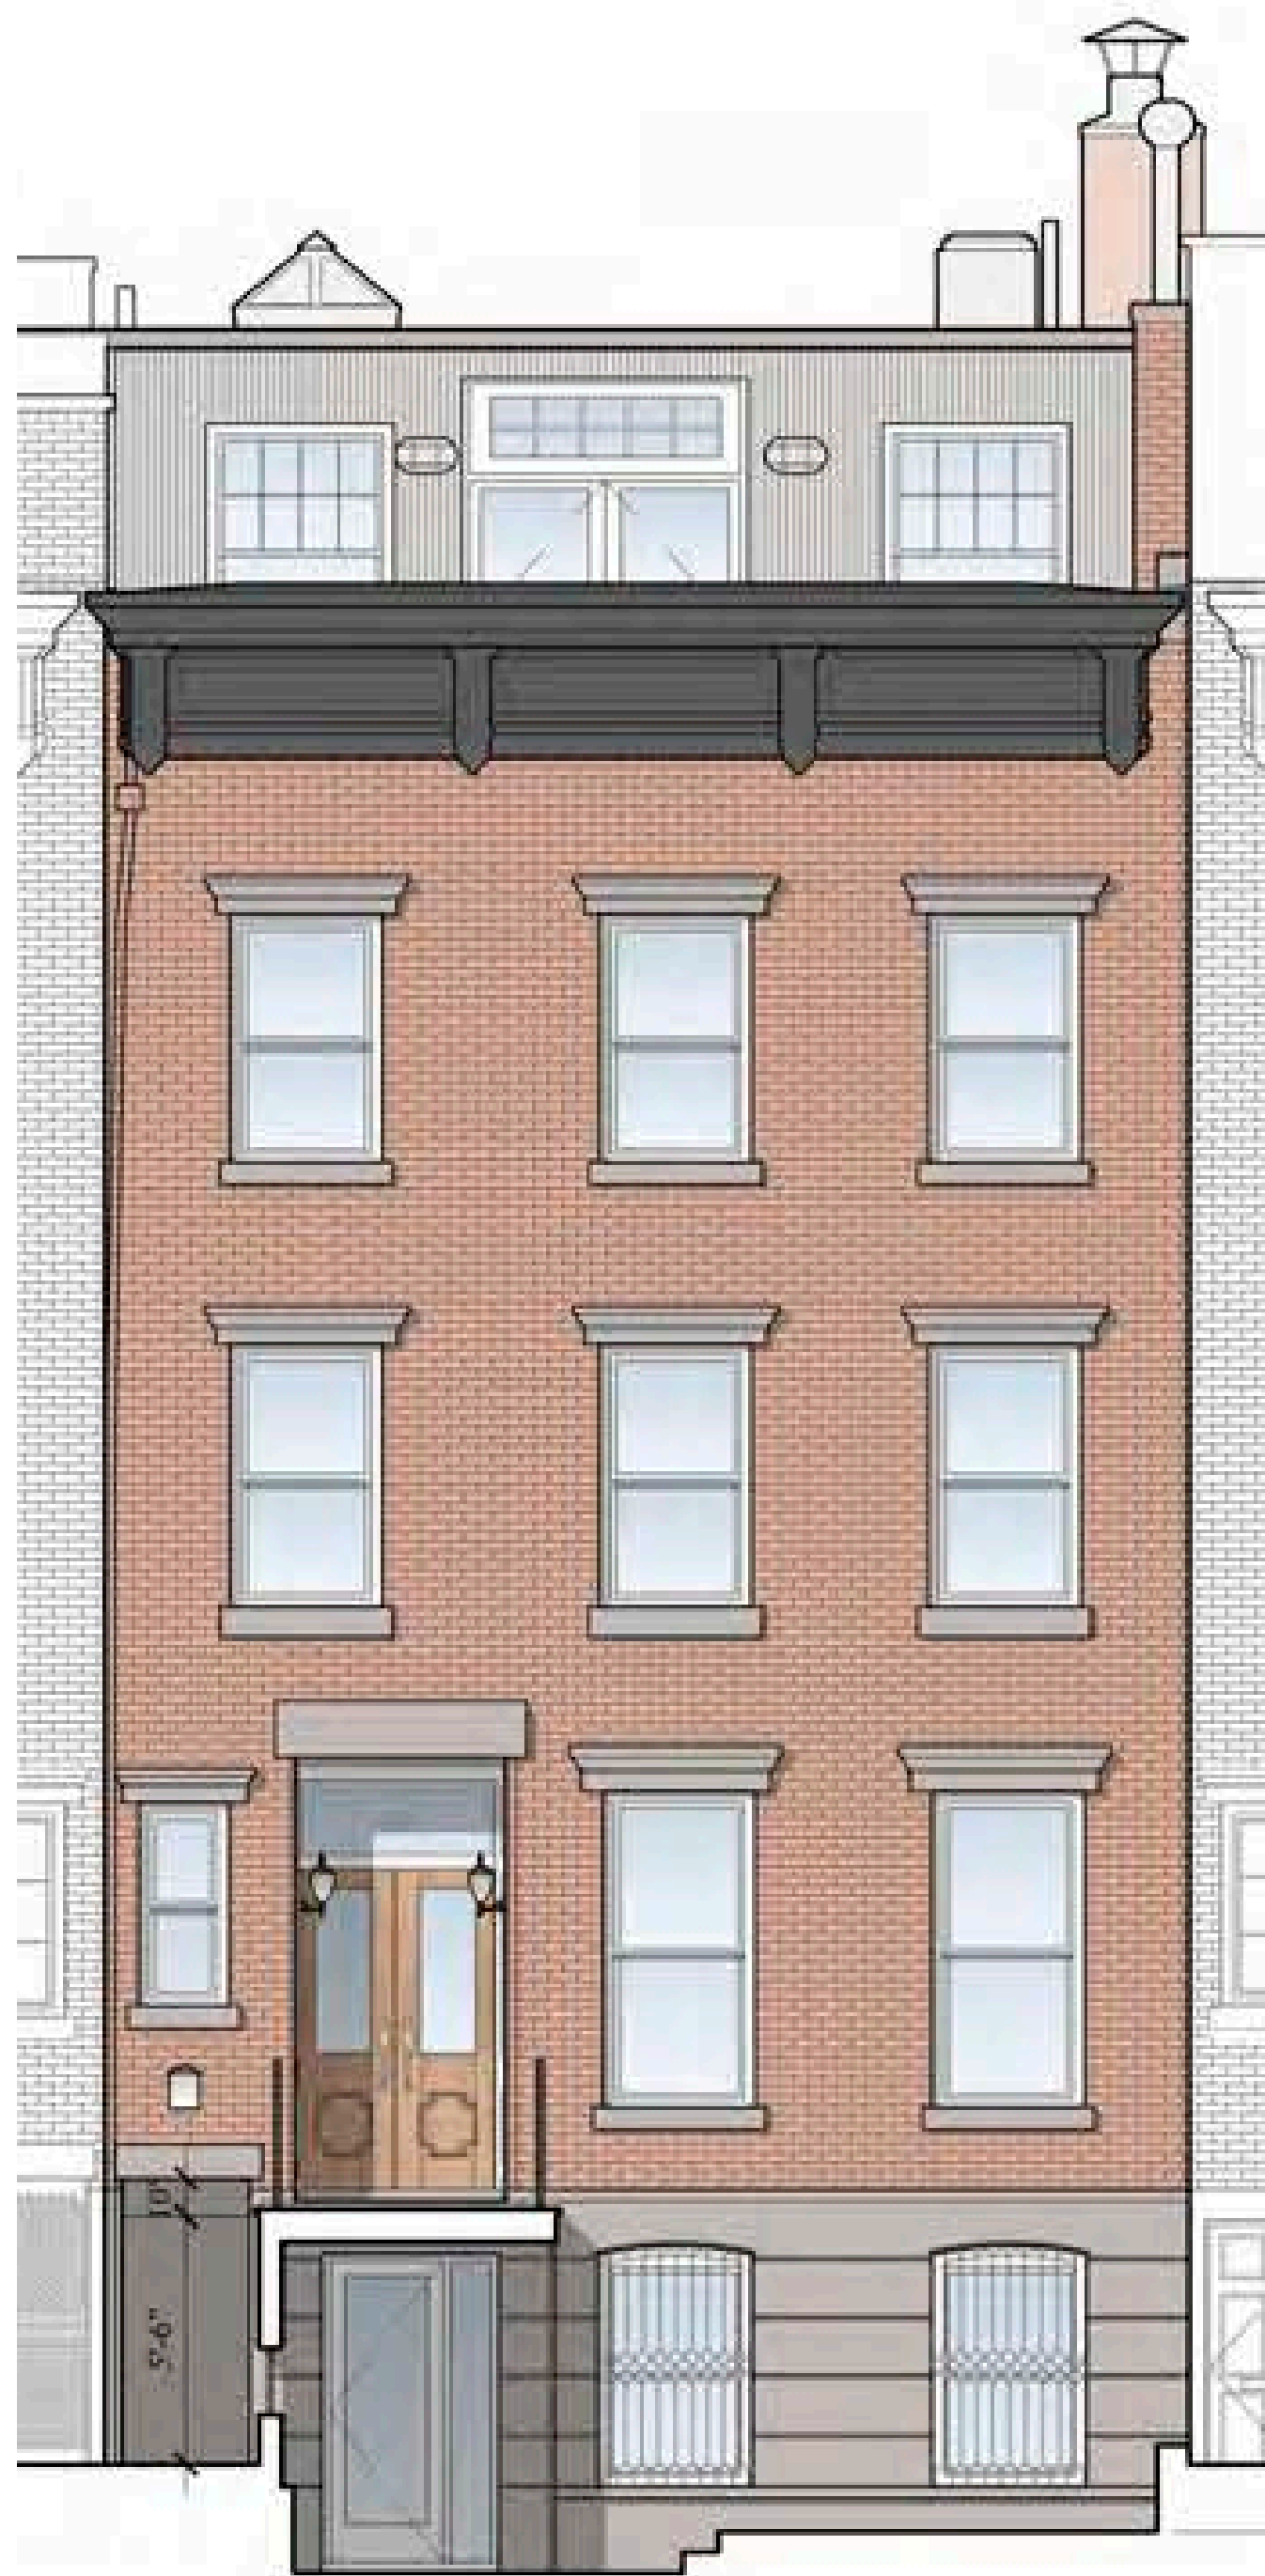
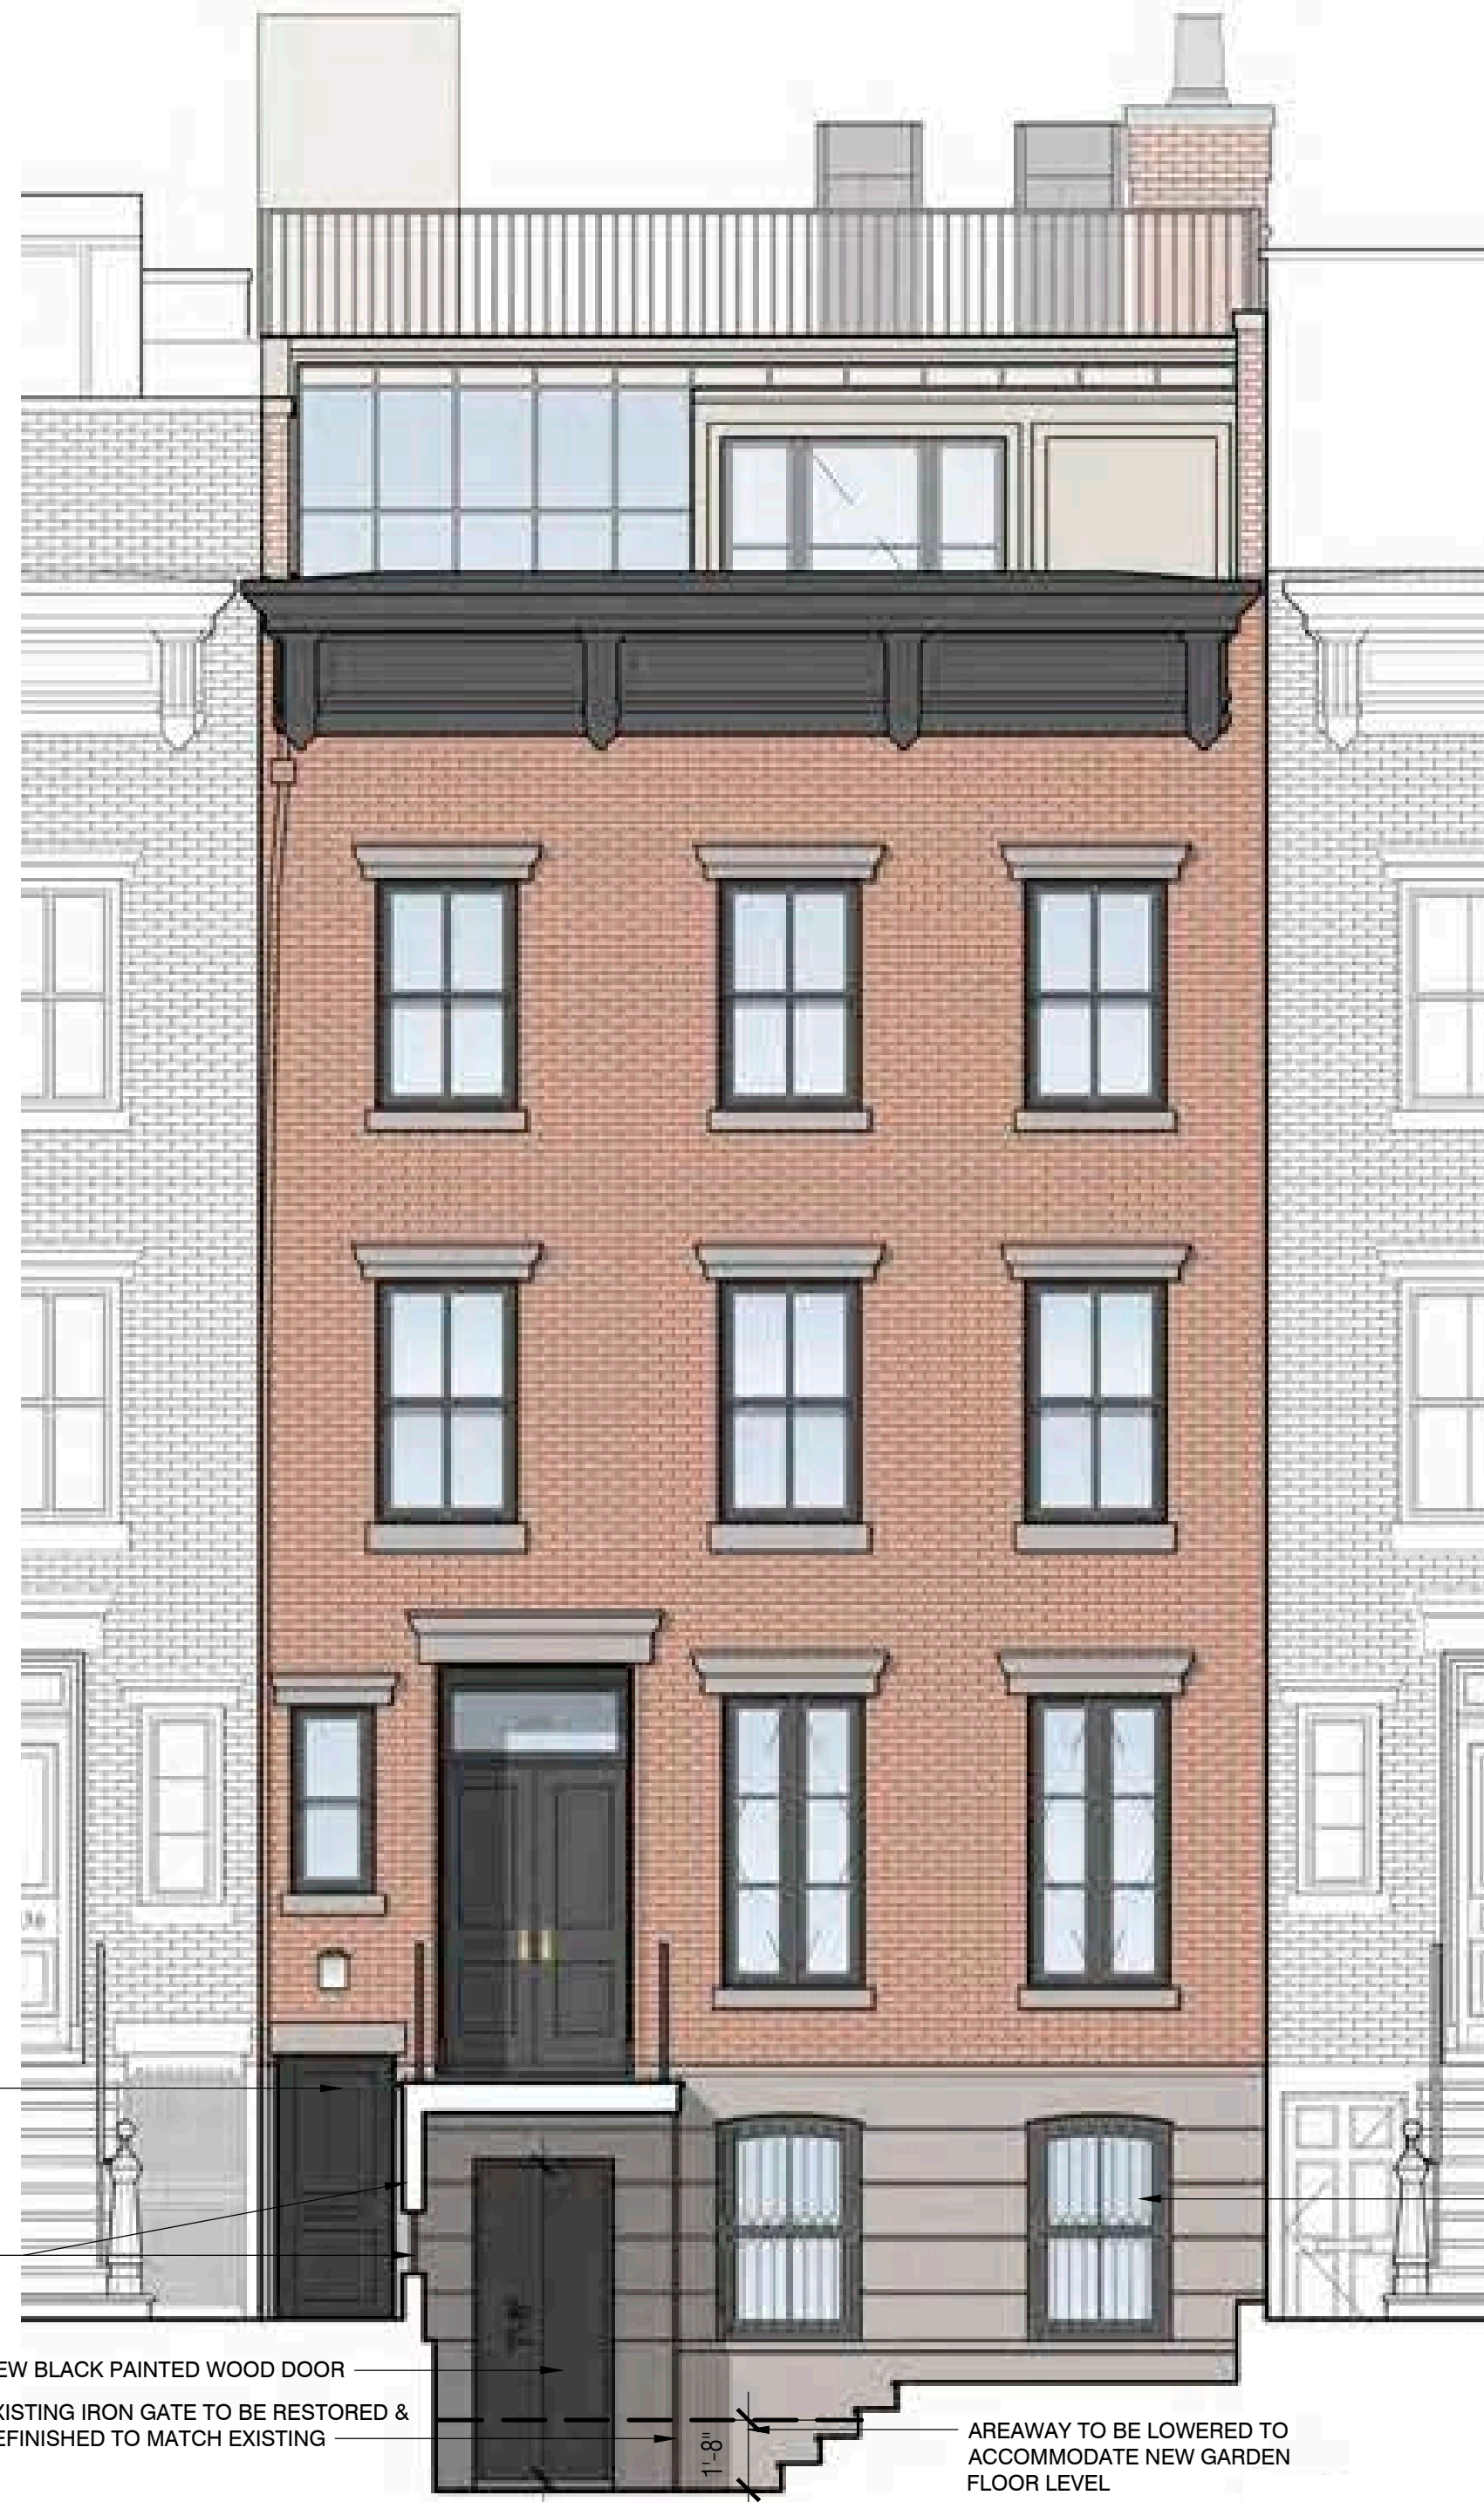
NEW BLACK-PAINTED  
SOLID DOOR SET BACK  
~2'-6" FROM GATE
