# The High School of Fashion Industries Building Rehabilitation

*Informational Meeting  
with NYC Council Member  
Corey Johnson,  
Community Board 4, and  
the NYC SCA.*

*October 7, 2019*

***The Cycle 8A Local Law 11 Façade Inspection Report prepared by HAKS Engineers & Architects dated 11/19/2015, classified the existing conditions of HS of Fashion Industries as **UNSAFE** or **SWARMP** (Safe with a Repair and Maintenance Program).***

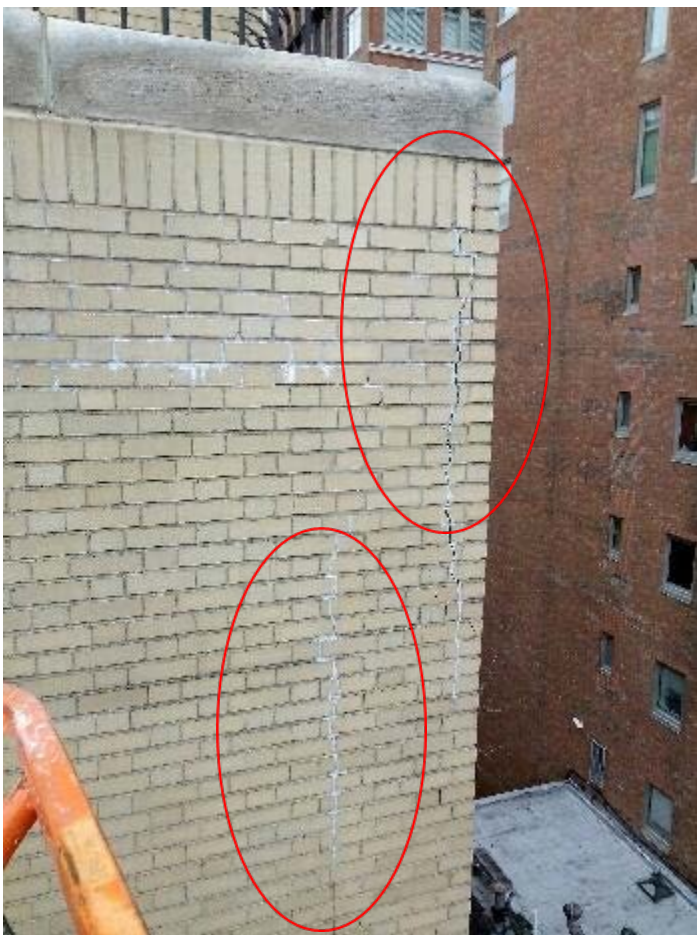
Photo: P08      Date 10/5/2015

- **Condition:** Vertical masonry crack at building corner

- **Classification:** UNSAFE

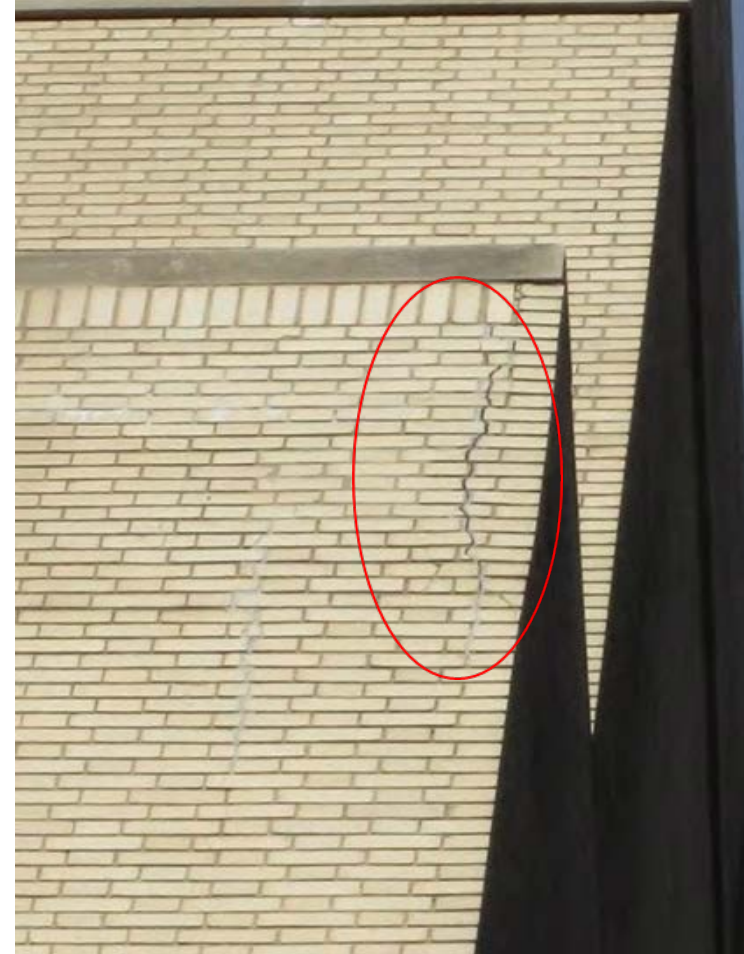
Photo: P08      Date 10/5/2015

- **Condition:** Vertical masonry crack at building corner

- **Classification:** UNSAFE

**CRACK IN BRICK WALL**

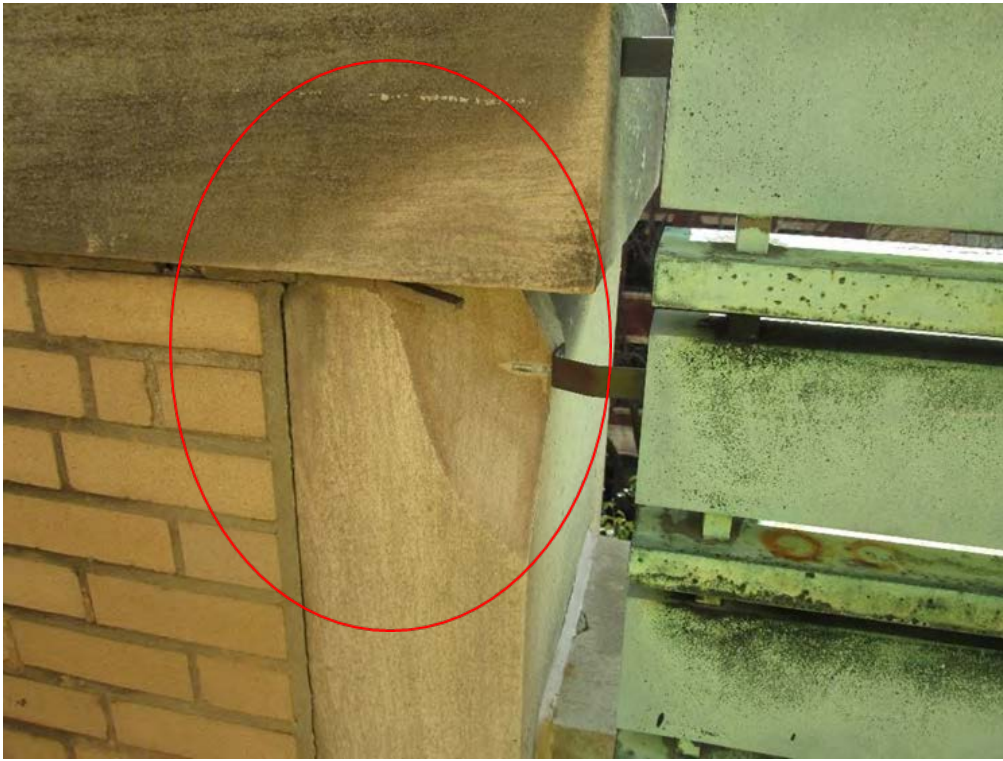
Photo: P07      Date 10/5/2015      ▪ Classification: SWARMP

▪ Condition: Deteriorated stone

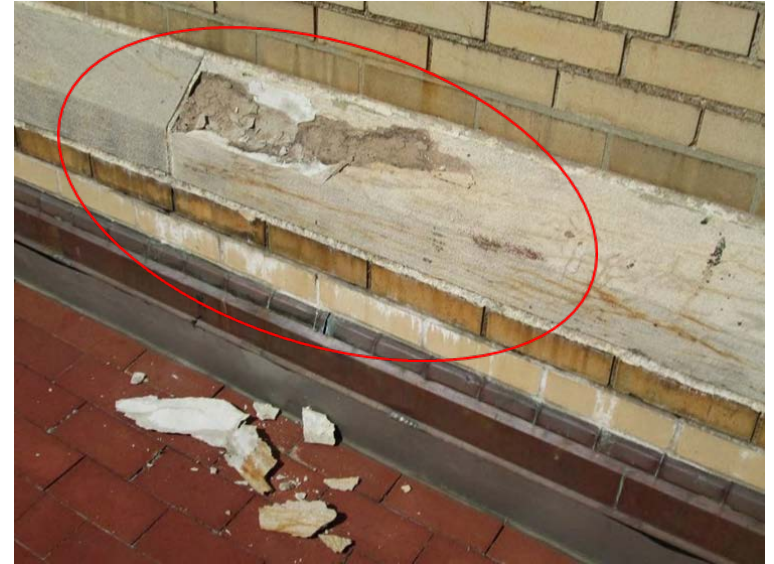
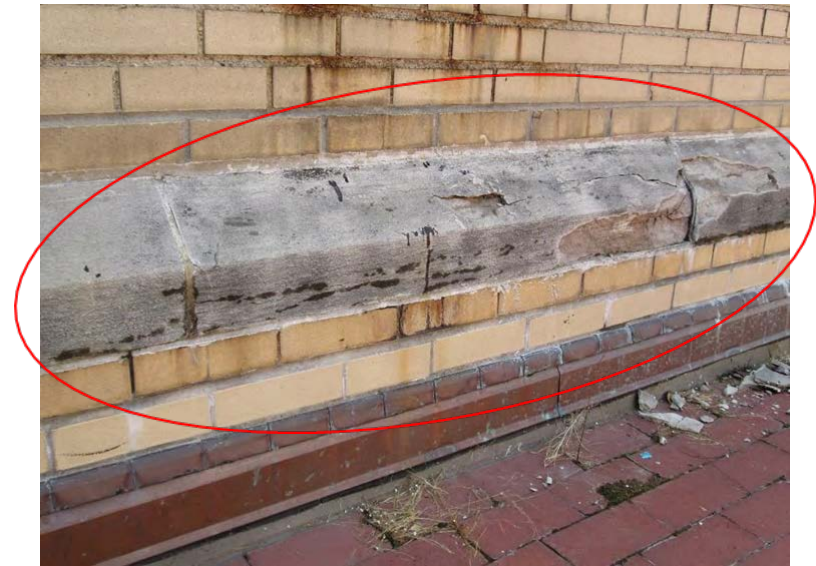
**CRACK IN LIMESTONE LEDGE**

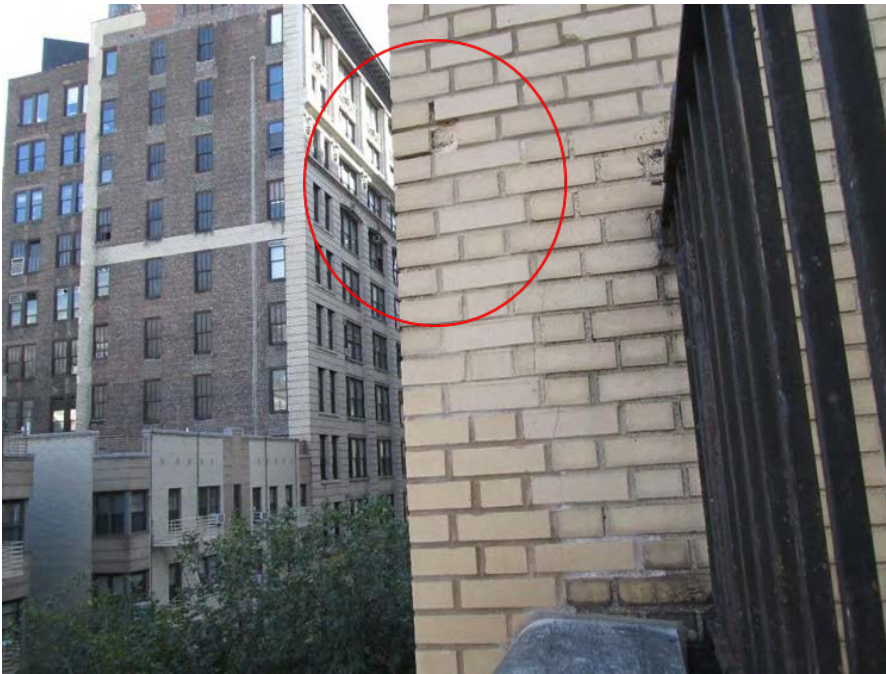
Photo: P21      Date 10/5/2015

▪ Classification: UNSAFE

▪ Condition: Deteriorated face brick

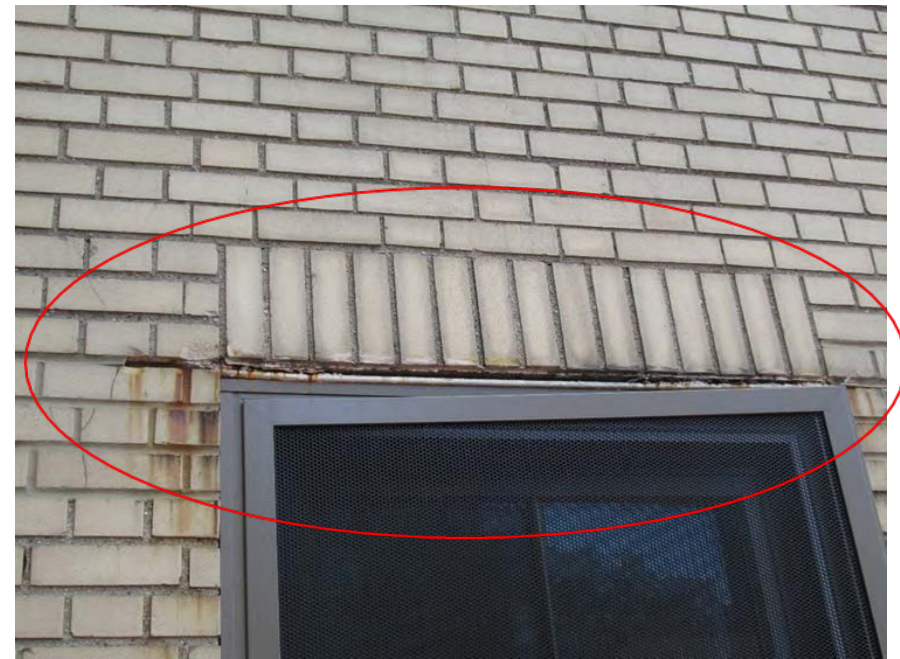
Photo: P26      Date 10/5/2015

▪ Condition: Deteriorated lintel

▪ Classification: SWARMP

### LOOSE METAL BIRD CONTROL SPIKES AND CRACK IN LIMESTONE

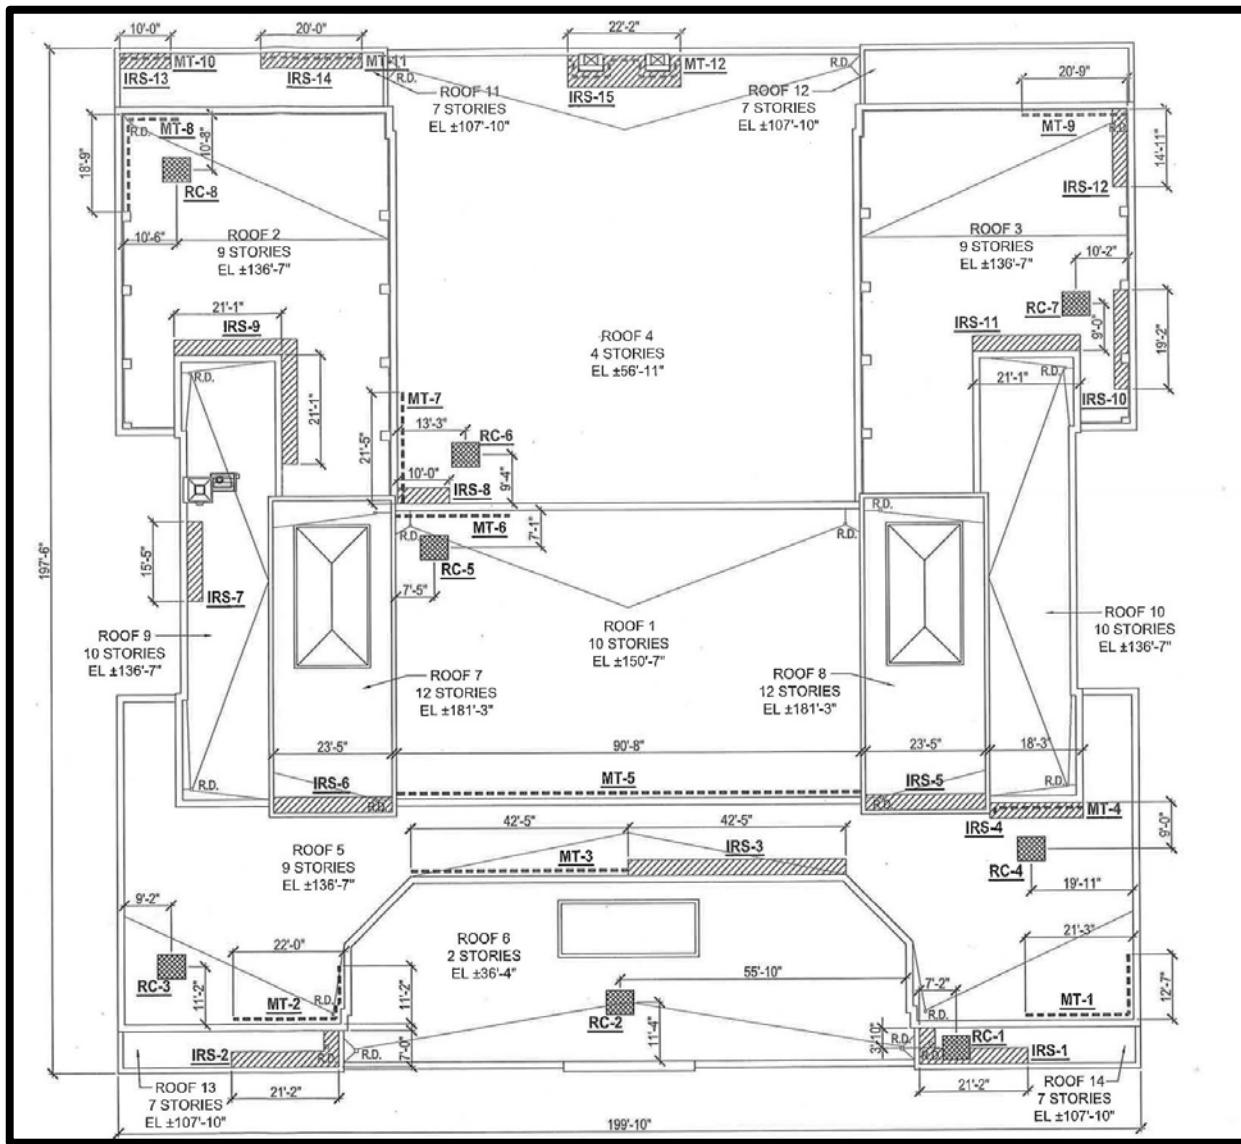
**ROOF & MASONRY NON-DESTRUCTIVE TEST PERFORMED TO DETERMINE WATER INFILTRATION THRU THE ROOF AND WALLS**

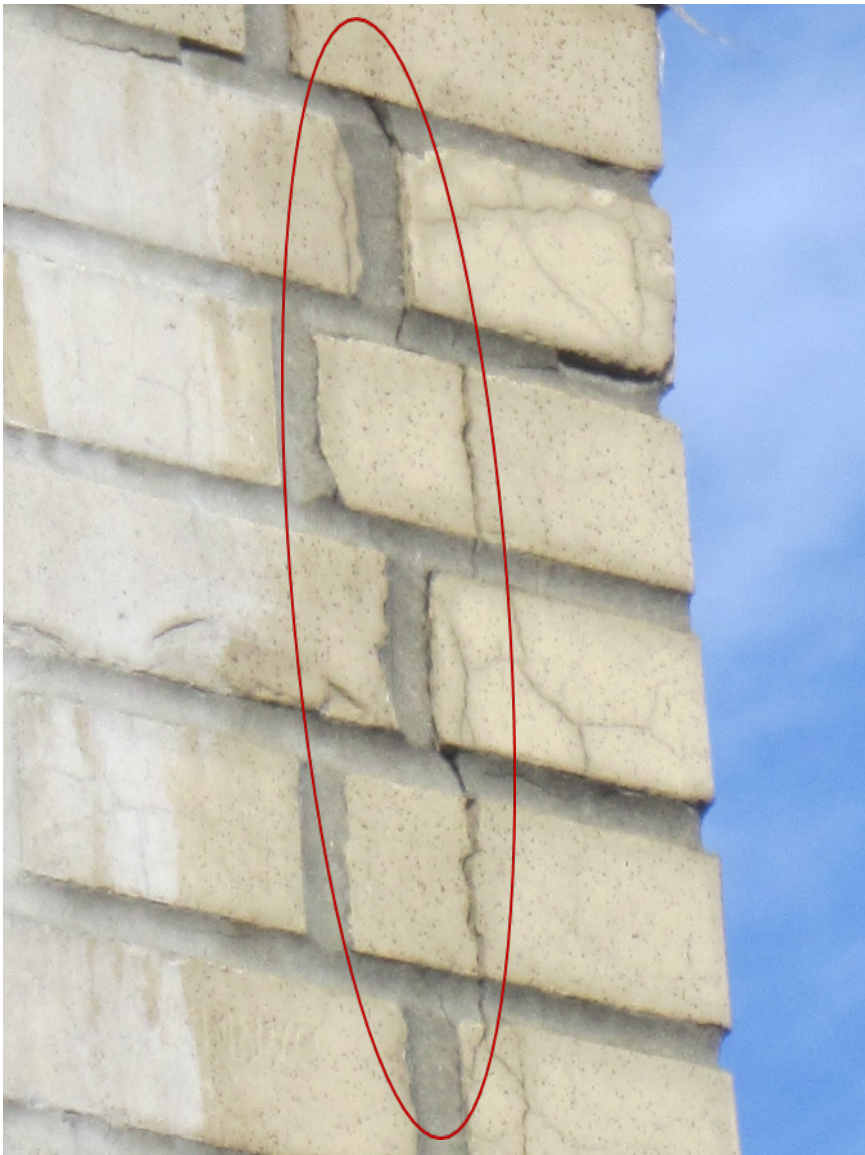
**MASONRY CRACKS & LARGE CONTROL JOINTS**

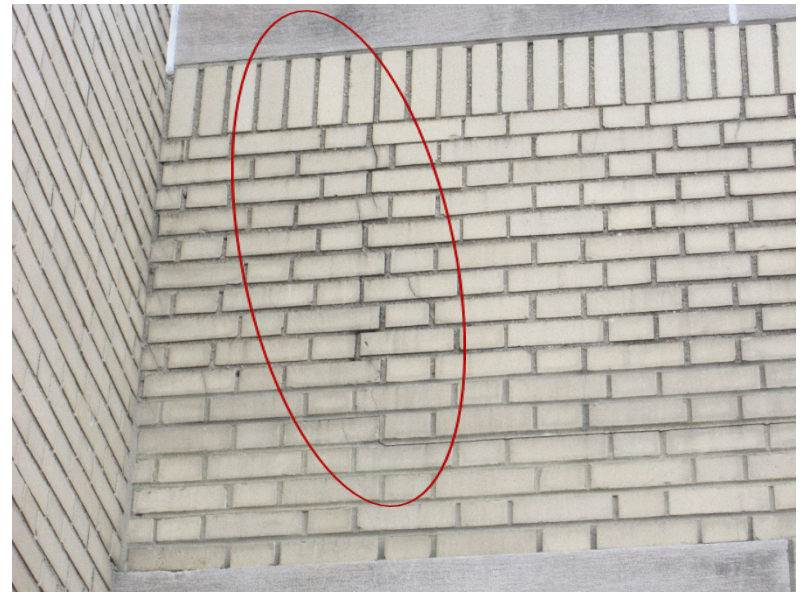
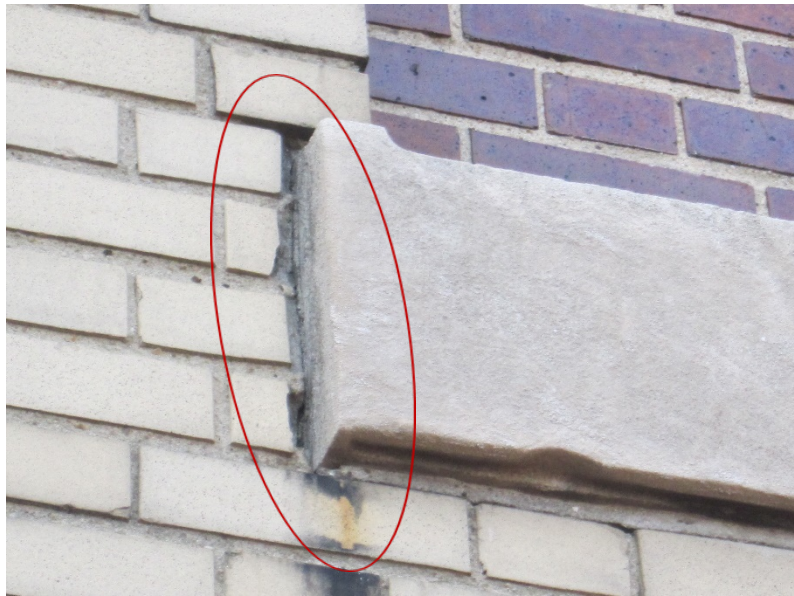
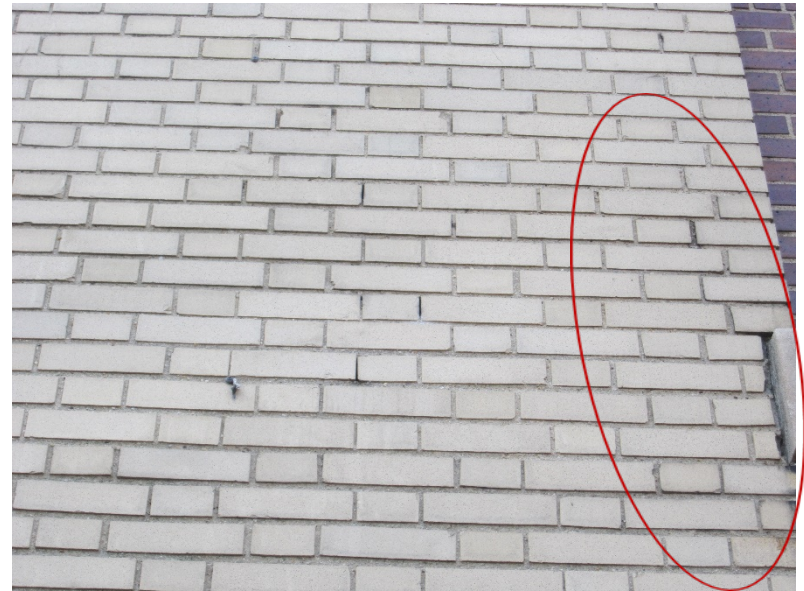
**MASONRY CRACKS & BULGING BRICK WALL**
