## 66 WEST 9th STREET - NY, NY 10011

Proposed ADA lift and Stair Alteration  
Landmark Preservation Commission Review

\*For Retail Space A as indicated

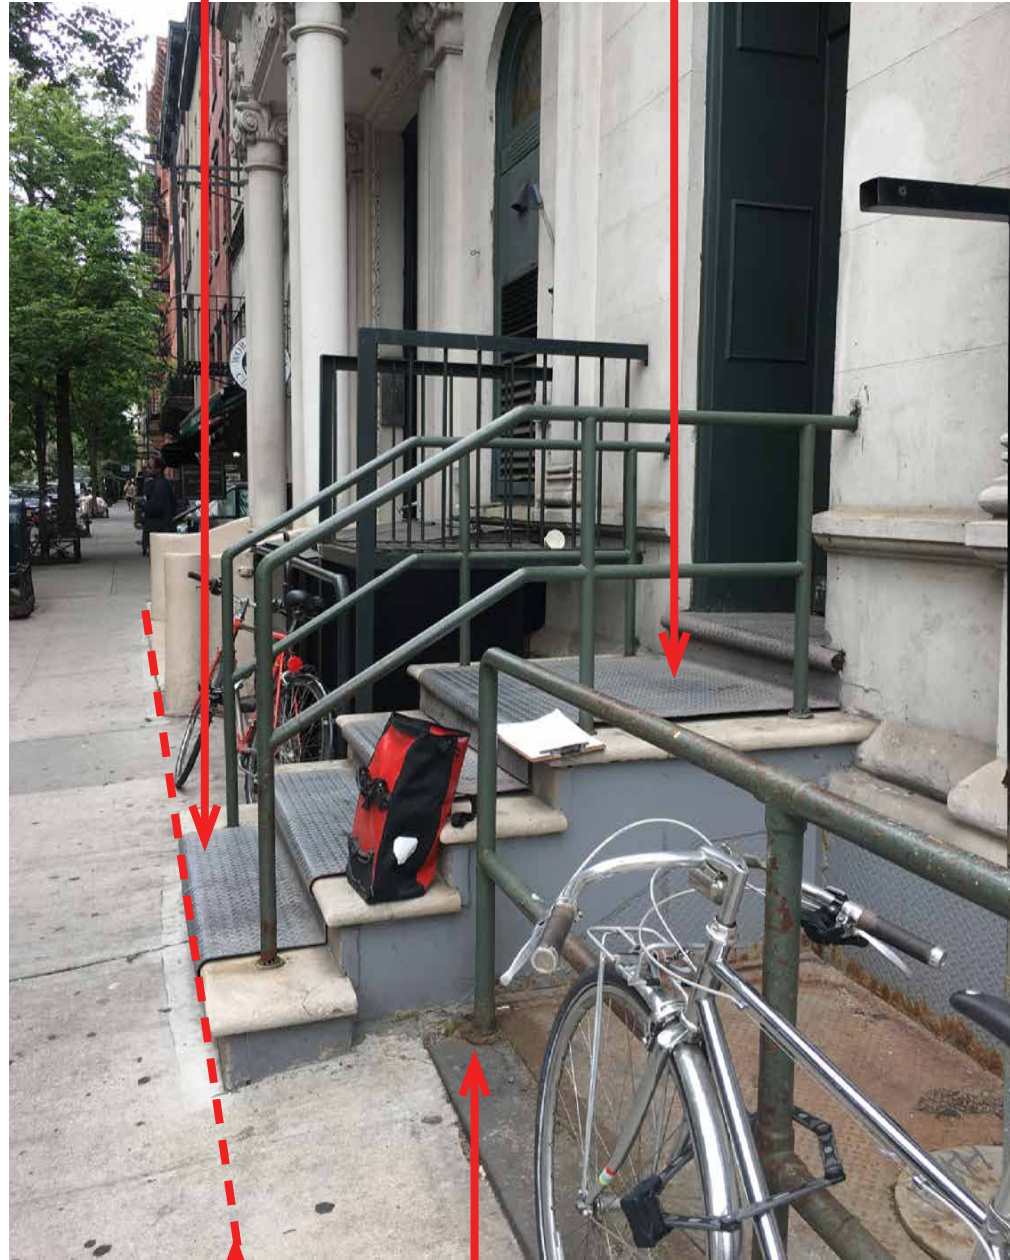
Existing Diamond Plate on Concrete Treads

5 Existing Steps on Concrete Platform

Existing Line of Encroachment

Existing Rail on Vault Wall

Existing Diamond Plate at Base of Stone Wall

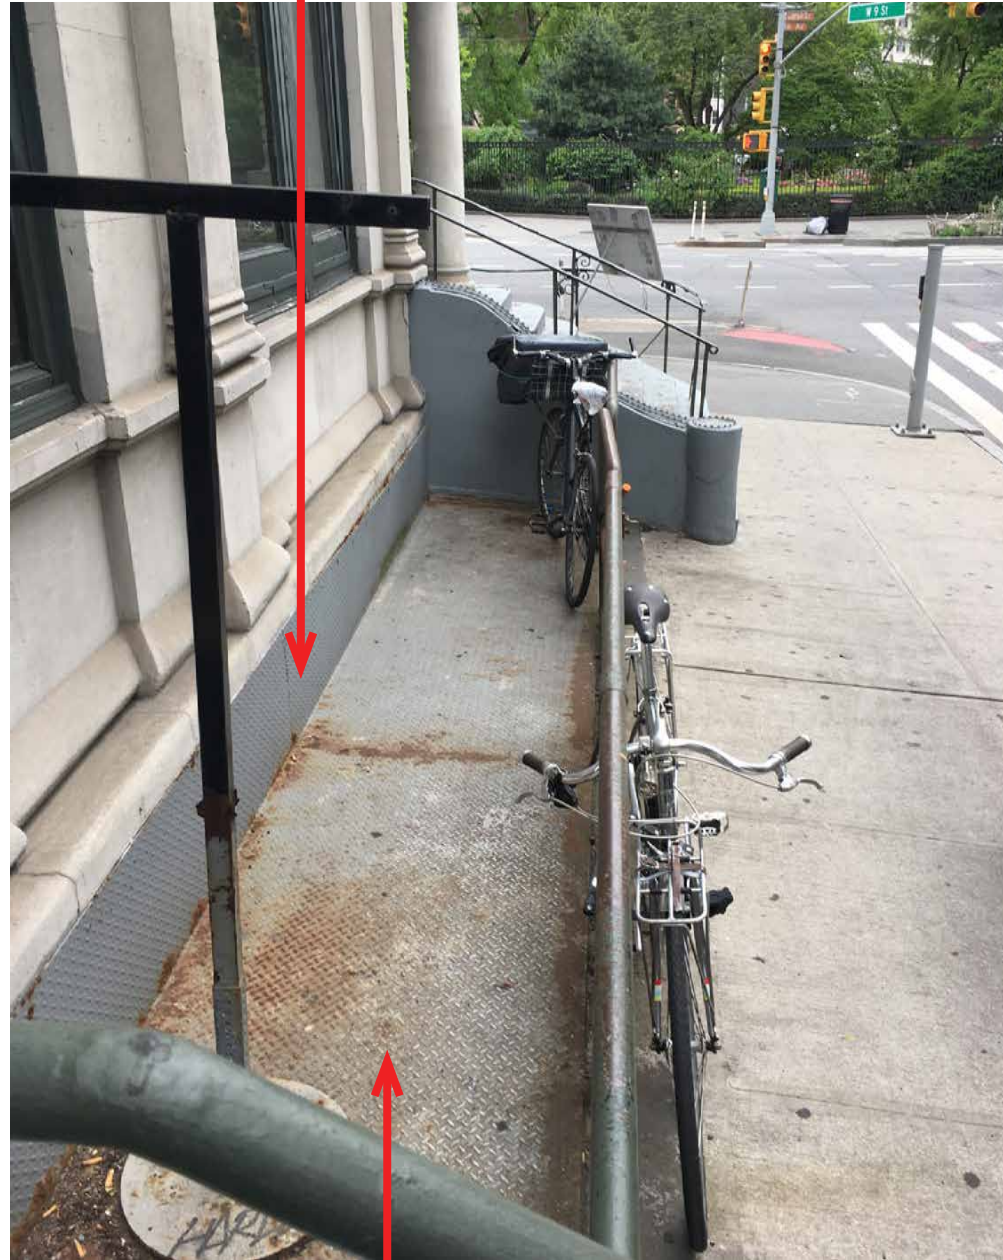
Existing Diamond Plate on Vault

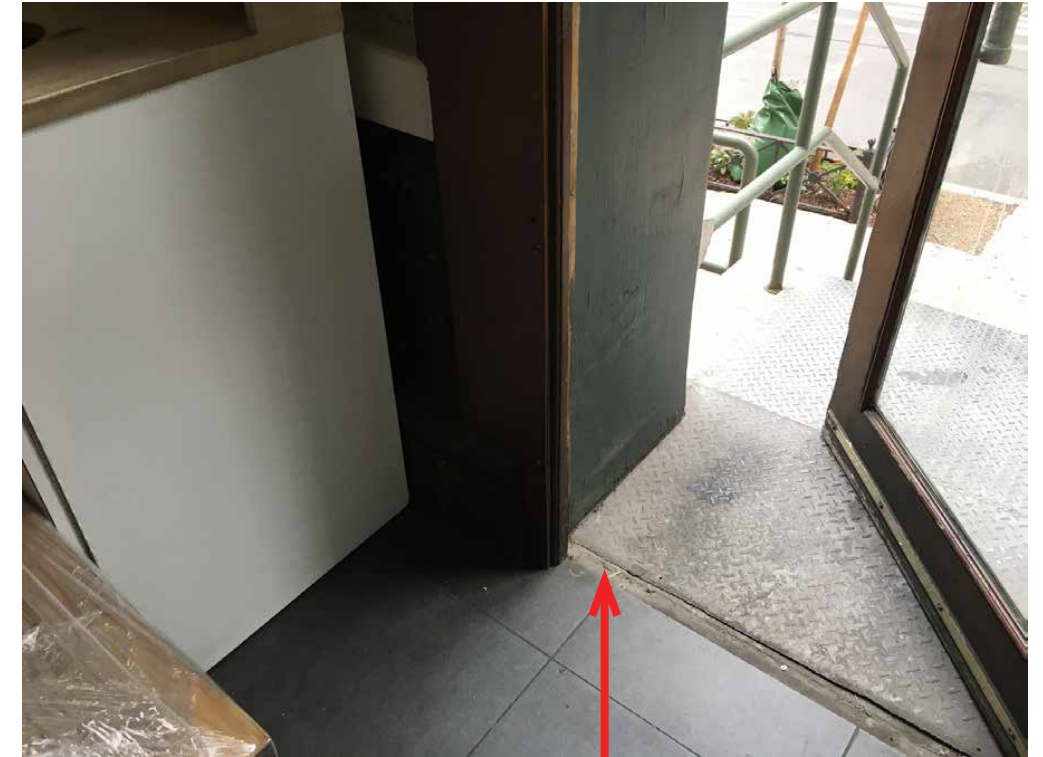
2" Elevation Change at Threshold
