149 Mercer, existing conditions

149 Mercer, proposed

SOHO-CAST IRON HISTORIC DISTRICT

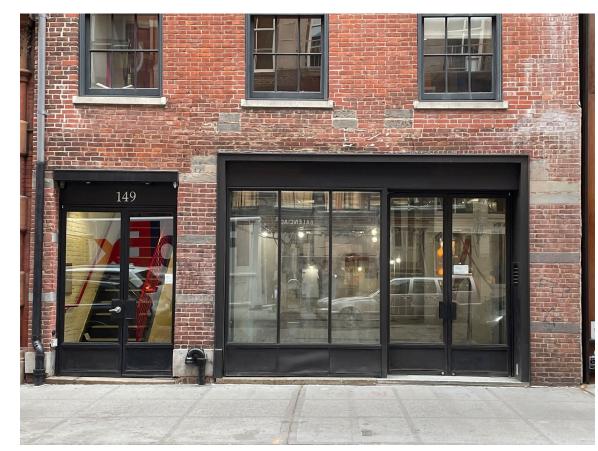
2022, existing conditions

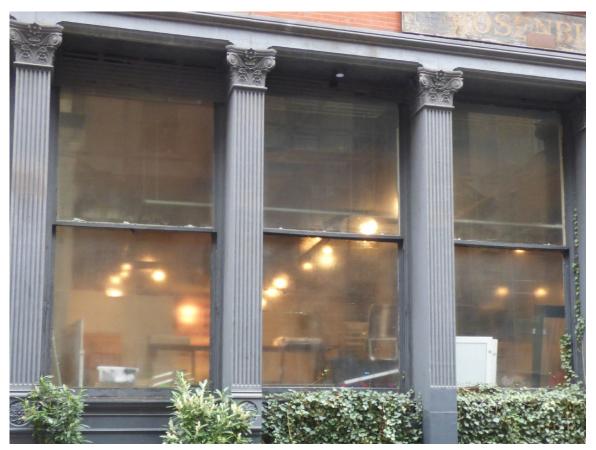
Mercer Street, applied texture glazing

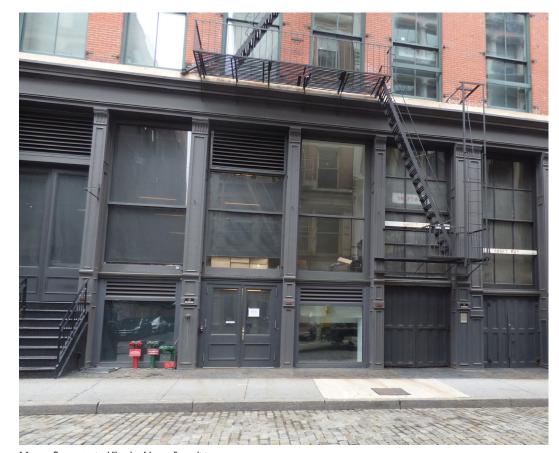
Mercer Street, typical "back-of-house" conditions

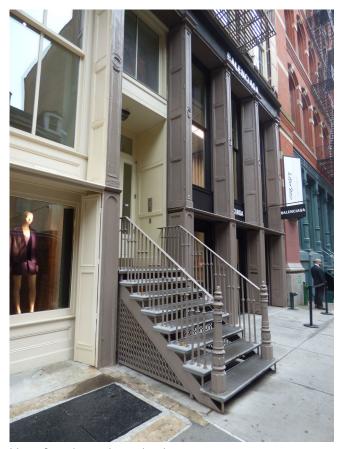
Mercer Street, historic shuttered windows

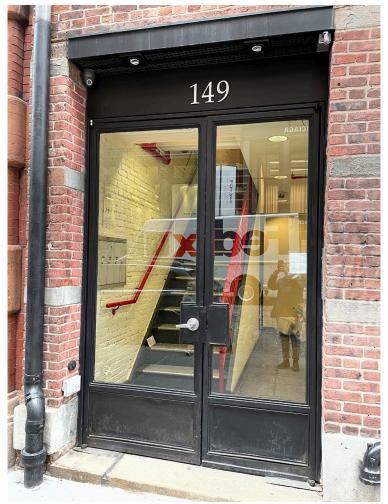
Residential entry doors.

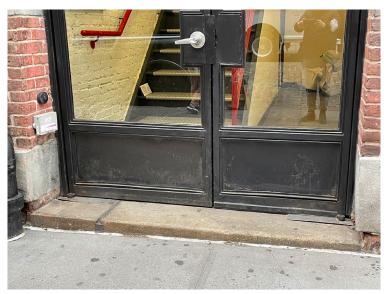
Residential entry, granite sill.

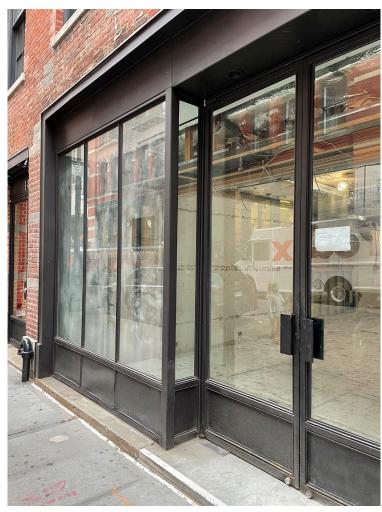
Storefront overview, looking southwest.

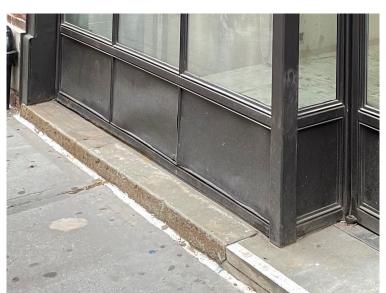
Storefront base, granite sill.

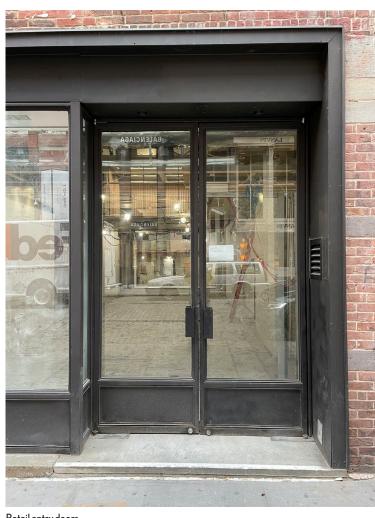
Retail entry doors.

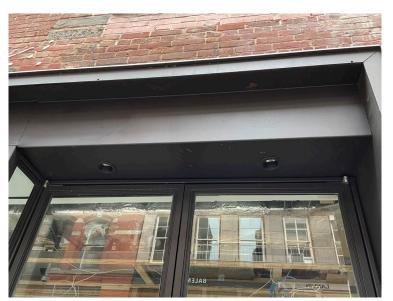
Retail entry header and lighting detail.

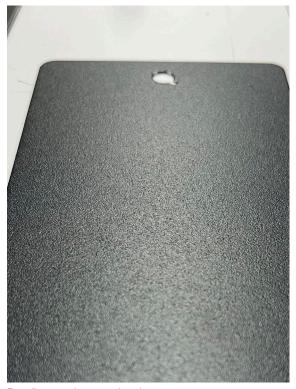
Entry floor sample, textured steel
