Storefronts - Proposed Elevations

Storefront - New Storefront Profile in Existing Opening (Enlarged Elevations and Details)

Storefront - Canopy Details

Cornice - Details

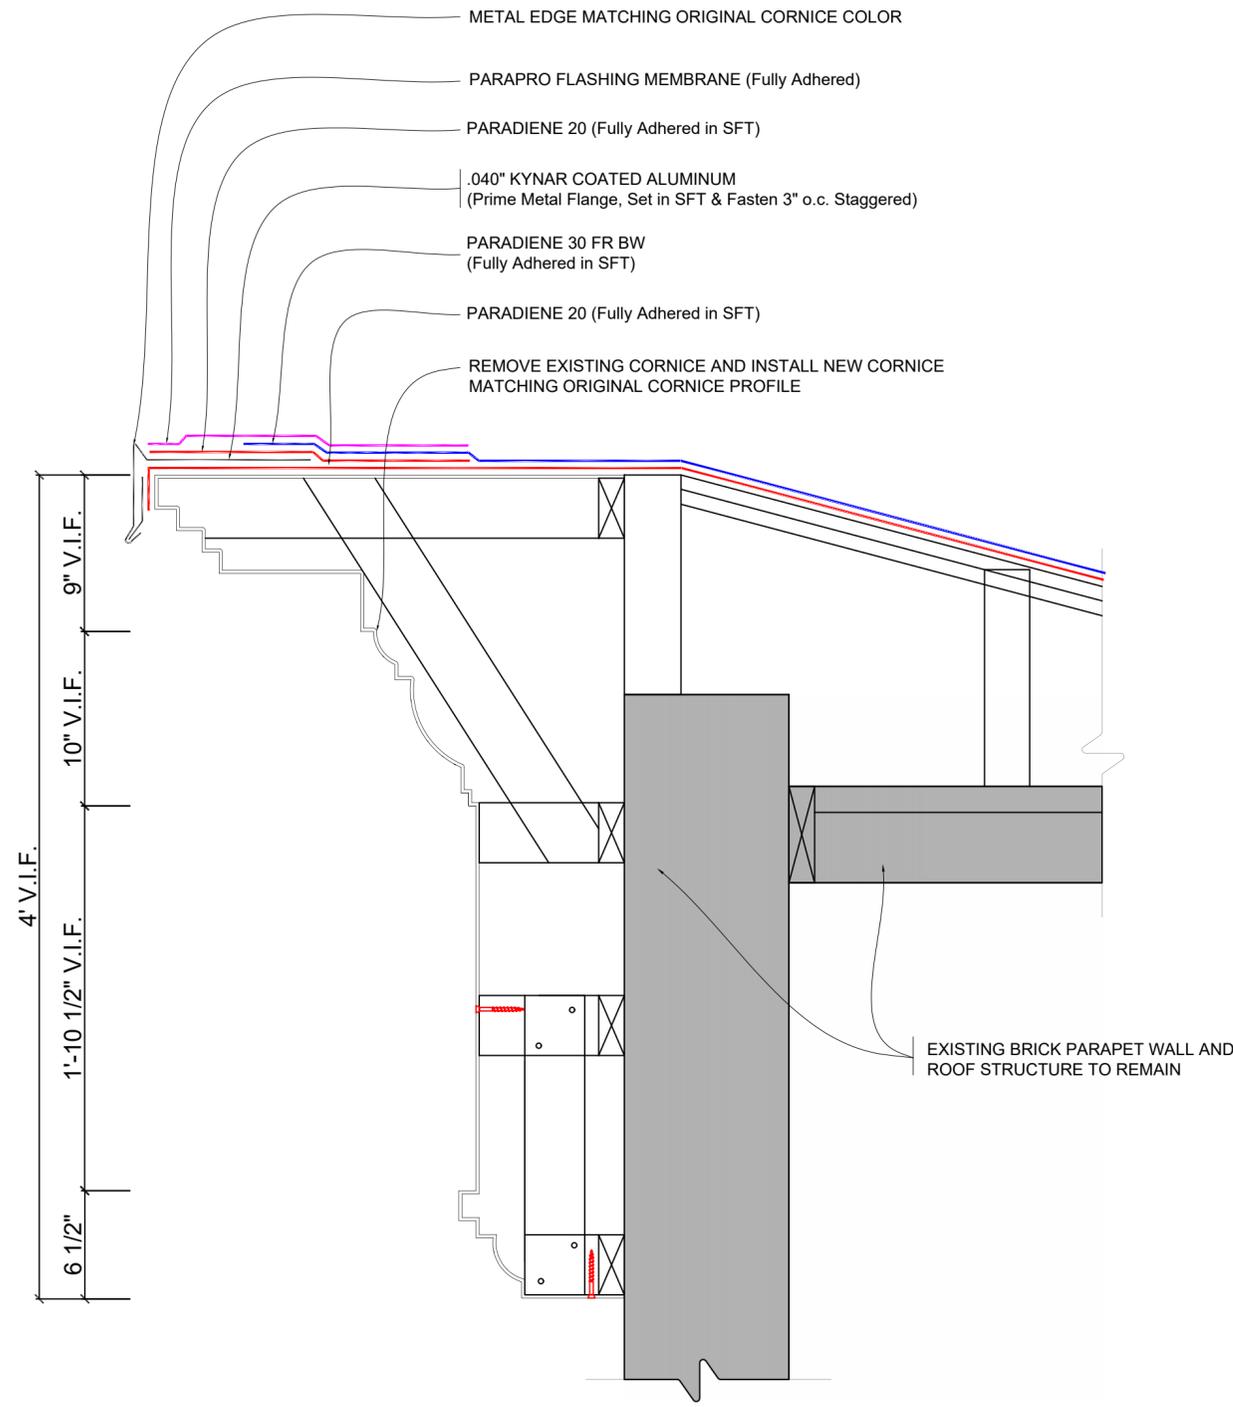
CORNICE SECTION DETAIL

- METAL EDGE MATCHING ORIGINAL CORNICE COLOR
- PARAPRO FLASHING MEMBRANE (Fully Adhered)
- PARADIENE 20 (Fully Adhered in SFT)
- .040" KYNAR COATED ALUMINUM (Prime Metal Flange, Set in SFT & Fasten 3" o.c. Staggered)
- PARADIENE 30 FR BW (Fully Adhered in SFT)
- PARADIENE 20 (Fully Adhered in SFT)
- REMOVE EXISTING CORNICE AND INSTALL NEW CORNICE MATCHING ORIGINAL CORNICE PROFILE

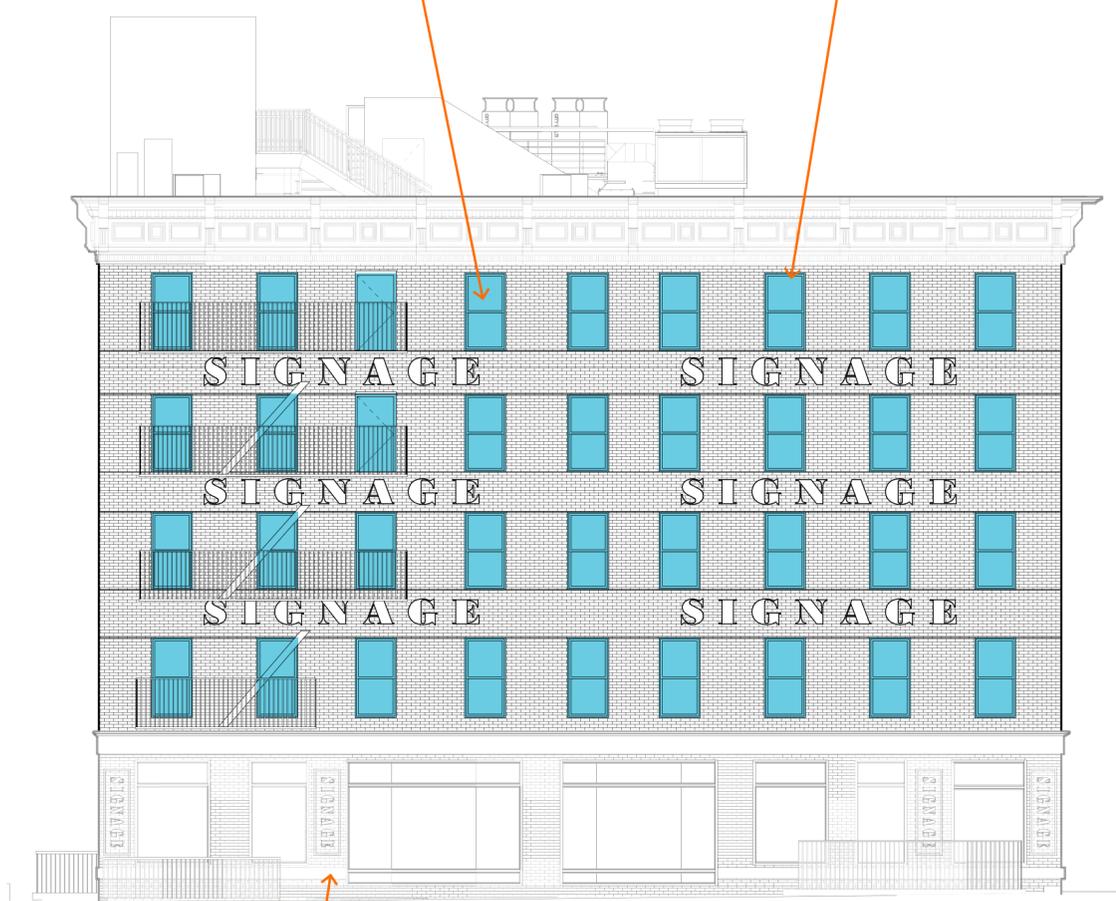
New aluminum window replacement to match historic

Lintel and Sills to be replaced. Cast Stone to match historic brownstone

Typical brick restoration as required
