PROJECT LOCATION
829 Greenwich St
Manhattan

LPC DISTRICT
Greenwich Village
Historic District

EXISTING CONDITIONS

APPENDIX

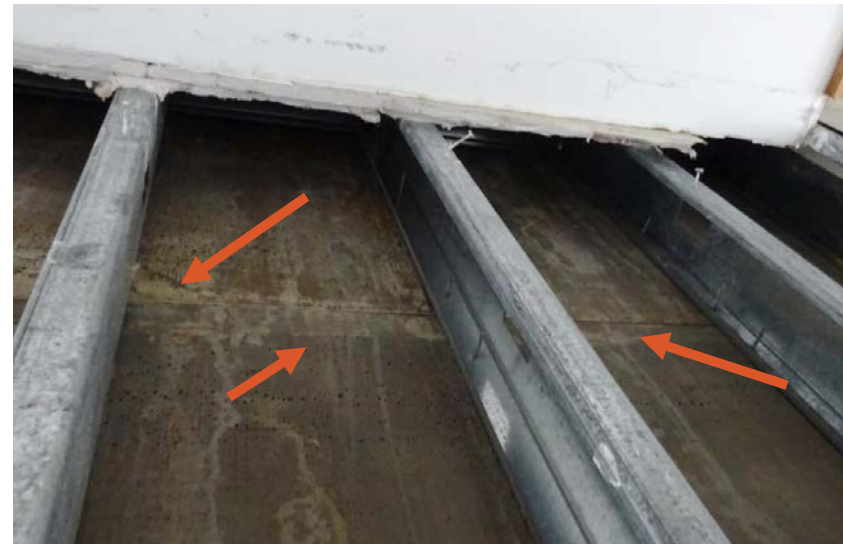
Steel plate, XPS insulation, self-adhered membrane waterproofing

Interior surface of exterior sheathing-staining and deterioration

Steel plate has water leaks, thermal bridges, and poor thermal performance

1. Replace rolled steel-framed curtain wall with opaque rainscreen systems
2. Provide punched openings with high-performance thermally-broken aluminum-framed window system
3. Replace doors with thermally-broken aluminum-framed system

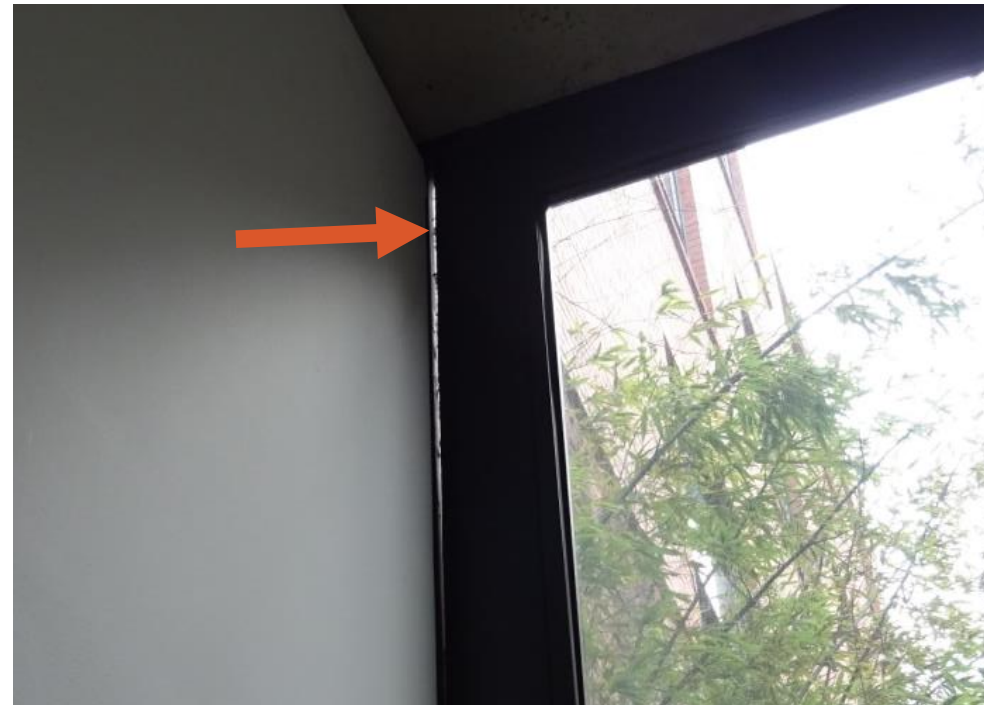
2

Misalignment / lack of gasket compression at bi-fold door

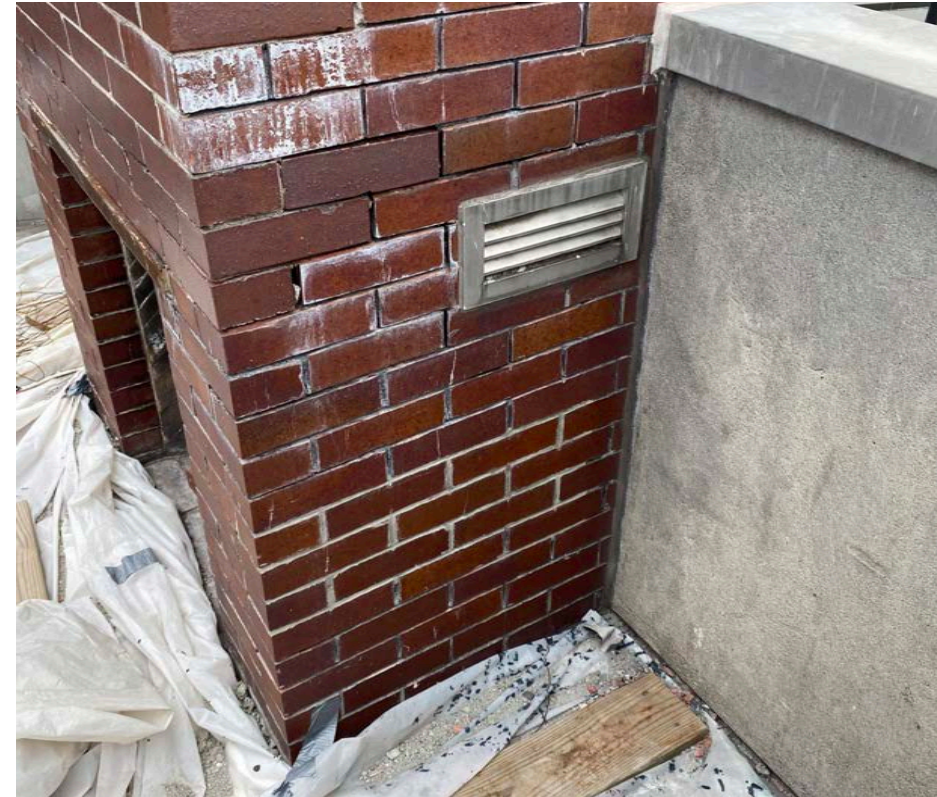
1
Deteriorated mortar at brick masonry chimney

1. Provide interior drainage system at cellar walls
2. Perform negative-side waterproofing repairs
3. Provide blind-side waterproofing at new foundation slab
4. Clad chimney

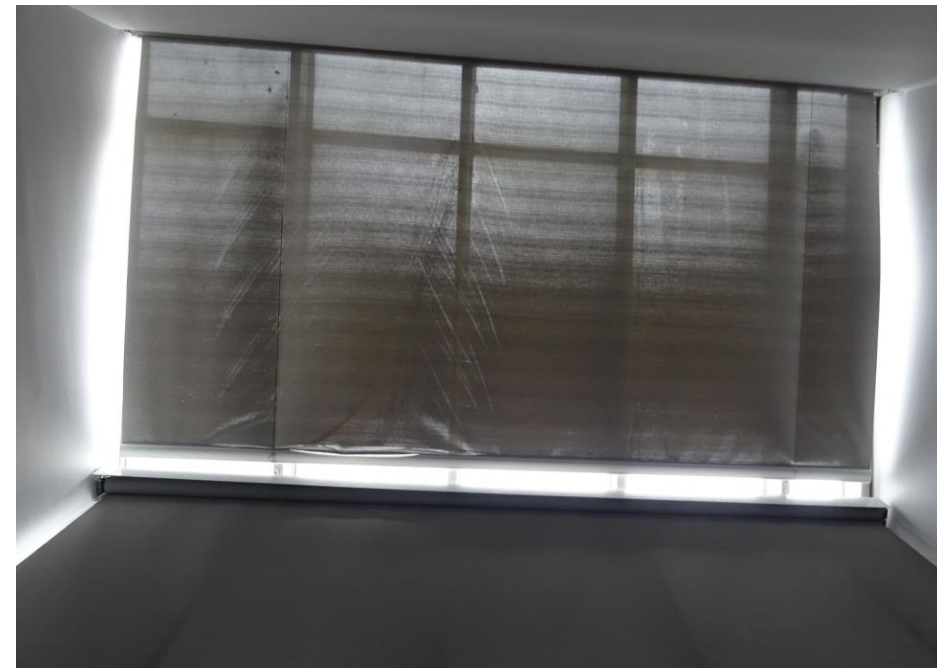
2
Excessive solar heat gain from roof skylight (shade installed to reduce heat gain)

Large skylight and bulkhead has air leaks, condensation at frames, and contributes to excessive solar heat gain

Replace large skylight/bulkhead with new smaller bulkhead with opaque rainscreen system and high-performance aluminum framed windows and door

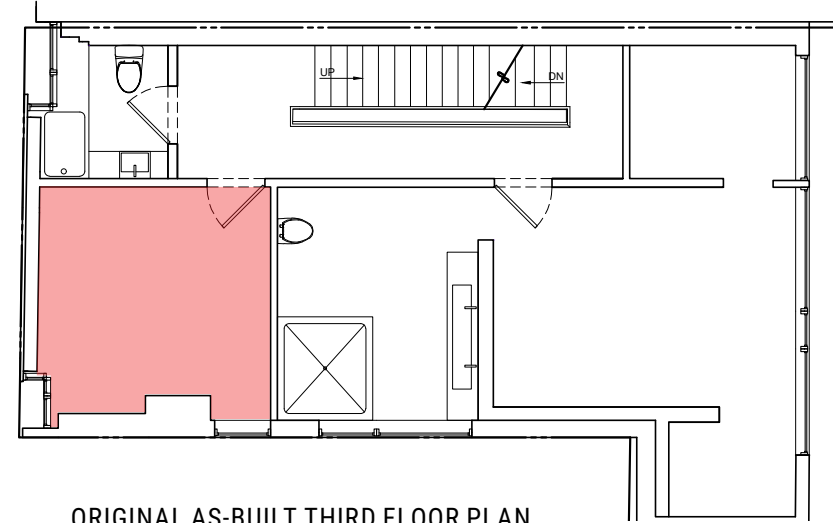
ORIGINAL AS-BUILT THIRD FLOOR PLAN

Existing front facade windows do not provide adequate light to interior habitable spaces at 2nd & 3rd floors, as per building code requirements

Original third floor front bedroom glazing area does not comply with code requirements

Floor area = 123 SF
 Required light (10%) = 12.3 SF
 Provided light = 8.2 SF

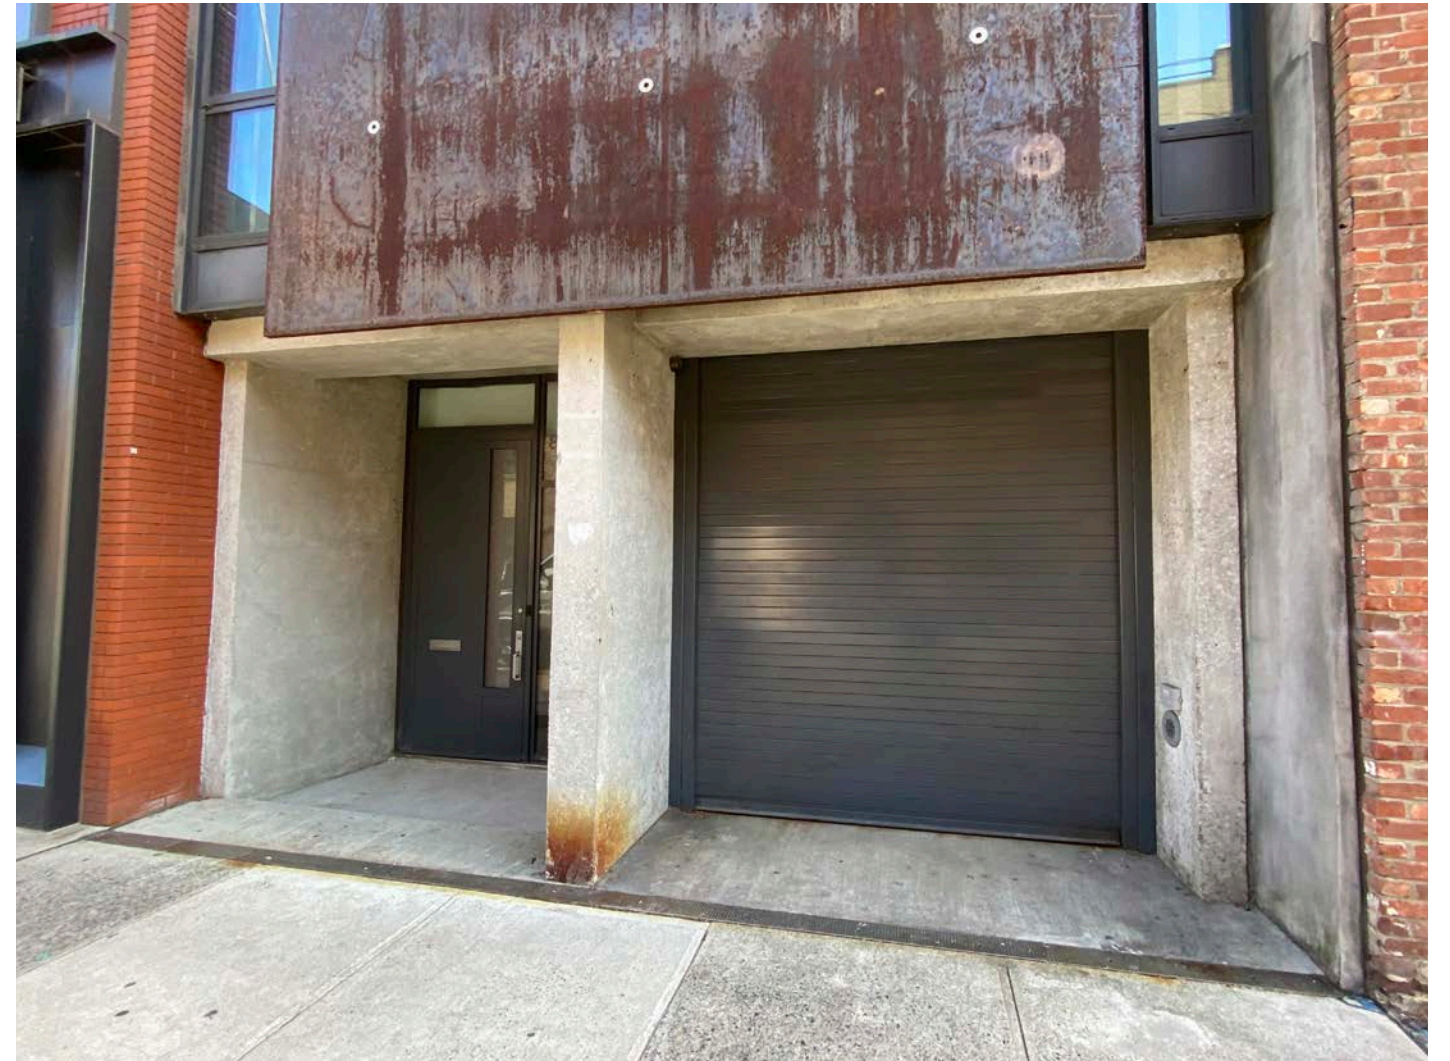
Recessed spaces at the entry door and garage door on the ground level of the front facade are deep enough to be used as shelters for transient individuals, creating a safety hazard

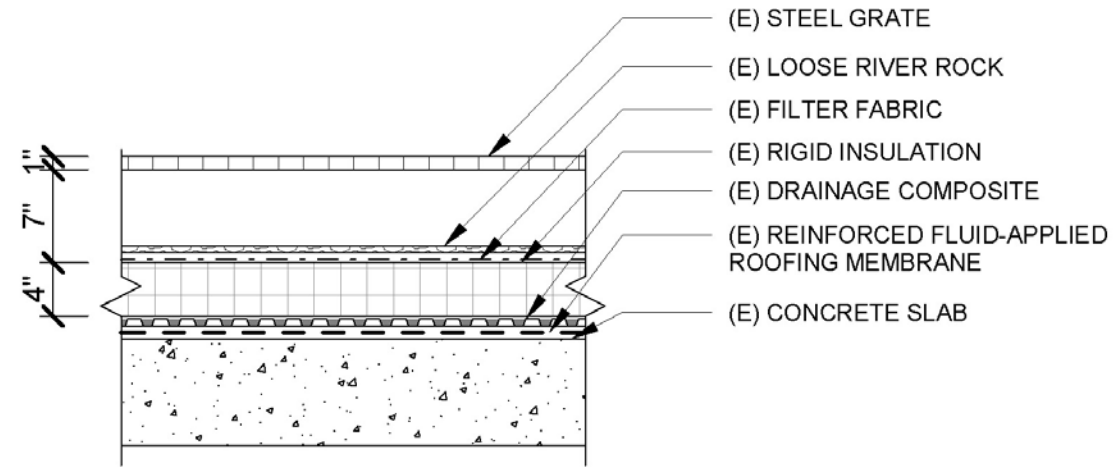
**EXISTING MAIN ROOF ASSEMBLY
 BACK TERRACE**

- Main Roof
 - Waterproofing terminates on uninsulated ducts, with unsealed seams
 - Poor thermal performance
- Parlor Level Terrace
 - Roofing system has failed
 - Water leaks to cellar
 - Stucco is deteriorated
- Skylights
 - Condensation at frames
 - Potential water leakage
 - Excessive solar heat gain

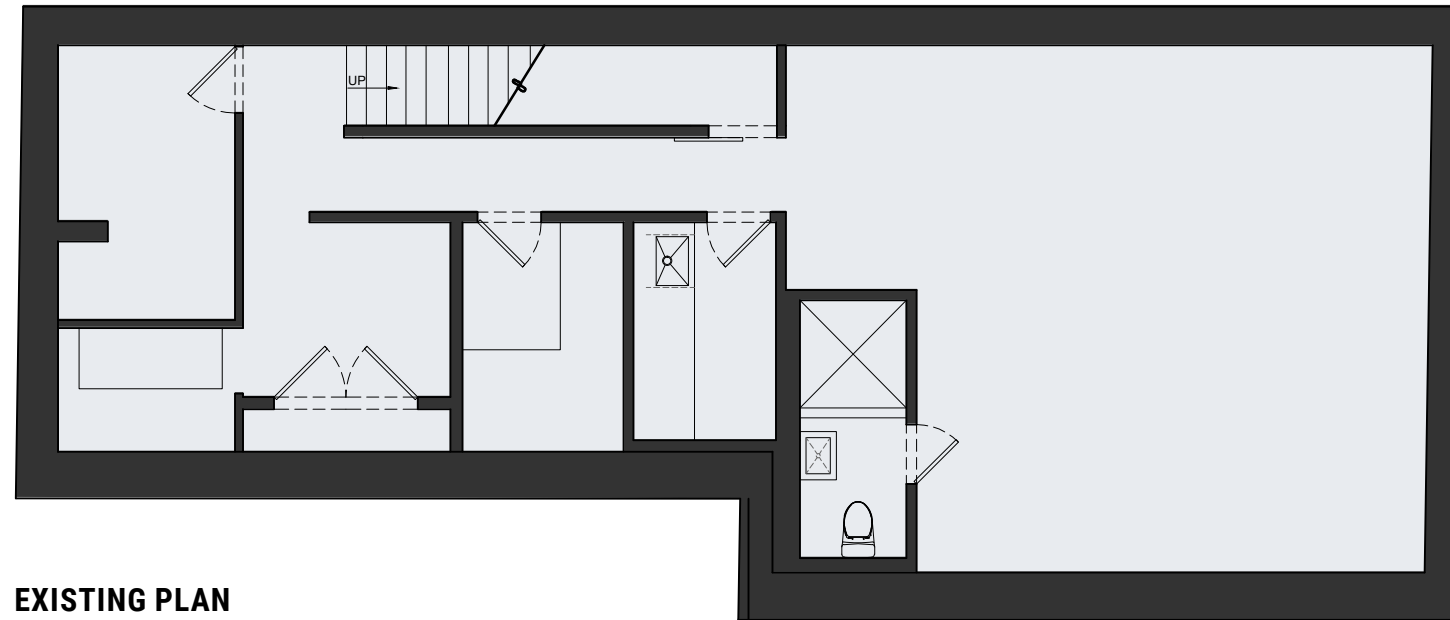
EXISTING PLAN

- Below-Grade Walls
 - Water leaks through existing rubble foundation walls
 - Ongoing pointing may reduce leakage but will not provide long term solution
 - Potential water leakage through east foundation wall
 - Foundation slab to be replaced
- Chimney
 - Water leaks through chimney
 - Ongoing pointing may reduce leakage but will not provide long term solution

Provide interior drainage system at cellar walls

Lower slab on west end of cellar for higher ceiling height and provide new waterproofing
