New York University Rubin Hall Renovation 35 Fifth Avenue, New York NY 10003

Landmarks Preservation Commission Community Board 2 Presentation

13 January 2022

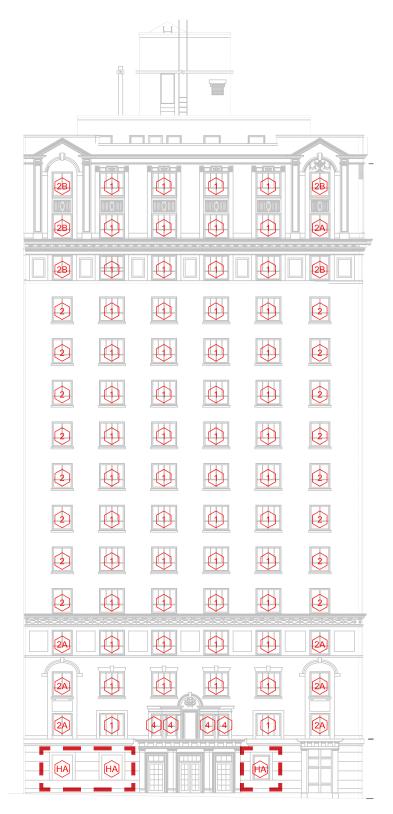
FIFTH AVENUE (WEST) ELEVATION

ASSIGNING HISTORIC WINDOW TYPES FOR REPLACEMENT

PROPOSED REPLACEMENT WINDOW TYPES ON PRIMARY FACADES ASSIGNED ACCORDING TO ARCHIVAL DOCUMENTATION

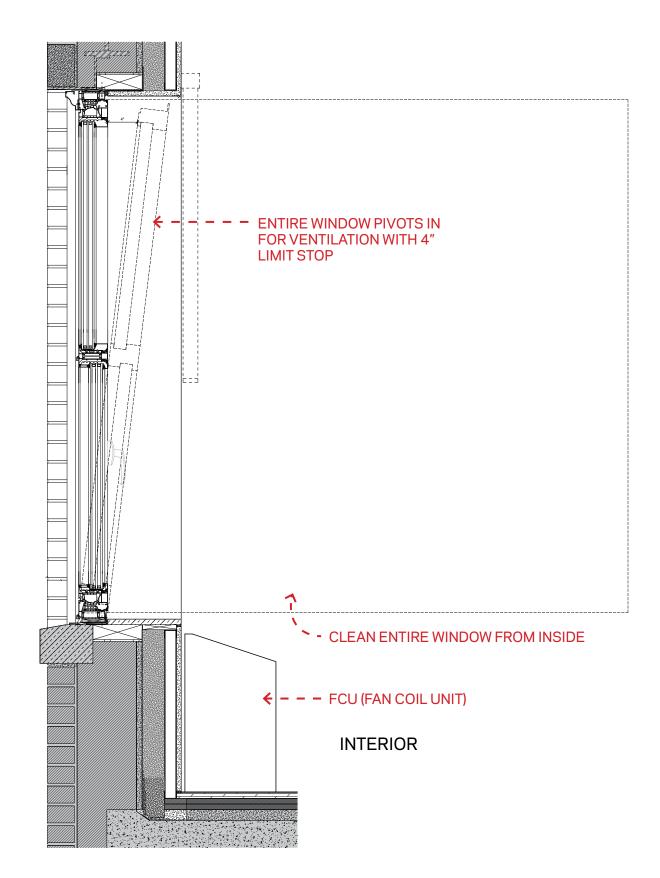
PROPOSED REPLACEMENT WINDOWS - SCHUCO

HISTORICAL APPROPRIATENESS:

- EXCEPT FOR OPERATION, ORIGINAL AESTHETIC OF THE WINDOWS
 WILL BE REINSTATED FOR THE FIRST TIME SINCE 1968
- NARROW MEETING RAIL, GLAZING REDUCTION FOR EXISTING HISTORIC WINDOWS IS MINIMIZED
- GLAZING PLANE IS OFFSET
- ORNAMENTAL ALUMINUM BRICK MOLD ADDS HISTORIC DETAILING

MAINTENANCE AND OPERATION:

- FULL WINDOW TILTS IN AS HOPPER FOR VENTILATION WITH 4" LIMIT STOP AND TURNS IN AS CASEMENT FOR MAINTENANCE, ALLOWING FULL ACCESS TO WINDOW FOR CLEANING
- ADA BEDROOMS WILL OPEN AS CASEMENT-ONLY FOR VENTILATION AND MAINTENANCE, ALLOWING FOR ADA COMPLIANT HANDLE OPERATION (ONLY OPTION DUE TO WEIGHT OF WINDOW)
- HIGHEST PERFORMANCE OF ALL OPTIONS, CONTRIBUTES TO LOCAL LAW 97 COMPLIANCE

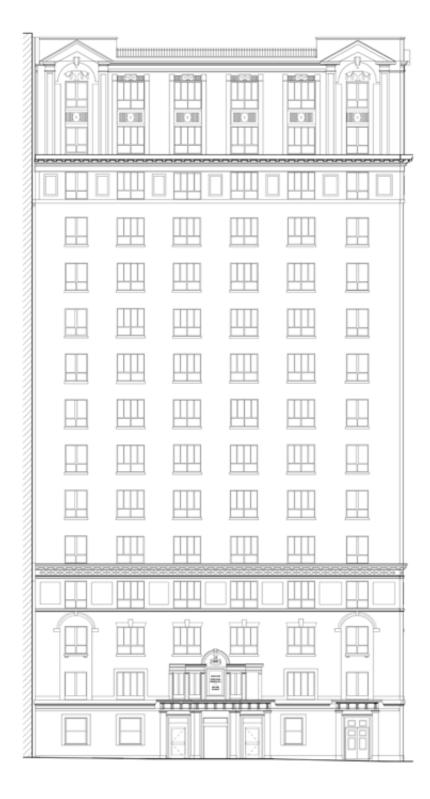
EXISTING NON-HISTORIC WINDOWS

BUILDING ELEVATIONS EXISTING AND PROPOSED - WEST FACADE (PRIMARY)

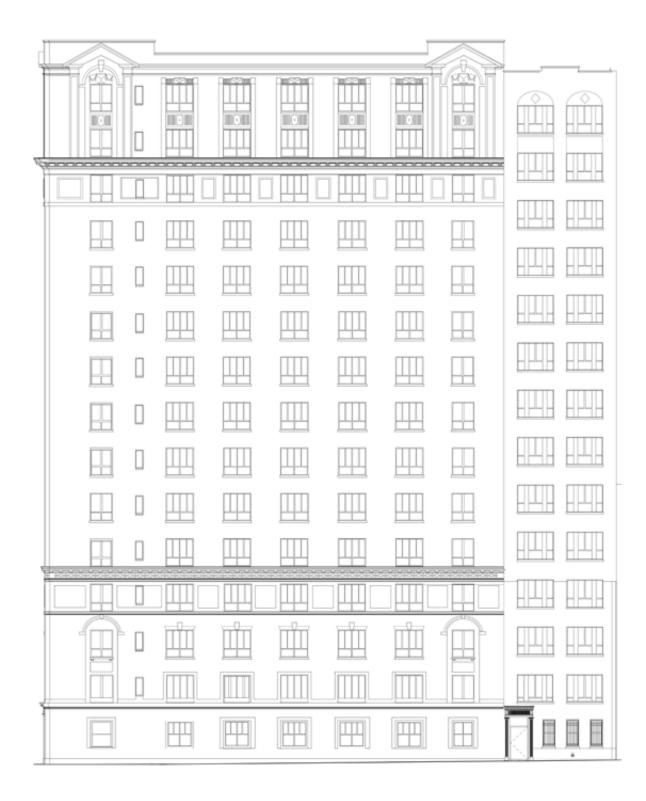
EXISTING NON-HISTORIC WINDOWS

BUILDING ELEVATIONS EXISTING AND PROPOSED - SOUTH FACADE (PRIMARY)

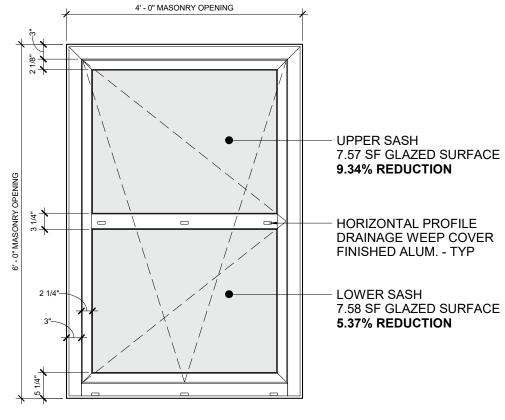
PROPOSED

PRIMARY FACADES: HISTORIC WINDOW TYPE HA HIGH-PERFORMANCE REPLACEMENT

5TH AVENUE 1ST FLOOR SCHUCO AWS 90.SI TILT/TURN

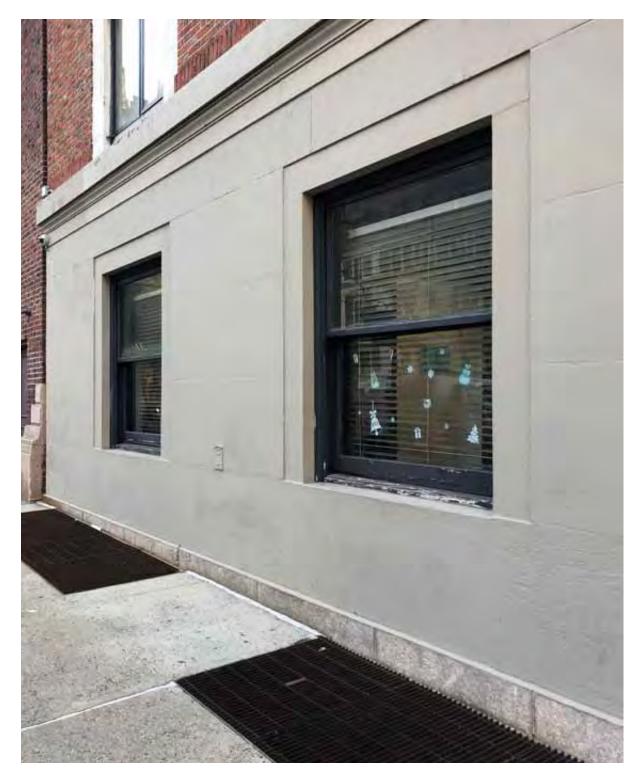
EXISTING TYPE HA WINDOWS

PRIMARY FACADES: HISTORIC WINDOW TYPE HA HIGH-PERFORMANCE REPLACEMENT - RENDERED VIEW

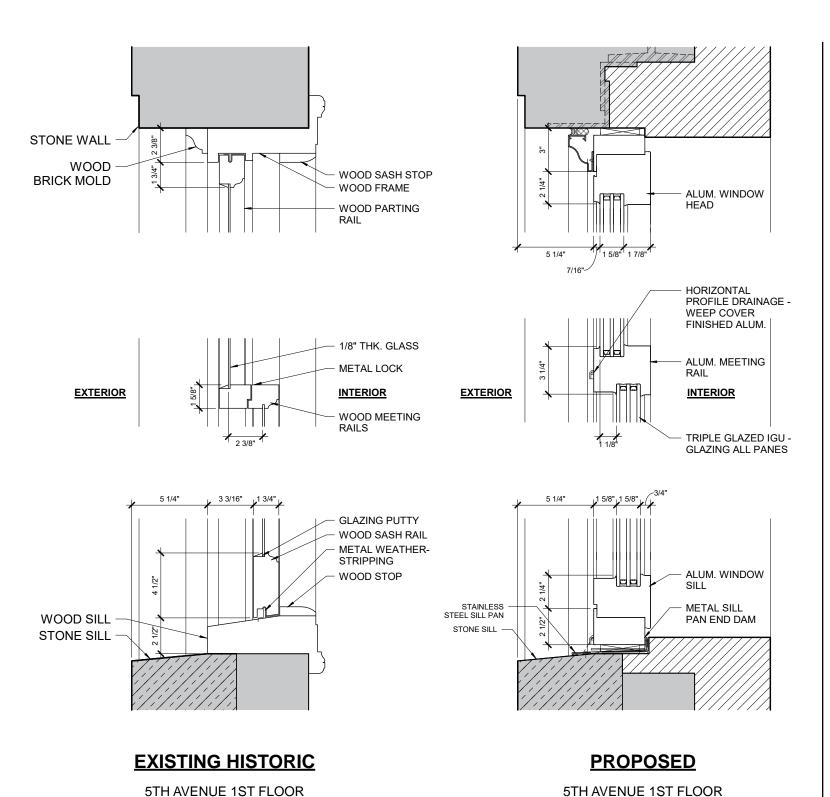
PRIMARY FACADES: HISTORIC WINDOW TYPE HA-1 HIGH-PERFORMANCE REPLACEMENT

SCHUCO AWS 90.SI TILT/TURN

INTERIOR TRIPLE GLAZED IGU **ALUMINUM JAMB** ALUMINUM BRICK MOLD STONE WALL **EXTERIOR**

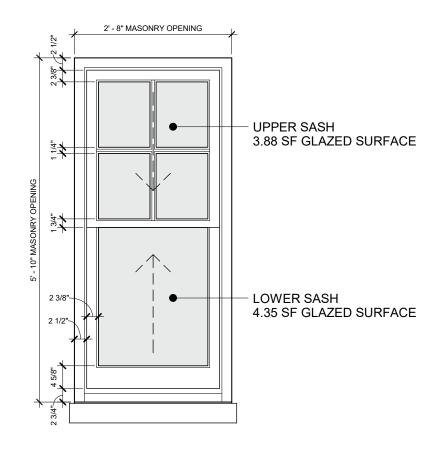
EXISTING HISTORIC

PRIMARY FACADES: HISTORIC WINDOW TYPE HB HIGH-PERFORMANCE REPLACEMENT

10TH STREET 1ST FLOOR (ANNEX)

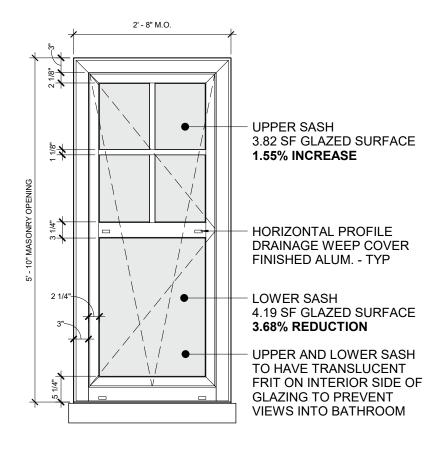
PROPOSED

10TH STREET 1ST FLOOR (ANNEX) SCHUCO AWS 90.SI TILT/TURN

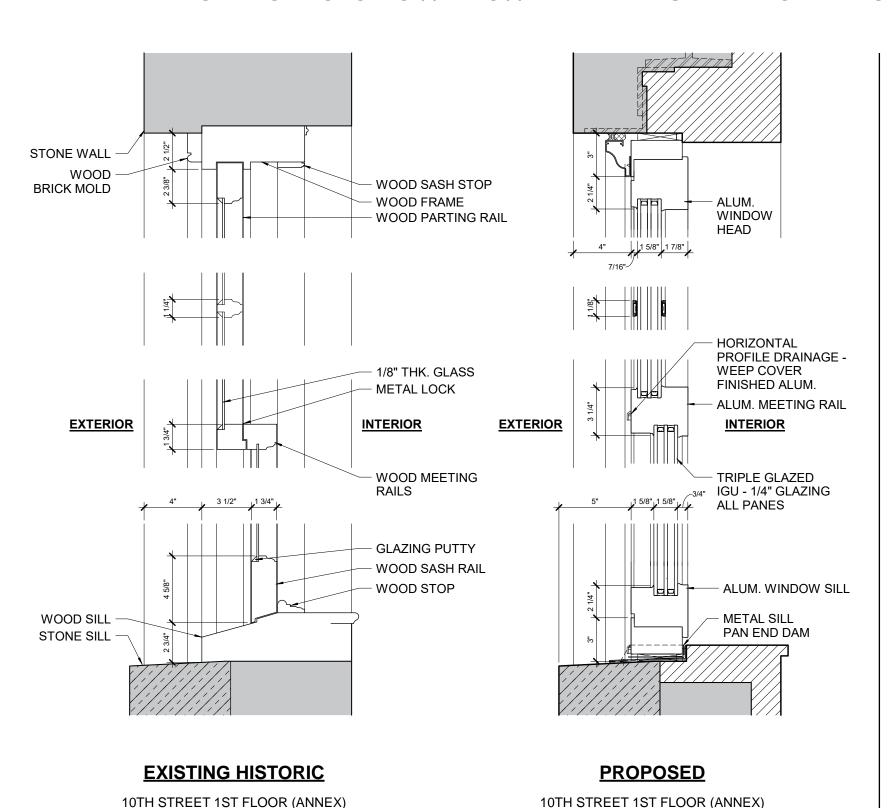
PRIMARY FACADES: HISTORIC WINDOW TYPE HB HIGH-PERFORMANCE REPLACEMENT

SCHUCO AWS 90.SI TILT/TURN

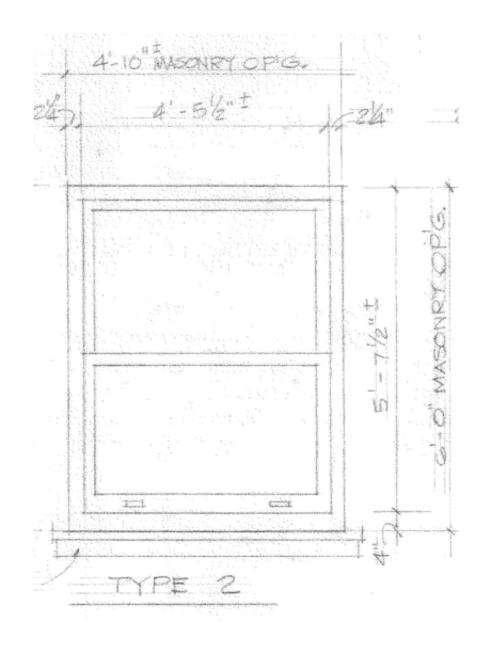
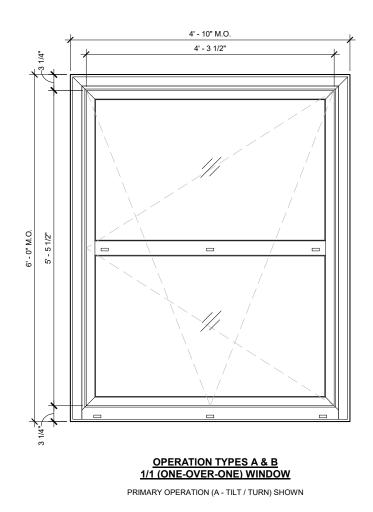
1968 HISTORIC WINDOW DOCUMENTATION (SHOWN FROM INTERIOR)

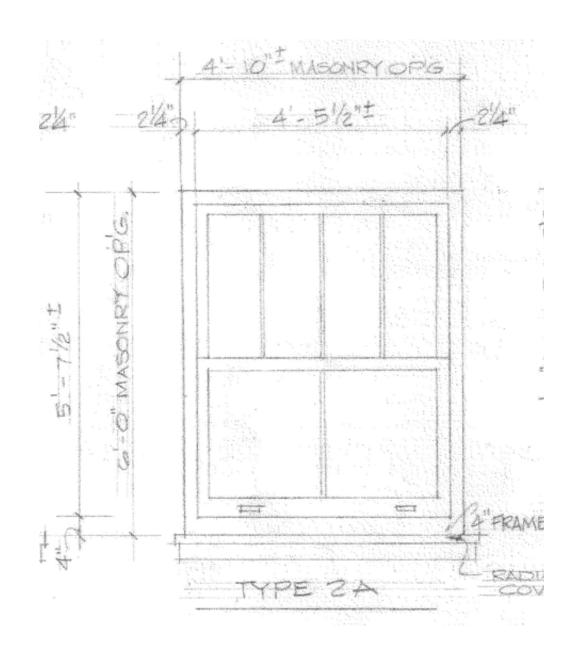
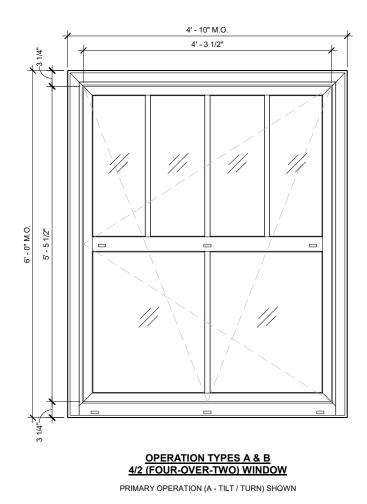
1968 HISTORIC WINDOW DOCUMENTATION (SHOWN FROM INTERIOR)

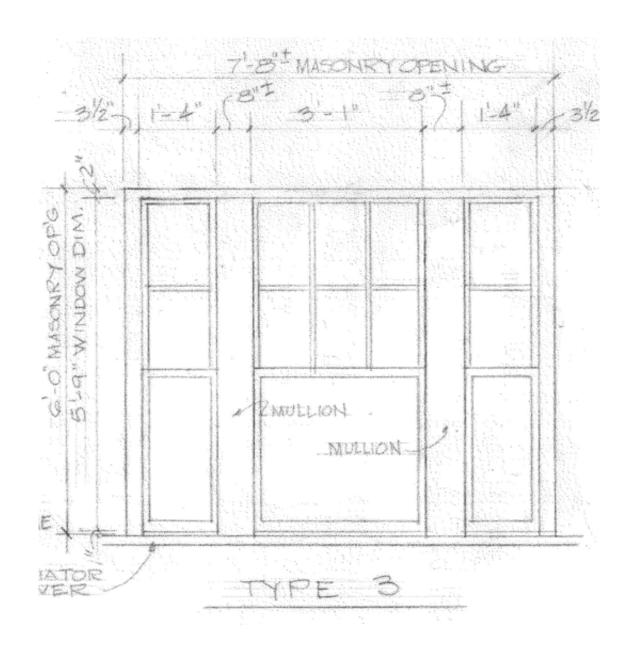
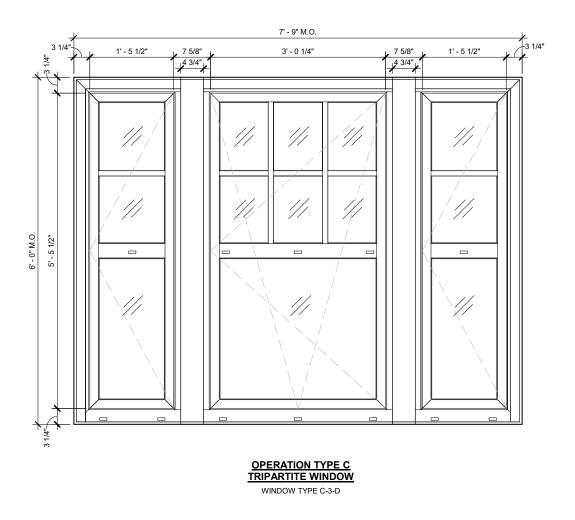
1968 HISTORIC WINDOW DOCUMENTATION (SHOWN FROM INTERIOR)

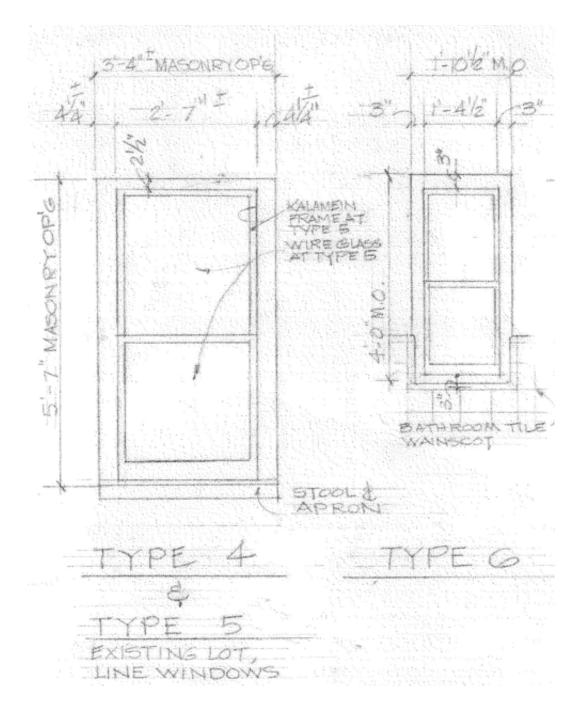
1968 HISTORIC WINDOW DOCUMENTATION (SHOWN FROM INTERIOR)

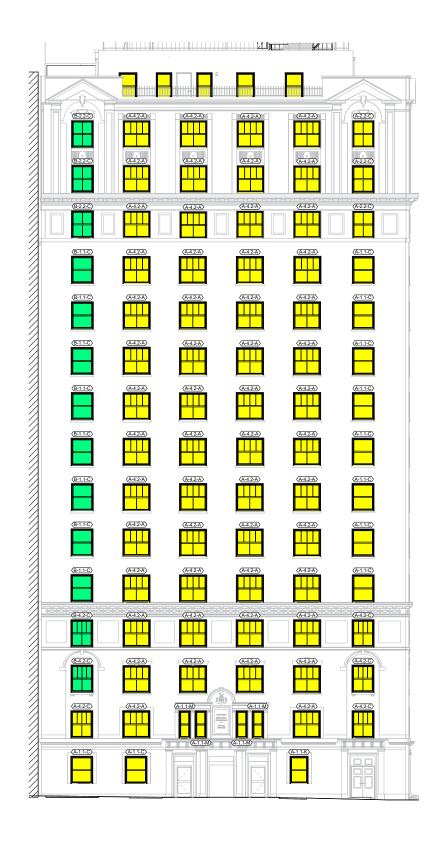
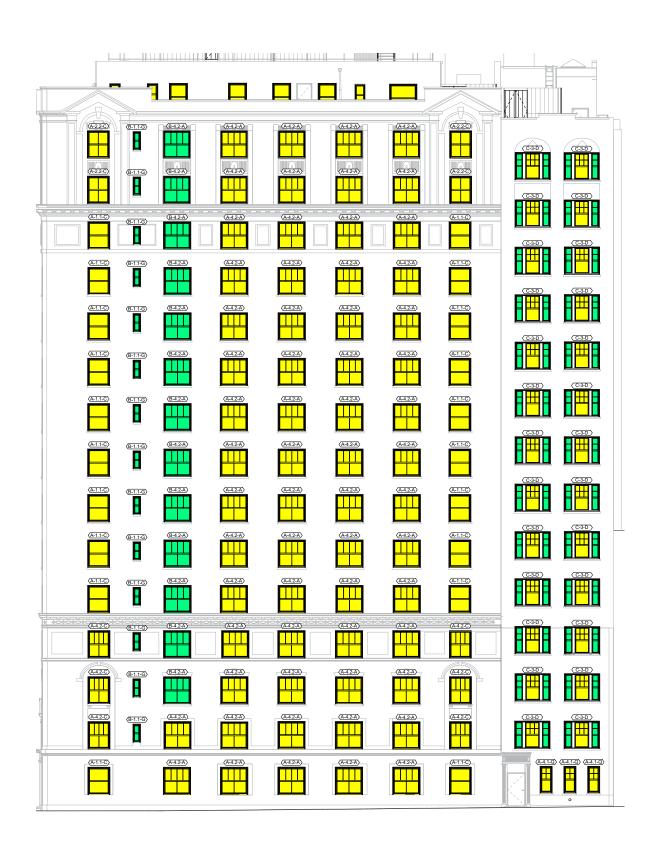
WINDOW OPERATON KEYED ELEVATIONS

- TILT FOR VENTILATION
- CASEMENT FOR MAINTENANCE

- ADA BEDROOMS
- NARROW WINDOW LOCATIONS

- CENTER TILT/TURN
- SIDES CASEMENT (MAINT. ONLY)

D - FIXED WINDOW (NOT VISIBLE)

- EXTREMELY NARROW WINDOWS
- SELECT PENTHOUSE LOCATIONS

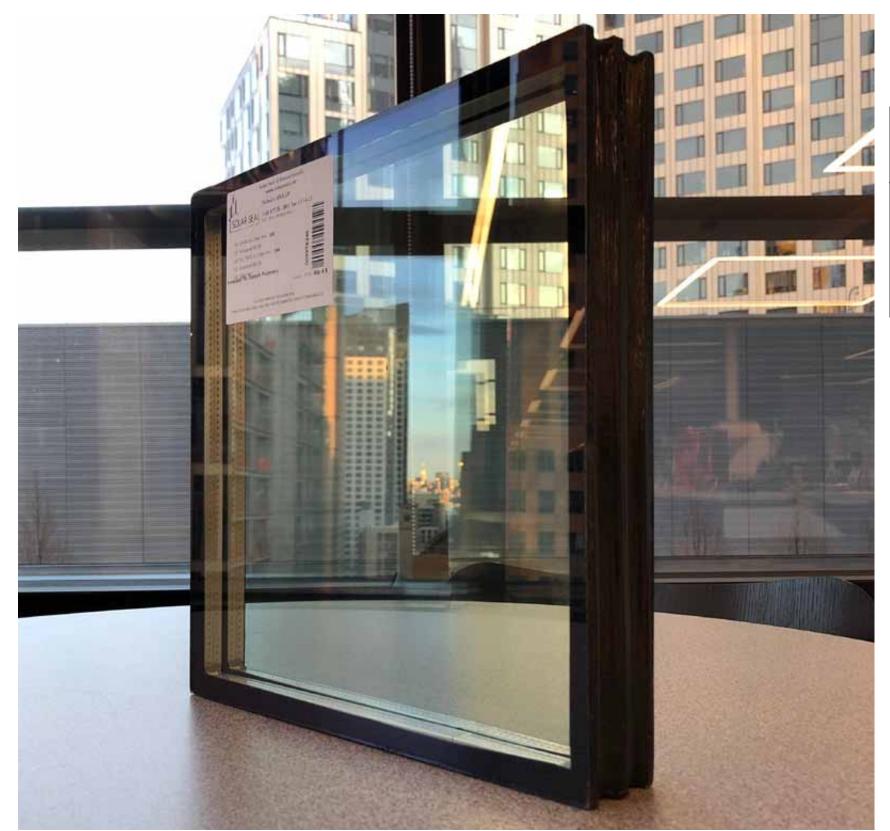
WINDOW GLAZING

Make-up Name	Make-up Icon	Glass 1 & Coating	Glass 2 & Coating	Visible Light				Solar Energy			Thermal Properties	
Ma					Transmit tance	Reflectance		Color Rendering	Transmit tance	Reflectan ce	Gain	U-Value	
					Visible (τ _V %)	ρ _V % out	ρ _V % in	Index (R _a)	Solar (τ _e %)	ρ _e % out	Coefficient (SHGC)	Winter Night (Btu/hr-ft²-F)	Summer Day (Btu/hr-ft²-F)
Neu	N68 #2 with utral 78/65 #4 ith Krypton	111	SunGuar d® SN 68 (North America) on Guardian Clear Glass (North America)	America)	59.7	13.6	15.9	93.9	27.8	34.1	0.330	0.117	0.093

- CONTRIBUTE TO LOCAL LAW 97
 COMPLIANCE
 - AIR INFILTRATION
 - 1.0 ACH REQUIREMENT
 - EXCLUDES DOUBLE HUNG WINDOWS
 - THERMAL PERFORMANCE
 - -TRIPLE GLAZING
 - U-VALUE 0.18
 - ENERPHIT COMFORT CRITERIA
 IF POSSIBLE
- MATERIAL/DURABILITY
 - ALUMINUM WINDOWS (AW60 MINIMUM RATING)

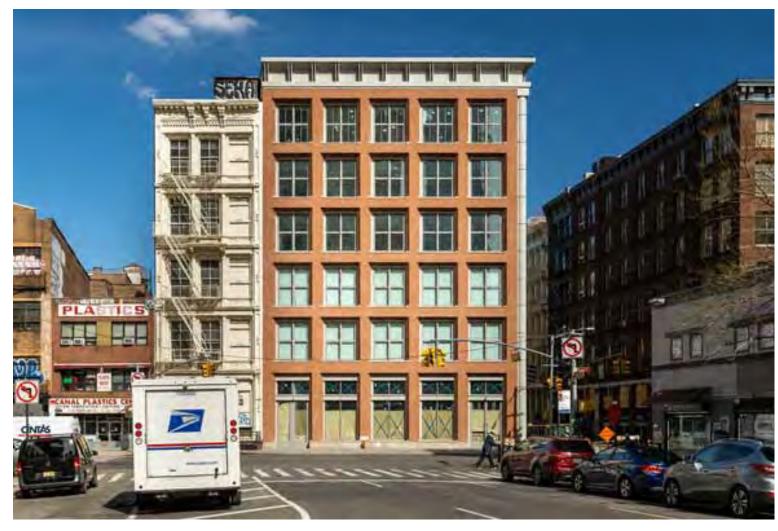
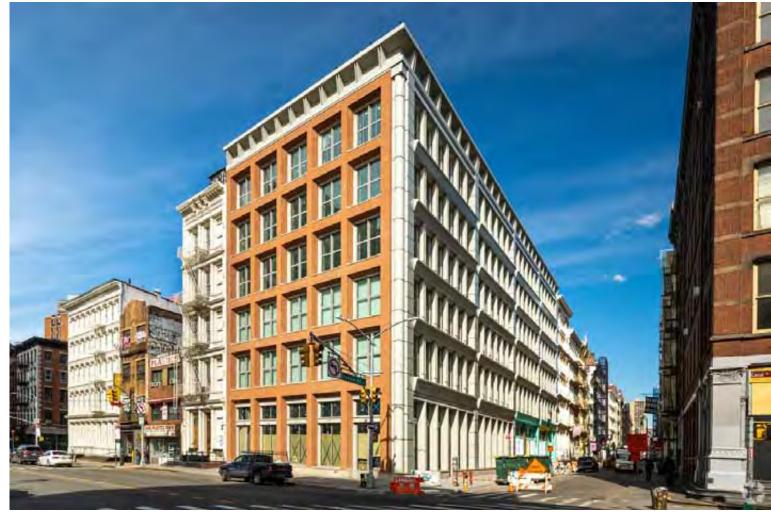
WINDOW - SIMILAR SCHUCO TILT/TURN WINDOW IN HISTORIC DISTRICT

11 GREENE STREET, SOHO NY SCHUCO TILT-TURN WINDOWS (NOT OFFSET GLAZING) ROOFTOP MECHANICAL, ELECTRICAL & PLUMBING EQUIPMENT

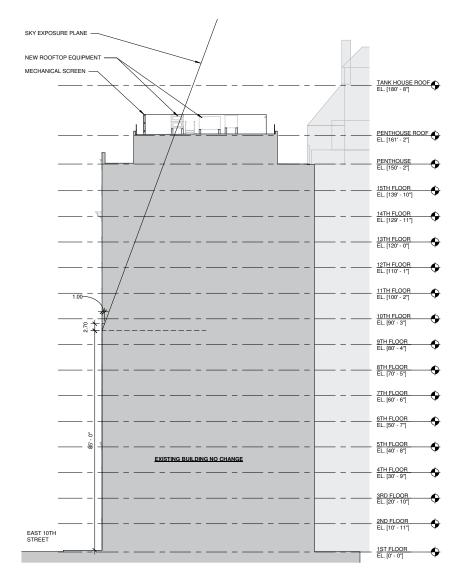
MECHANICAL SCREENING REQUIREMENT (23-51 PERMITTED OBSTRUCTIONS)

MECHANICAL EQUIPMENT IS PERMITTED TO OBSTRUCT THE SKY EXPOSURE PLANE PROVIDED THAT:

- THE EQUIPMENT BE NOT LESS THAN 10 FEET FROM THE STREET WALL
- THE EQUIPMENT BE SCREENED

ZONING DIAGRAM SHOWING SKY EXPOSURE PLANE

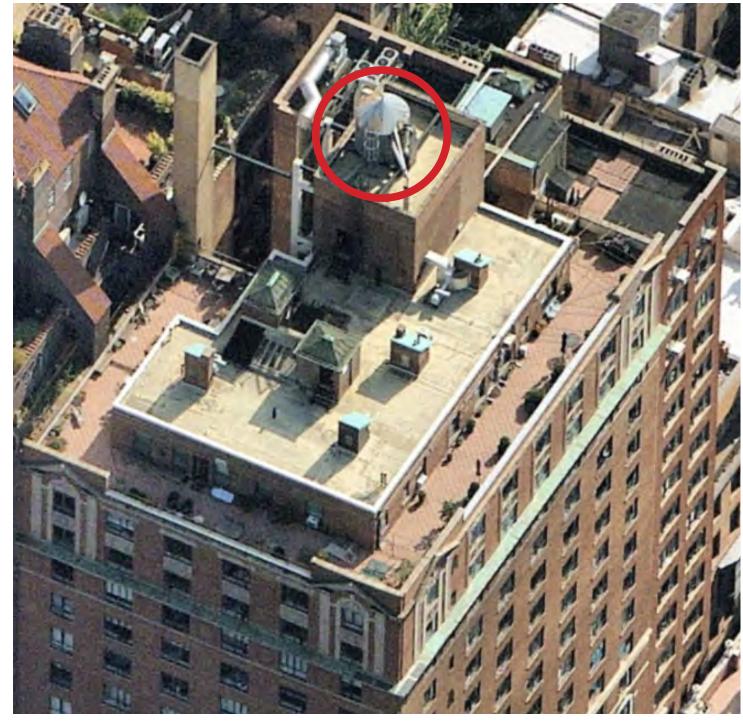
WATER TANK REMOVAL

AERIAL VIEW OF ROOF - VIEW TO NORTHEAST

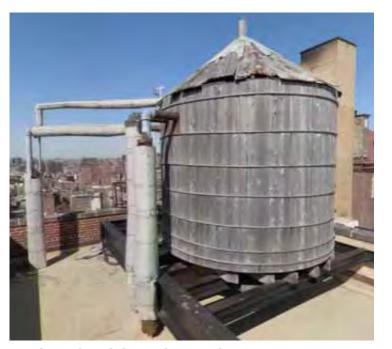
EXISTING WOOD WATER TANK

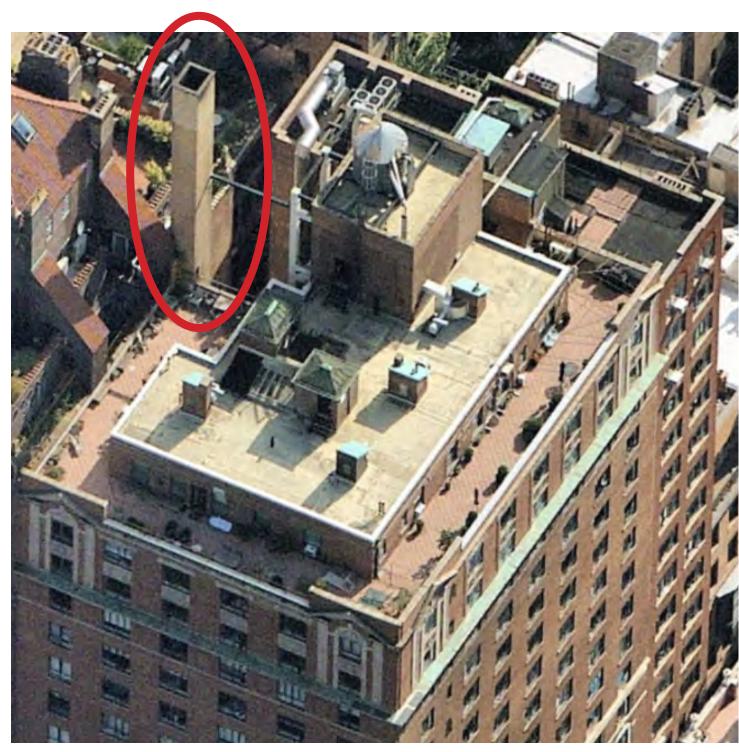
BRICK FLUE REMOVAL

AERIAL VIEW OF ROOF - VIEW TO NORTHEAST

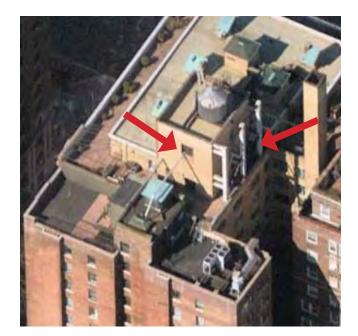
AERIAL VIEW OF TANK HOUSE

ADDITION OF VENTILATION FOR EMERGENCY GENERATOR AT TANK HOUSE

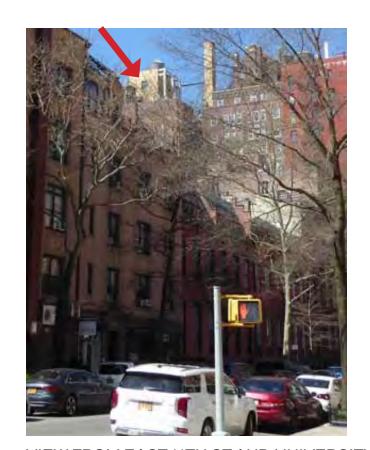
VIEW FROM EAST 11TH ST AND UNIVERSITY PL

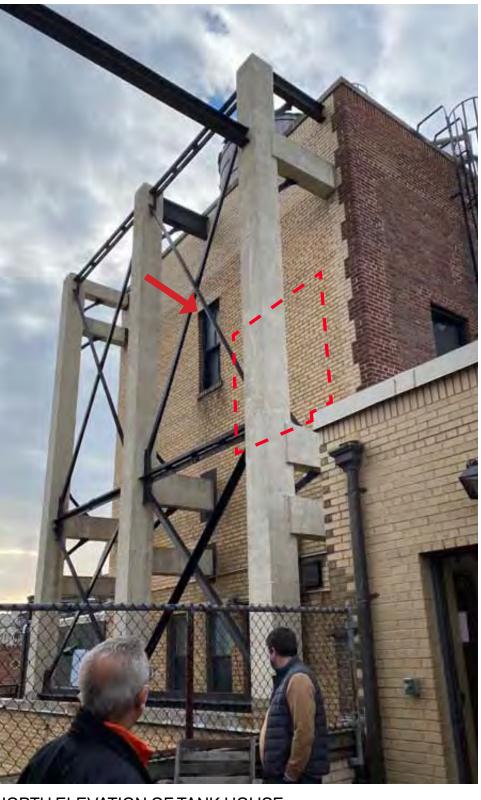
NORTH ELEVATION OF TANK HOUSE

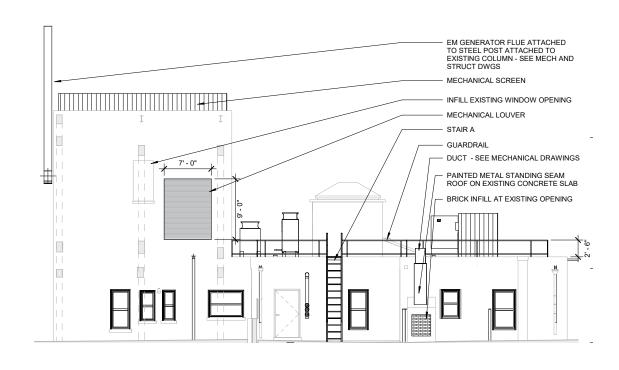
NORTH ELEVATION OF TANK HOUSE

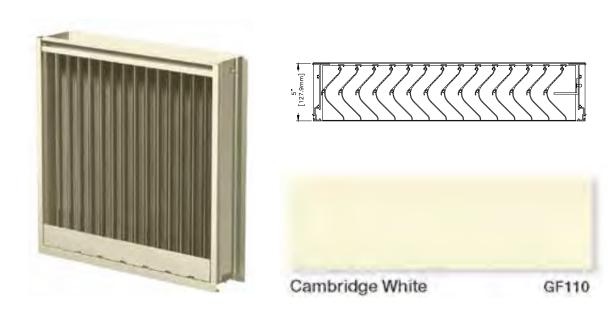
LOUVER IMAGE AND FINISH COLOR

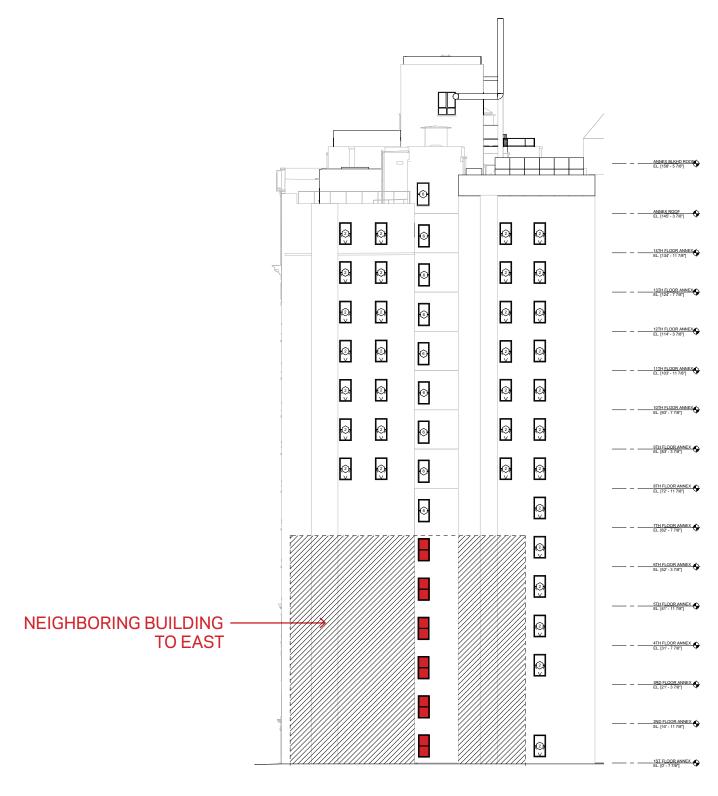
REMOVAL AND INFILL OF EXISTING NON-VISIBLE STAIR, BATHROOM AND DORM WINDOWS

EAST ELEVATION (STAIRWELL WINDOWS)

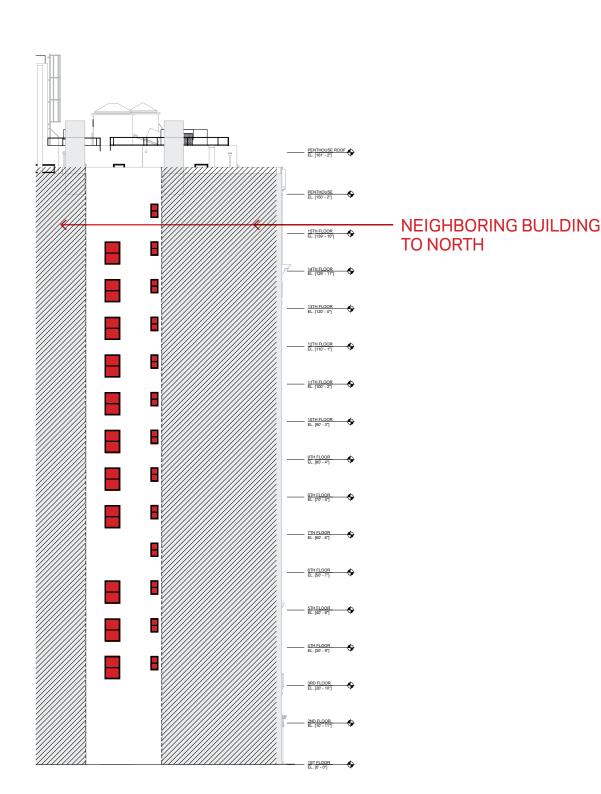
NORTH ELEVATION (BATHROOM & DORM WINDOWS)

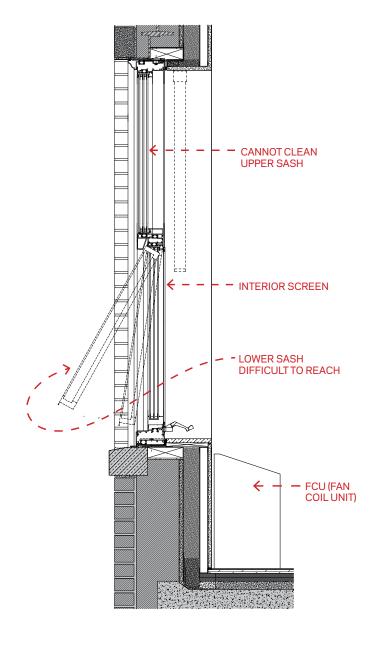
OPTION 1A - WAUSAU
OUT-SWING AWNING LOWER
U-VALUE 0.278

Wausau - Option 1a (Woolworth - Customized)	Wausau - Option 1b (Woolworth - Customized)	Schuco - Option 2 (AWS-90.SI - Customized)
Operation	Simulated Double Hung Fixed upper, out-swing awning lower	Simulated Double Hung Out-swing awning lower for ventilation, in-swing awning upper for maintenance	Simulated Double Hung Full-window in-swing hopper for ventilation, full-window in-swing casement for maintenance
Cleanability from Interior	Not cleanable from interior	Fully cleanable from interior	Fully cleanable from interior
Sash/Glazing planes closely match historic	Sash and glazing are offset	Sash and glazing are offset	Glazing is offset, sash is not
Details closely match historic	 Head, sill and jamb details approximate original Meeting rail is slim, but offset from center to accomodate hardware Brick molds and muntins will approximate original 	 Head, sill and jamb details approximate original Meeting rail is wide to accomodate upper sash operability, and offset from center to accomodate hardware Brick molds and muntins will approximate original 	 Head, sill and jamb details differ from original Meeting rail is slim Brick molds and muntins will approximate original

Glazing area diminution 6% nominal maximum	Yes - or close (see elevations)	No - Over 6% (see elevations)	Yes - or close (see elevations)
Passive House level U-value (Triple Glazing) & Airtightness	No U-value 0.278	No U-value 0.285	Yes U-value 0.18
Meets EnerPHit comfort criteria	No - requires perimeter heat source	No - requires perimeter heat source	Yes
NYU Priority	Does not meet NYU criteria	NYU 2nd Choice	NYU 1st Choice

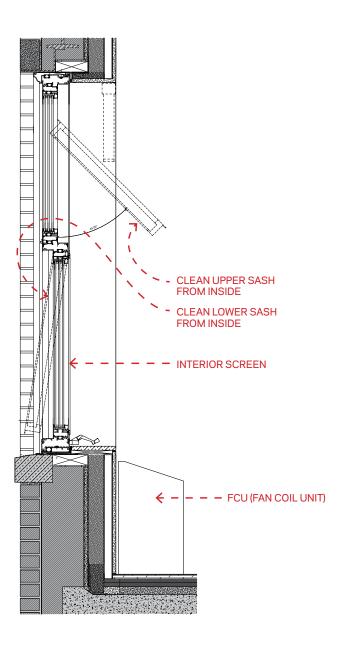
OPTION 1B - WAUSAU
IN-SWING AWNING UPPER
OUT-SWING AWNING LOWER
U-VALUE 0.285

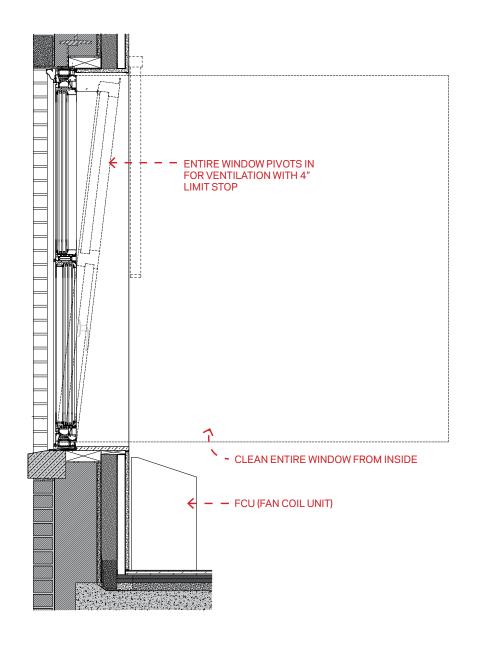
OPTION 2 - SCHUCO
WHOLE-WINDOW TILT/TURN
U-VALUE 0.18

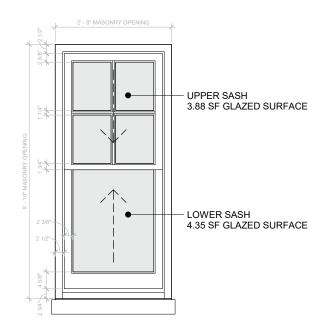
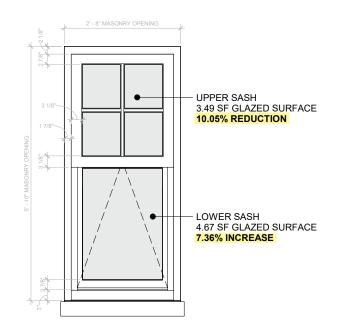
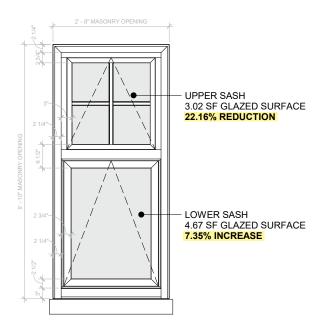
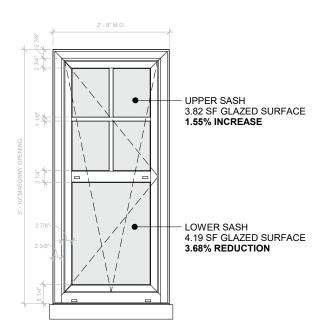
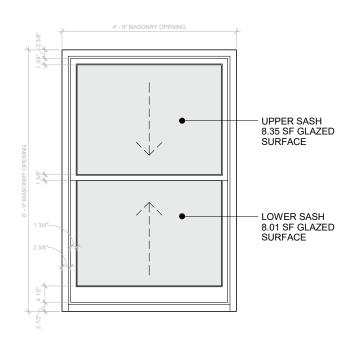
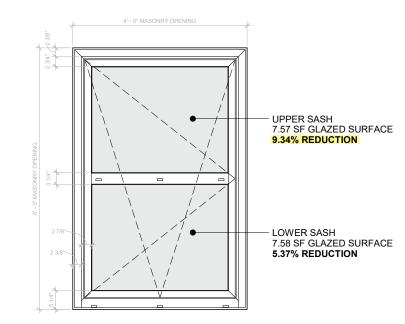
COMPARING EXISTING HISTORIC WINDOWS WITH HIGH-PERFORMANCE REPLACEMENT OPTIONS

UPPER SASH
7.18 SF GLAZED
SURFACE
14.01% REDUCTION

LOWER SASH
8.09 SF GLAZED
SURFACE
1.00% INCREASE

UPPER SASH
6.38 SF GLAZED
SURFACE
23.44

LOWER SASH
8.06 SF GLAZED
SURFACE
0.62% INCREASE

EXISTING HISTORIC WINDOWS
TYPE HB (UPPER) & HA (LOWER)

DOUBLE HUNG

REPLACEMENT WINDOWS
OPTION 1B - WAUSAU
LOWER OUT-SWING AWNING (VENT.)

UPPER IN-SWING AWNING (MAINT.)

OPTION 2 - SCHUCO

FULL WINDOW IN-SWING HOPPER (VENT.)

FULL WINDOW IN-SWING CASEMENT (MAINT.)

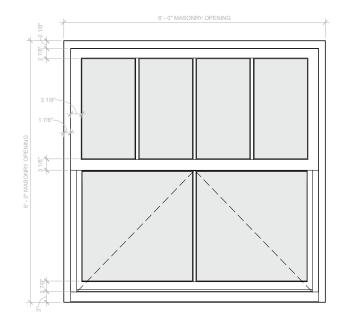
TYPE 1 WINDOW - OPTION 1A - WAUSAU LOWER OUT-SWING AWNING OPERATION

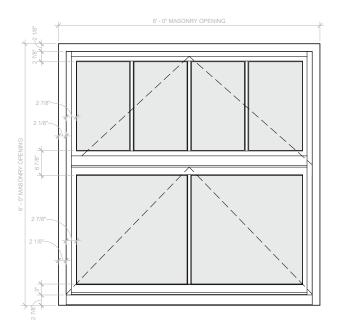
TYPE 1 WINDOW - OPTION 1B - WAUSAU
LOWER OUT-SWING AWNING (VENTILATION)
UPPER IN-SWING AWNING (MAINTENANCE)

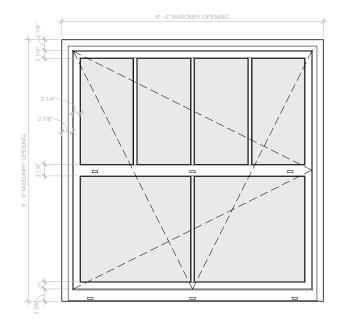
TYPE 1 WINDOW - OPTION 2 - SCHUCO

FULL WINDOW IN-SWING HOPPER (VENTILATION)

FULL WINDOW IN-SWING CASEMENT (MAINTENANCE)

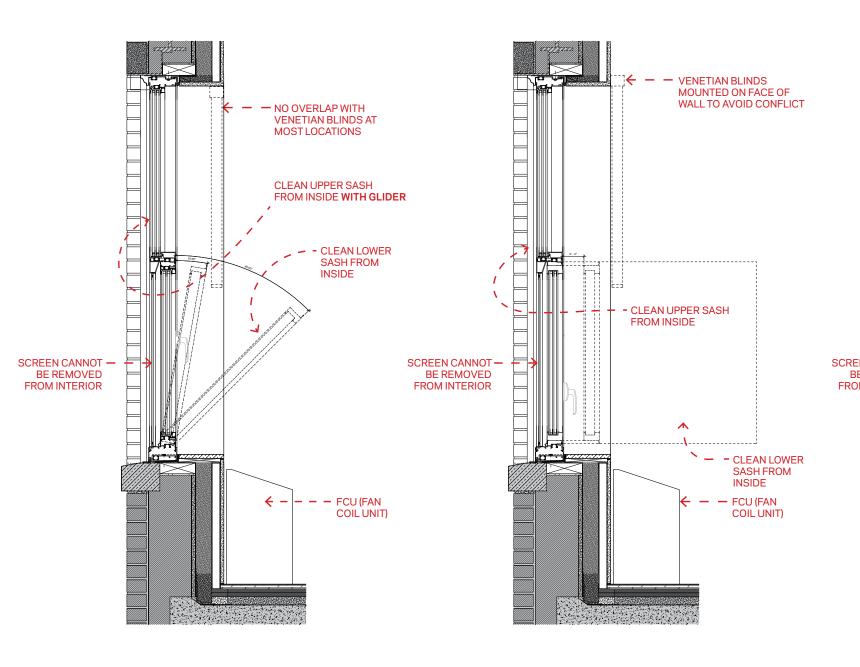
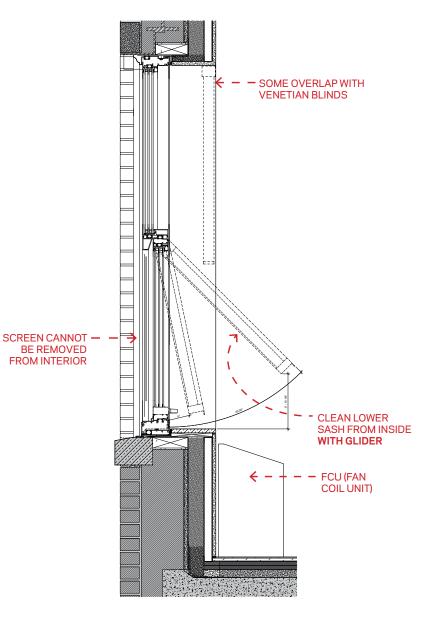
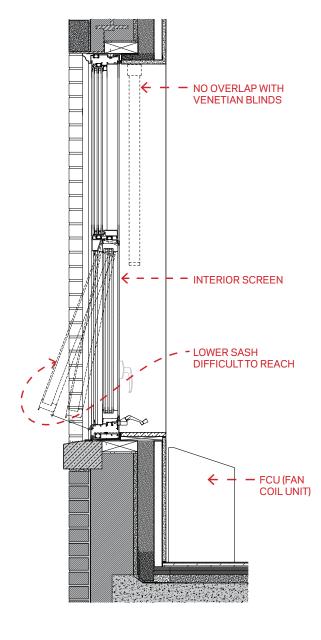
WINDOW STUDIES - WAUSAU - OPTION 1A STUDY

HOPPER LOWER

★ NOT ADA COMPLIANT DUE TO WEIGHT OF SASH AND LOCATION OF HANDLES

CASEMENT LOWER

★ NOT ACHIEVABLE DUE TO WEIGHT AND SASH GEOMETRY

IN-SWING AWNING LOWER

- **★ LOWER SASH CLEANABLE**BUT DIFFICULT TO REACH
- ★ UPPER SASH NOT CLEANABLE
- ***** WATER INFILTRATION LIKELY
- ★ SCREEN NOT ACCESSIBLE FROM INTERIOR

OUT-SWING AWNING LOWER

- **★ LOWER SASH CLEANABLE**BUT DIFFICULT TO REACH
- **★** UPPER SASH NOT CLEANABLE
- ✓ NO WATER INFILTRATION
- ✓ INTERIOR INSECT SCREEN

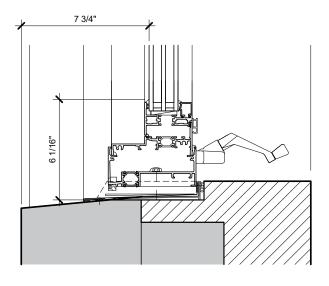
TYPE HA WINDOW
EXISTING HISTORIC
DOUBLE HUNG

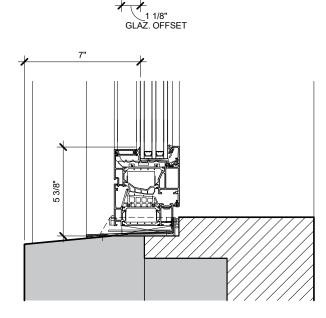
TYPE HA WINDOW
OPTION 1A - WAUSAU
LOWER OUT-SWING AWNING
